**LIMITED OCCURRENCE INVESTIGATION REPORT – FINAL**

| <b>Reference Number</b> | CA18/2/3/10627 | | | | | | |
| <b>Registration</b> | ZU-JHM | | | | | | |
| <b>Make; Model; S/N</b> | Samba XXL (Serial Number: SA XL 45) | | | | | | |

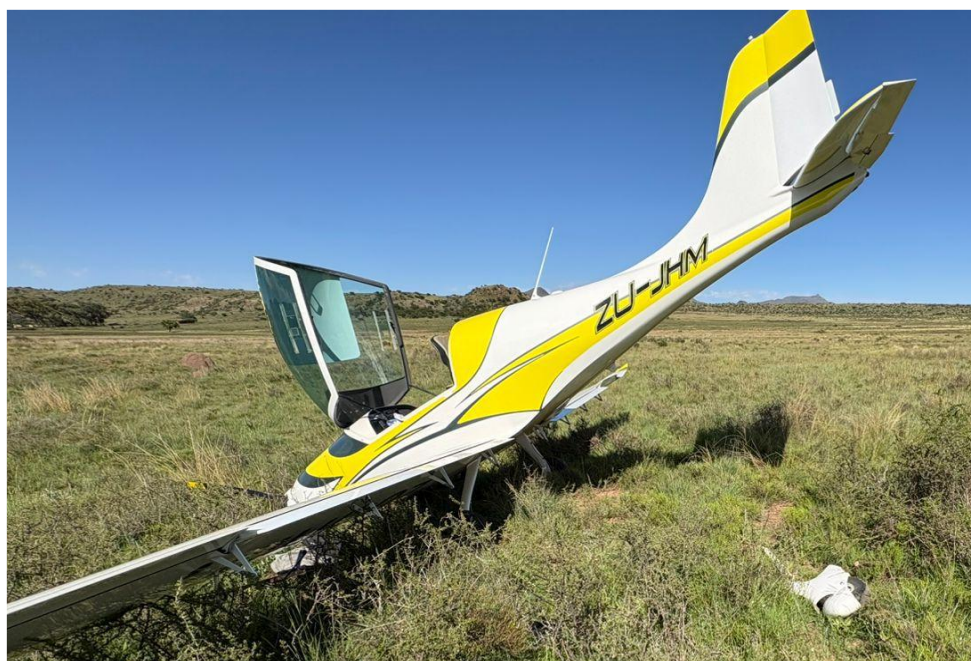
which the propeller struck the ground. The aircraft came to a stop approximately 100 metres beyond the runway threshold. The pilot and the passenger were not injured. The aircraft was substantially damaged.

**Figure 2:** The aircraft after the accident. (Source: Pilot)

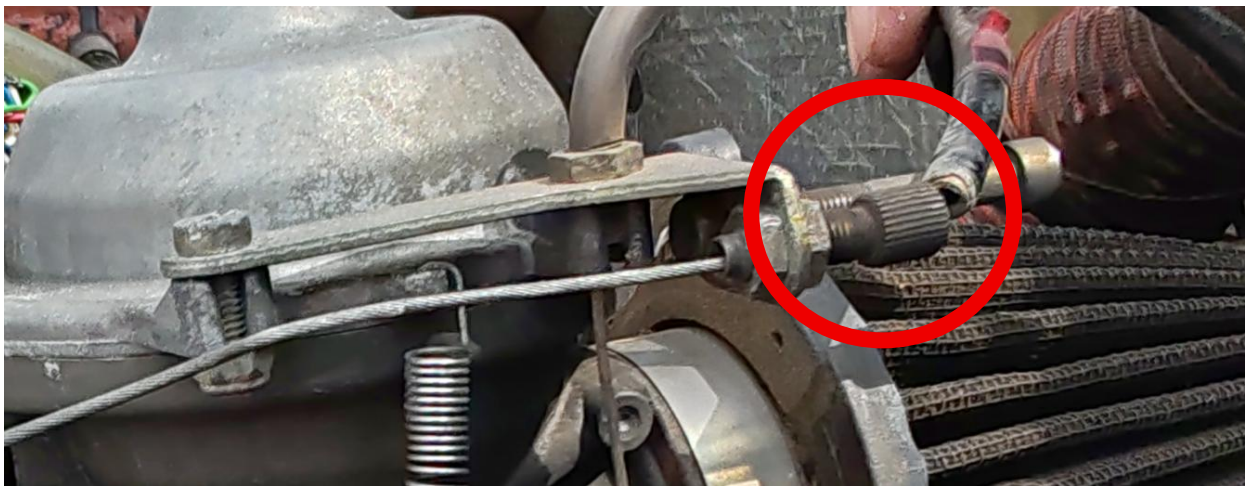
The aircraft was recovered to the aircraft maintenance organisation (AMO) facility after the accident. It was examined by the investigating team on 5 May 2026 due to the administrative processes on the operator side. The throttle push-pull cable sheath was found dislodged from the ferrule on the carburettor bracket. The examination also revealed that when the throttle was advanced to full (open) position, the sheath jammed on the outer surface of the ferrule, restricting operation of the throttle

control system. Operating the engine in this condition would prevent it from achieving the maximum take-off power, which was 5 800 rpm for this aircraft.

**Figure 3:** The left carburettor throttle cable sheath had dislodged from the ferrule on the carburettor bracket.

2.5 The left carburettor throttle cable sheath had dislodged from the carburettor bracket ferrule, restricting throttle travel which prevented the engine from achieving full power.

2.7 Throttle restriction and reduced air flow degraded engine performance, thus, contributing to the accident.

| Partial engine power prompted the pilot to reject take-off due to restricted throttle travel and air flow to the engine. |

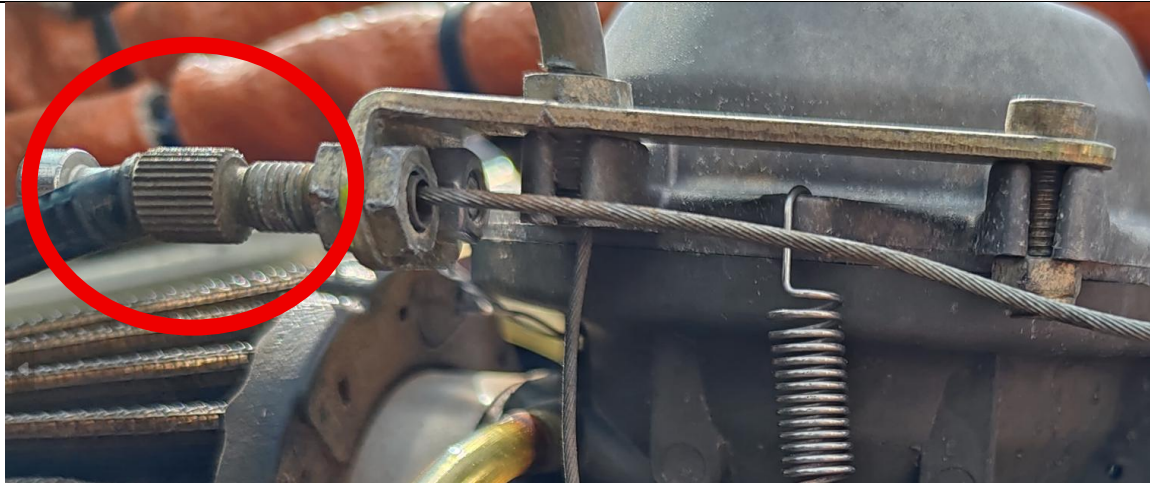
**Figure 4:** The right carburettor with the throttle cable sheath correctly seated in the ferrule.

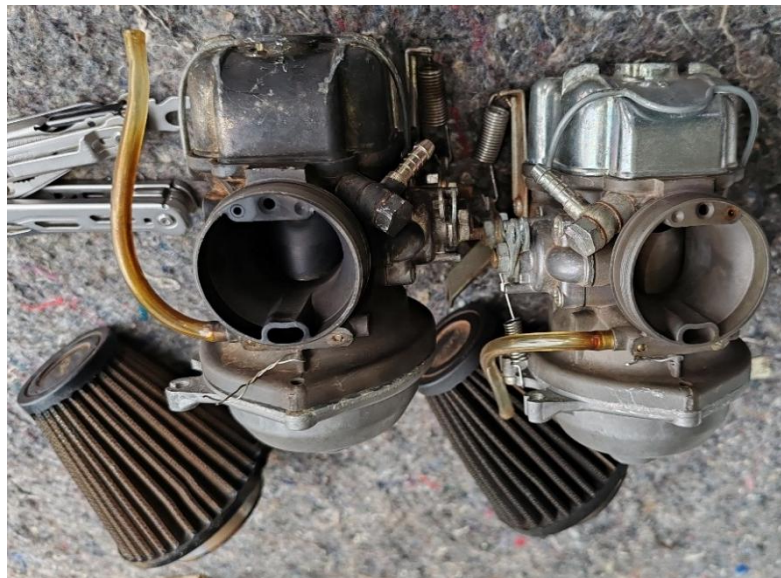
When the sheath was reseated in the ferrule, the left carburettor achieved maximum throttle and the engine ran smoothly. However, it still ran rough when it was advanced to maximum power. Further examination revealed that the air filter on the left carburettor was contaminated with oil and dust, which restricted air flow. Upon the removal of the air filter, the engine accelerated smoothly and achieved full power. It was also noted that the interior and exterior of the left carburettor was dirty and coked with carbon build-up.

**Figure 5:** The left and right carburettors; the left carburettor shows carbon build-up.

2.6 The left carburettor air filter was contaminated with oil and dust, restricting air flow to the engine.

| The contaminated air filter on the left carburettor restricted air flow and reduced the maximum power that the engine could produce. |
