## LIMITED OCCURRENCE INVESTIGATION REPORT – FINAL

<b>Reference Number</b>	CA18/2/3/10628						
<b>Classification</b>	Accident		<b>Date</b>	30 December 2025		<b>Time</b>	1000Z
<b>Type of Operation</b>	Training (Part 141)						
<b>Location</b>							
Place of Departure	Secunda Aerodrome (FASC), Mpumalanga Province		Place of Intended Landing		Secunda Aerodrome (FASC), Mpumalanga Province		
Place of Occurrence	On Runway 25 at Vlakspruit Farm Airstrip						
GPS Co-ordinates	Latitude	26°35'49.3" S	Longitude	29°17'18.8" E	Elevation	5 421 ft	
<b>Aircraft Information</b>							
Registration	ZS-ETL						
Make; Model; S/N	Cessna; 172H (Serial Number: 172-55746)						
Damage to Aircraft	Substantial			Total Aircraft Hours	16 339.1		
<b>Pilot-in-command</b>							
Licence Type	Student Pilot Licence (SPL)		Gender	Male		Age	18
Licence Valid	No	Total Hours	52.1		Total Hours on Type	5.4	
Total Hours 30 Days	2.9		Total Flying on Type Past 90 Days		5.4		
<b>People On-board</b>	1 + 0	<b>Injuries</b>	0	<b>Fatalities</b>	0	<b>Other (on ground)</b>	0

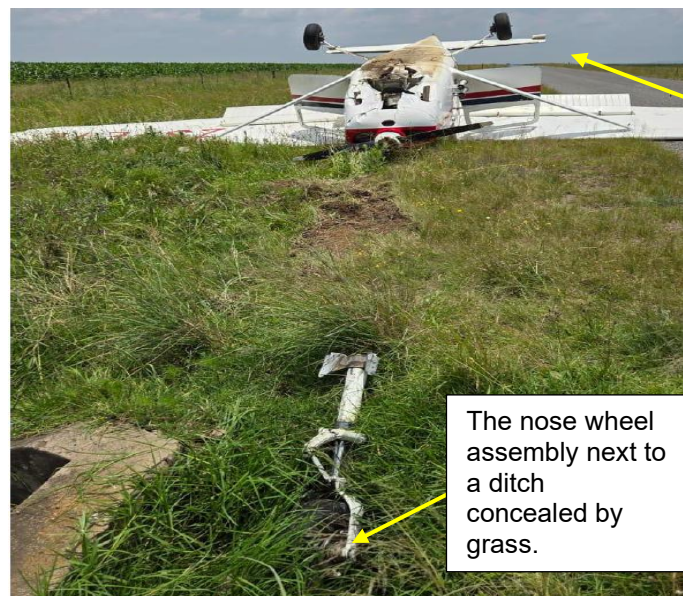
The aircraft exited the runway and the nose wheel rolled over a grass-concealed ditch. Consequently, the nose gear strut broke and the propeller struck the ground. The aircraft nosed over. After the accident, the pilot disembarked from the aircraft; he was not injured. The propeller, nose section, wings, tail fin and the empennage were substantially damaged.

**Figure 2:** The final position of the aircraft in the background. The yellow arrow on the top right corner shows the direction of travel. In the foreground is the nose wheel that is stuck in a ditch. (Source: Operator)
