LIMITED OCCURRENCE INVESTIGATION REPORT – FINAL

Reference Number	CA18/2/3/10630						
Classification	Accident		Date	9 January 2026		Time	0730Z
Type of Operation	Agricultural Operations (Part 137)						
Location							
Place of Departure	Groot Geluk Farm Airstrip, Free State Province		Place of Intended Landing	Groot Geluk Farm Airstrip, Free State Province			
Place of Occurrence	On the maize field in Groot Geluk Farm, Free State Province						
GPS Co-ordinates	Latitude	28° 04' 27.33" S	Longitude	029° 00' 14.15" E	Elevation	5 405 ft	
Aircraft Information							
Registration	ZS-KWA						
Make; Model; S/N	Ayres; S2R-T34 Turbo Thrush (Serial Number: T34-035DC)						
Damage to Aircraft	Destroyed		Total Aircraft Hours	11356.4			
Pilot-in-command							
Licence Type	Commercial Pilot Licence (CPL)		Gender	Male		Age	24
Licence Valid	Yes	Total Hours	1 239.7		Total Hours on Type	934.8	
Total Hours 30 Days	64,7		Total Flying on Type Past 90 Days	133			
People On-board	1 + 0	Injuries	1	Fatalities	0	Other (on ground)	0

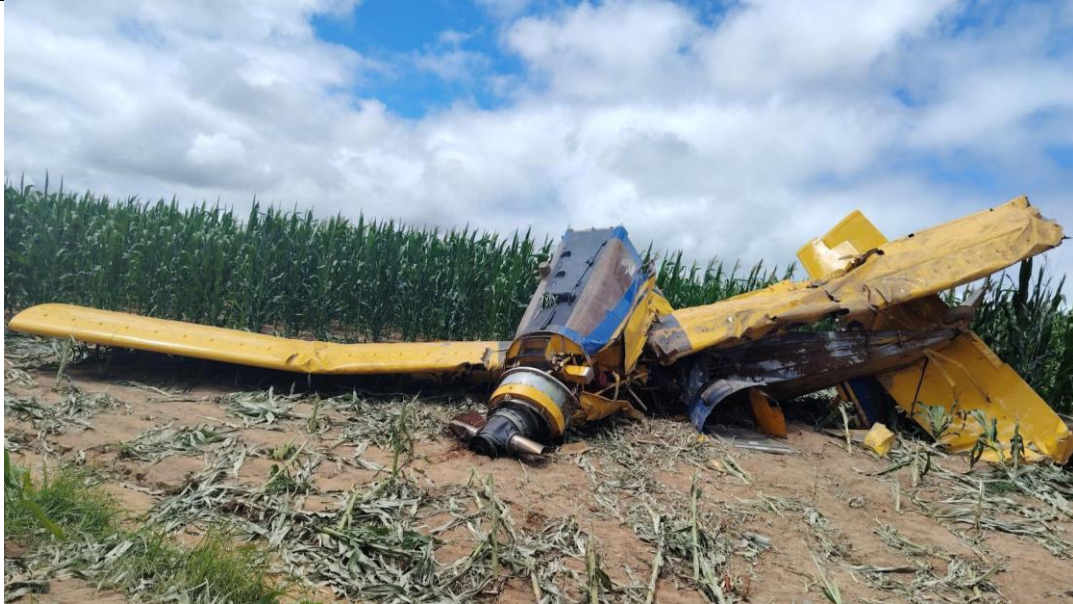
Figure 2: The aircraft at the accident site.

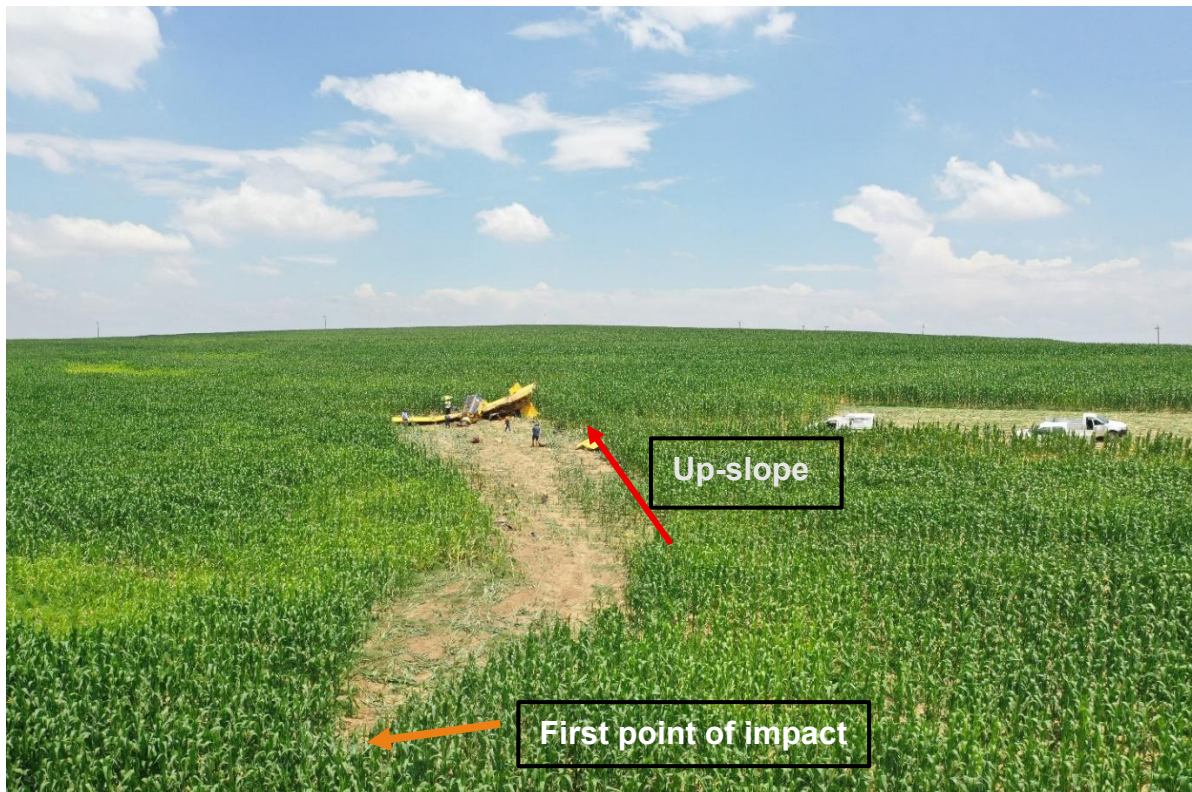
Figure 3: Ground marks impressed by the aircraft after it had crashed.

The topography of the accident site indicated that from the first point of impact (Indicated by orange arrow), the gradient on the terrain was steep (upward slope). Examination of the propeller blades indicated that the engine was producing a substantial amount of power at the time of the crash.

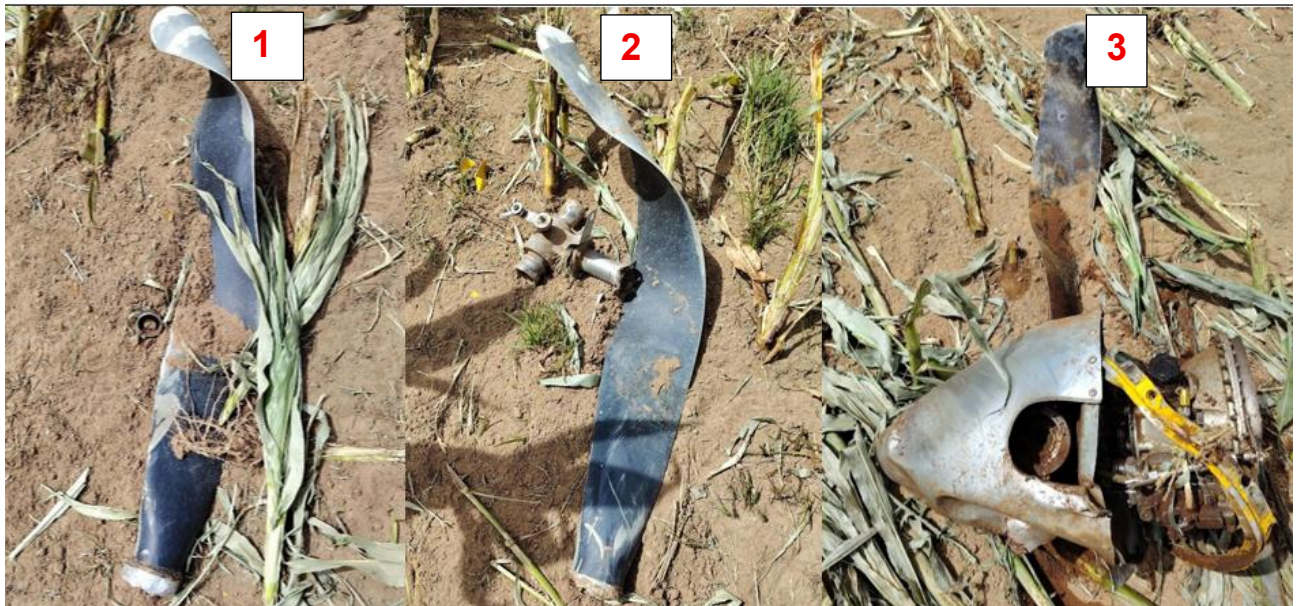
Figure 4: The three propeller blades indicate that the engine was producing power at the time of the accident.

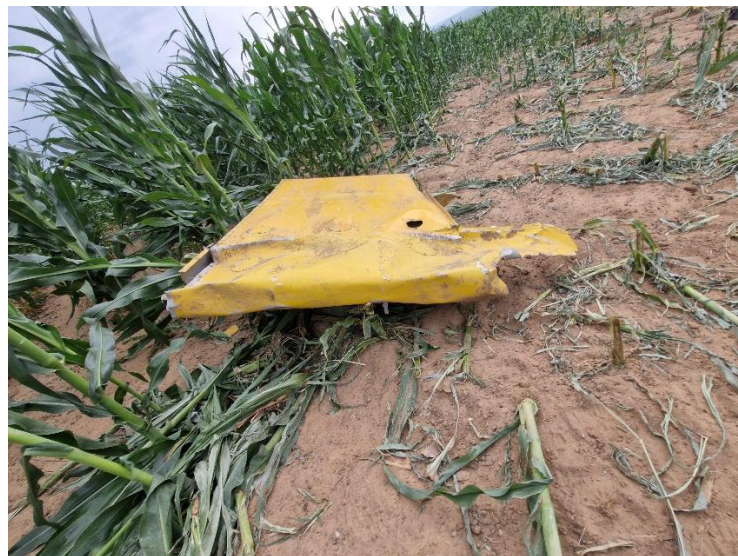
Figure 5: The left wing that impacted the ground and separated from the fuselage.

The accident resulted due to low-level flying in the direction of a rising (upslope) terrain. It is likely that the pilot lost situational awareness and misjudged the aircraft's position (above ground) during a left turn; as a result, the left-wing tip struck the ground. The left wing separated from the fuselage and the pilot lost control of the aircraft.
