## LIMITED OCCURRENCE INVESTIGATION REPORT

<b>Reference Number</b>	CA18/2/3/10631						
<b>Classification</b>	Accident		<b>Date</b>	12 January 2026		<b>Time</b>	1030Z
<b>Type of Operation</b>	Aerial Work Operations (Part 137)						
<b>Location</b>							
Place of Departure	Private Farm Airstrip, Verkykerskop, Free State Province		Place of Intended Landing		Private Farm Airstrip, Verkykerskop, Free State Province		
Place of Occurrence	Private Farm Airstrip at Verkykerskop, Free State Province						
GPS Co-ordinates	Latitude	27° 56' 12.85" S	Longitude	29° 11' 33.64" E	Elevation	5 970 ft	
<b>Aircraft Information</b>							
Registration	ZS-NMR						
Make; Model; S/N	Ayres; S2R-T34 Turbo Thrush (Serial Number: 0180 DC)						
Damage to Aircraft	Minor		Total Aircraft Hours	9 483.9			
<b>Pilot-in-command</b>							
Licence Type	Commercial Pilot Licence (CPL)		Gender	Male		Age	29
Licence Valid	Yes	Total Hours	2 546.4		Total Hours on Type	1 638.4	
Total Hours 30 Days	51.5		Total Flying on Type Past 90 Days		111.6

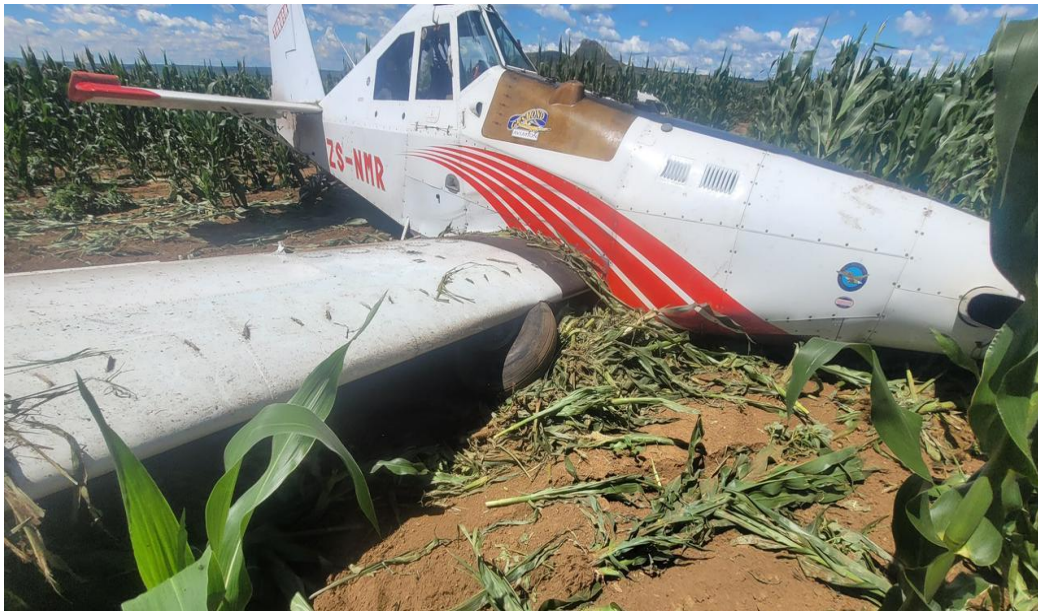
After spraying the fifth load, the pilot landed the aircraft and the ground crew switched to a different small grain fertiliser, Potassium Sulphate, also packaged in bags and each weighing 1000kg. This time, two bags of Potassium Sulphate fertiliser were loaded in the aircraft. Later, the aircraft commenced with the take-off run and rotated; however, it could not climb. The pilot opened the hopper dump door to dump the fertiliser, thus reducing the weight. However, the dumping process was not executed fast enough; consequently, the aircraft crash-landed on the nearby maize field. The aircraft sustained substantial damage. No injuries were reported.

**Figure 1:** The aircraft at the accident site. (Source: Pilot)

The investigation revealed that the aircraft's weight and balance conducted for the last flight with the two Potassium Sulphate fertiliser bags on-board and each weighing 1000kg was 9857 lbs, which exceeded its 6000 lbs MTOW. The investigation further revealed that the ground crew loaded the two bags of Potassium Sulphate fertiliser instead of one bag. The ground crew was confused about the different size bags, as the Potassium Sulphate fertiliser bag appeared to contain less content (smaller) than the Urea fertiliser bag; however they both measured the same weight, which was 1000kg.

The aircraft operated above its maximum certified gross weight; consequently, the take-off performance was degraded, and the aircraft could not climb, rendering ground impact inevitable.
