## AIRCRAFT ACCIDENT REPORT AND EXECUTIVE SUMMARY

| | | | | <b>Reference:</b> | | CA18/2/3/10633 | |
| <b>Aircraft Registration</b> | ZT-RPM | <b>Date of Accident</b> | 3 February 2026 | | <b>Time of Accident</b> | 1130Z | |
| <b>Type of Aircraft</b> | Bell 230 | | <b>Type of Operation</b> | | Training (Part 141) | | |

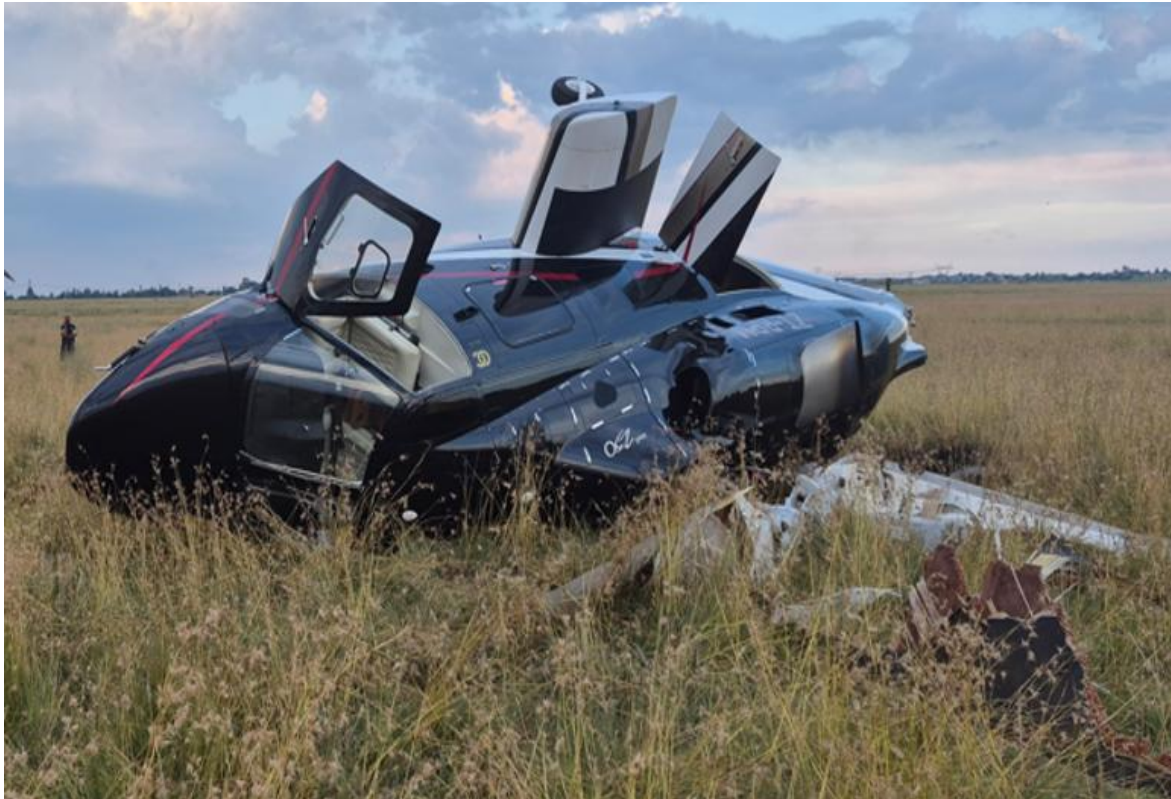
The FI applied the left anti-torque pedal and additional power to regain control, but recovery was unsuccessful. The helicopter subsequently impacted the ground hard with its landing gear and bounced. After the second touch down, it rolled to the left and the main rotor blades struck the ground and severed the tail boom. A post-impact fire ensued, and the pilot extinguished it using the cabin fire extinguisher. The helicopter sustained substantial damage; the FI and the pilot were not injured.

**Figure 2:** The helicopter resting on its left side after the accident.

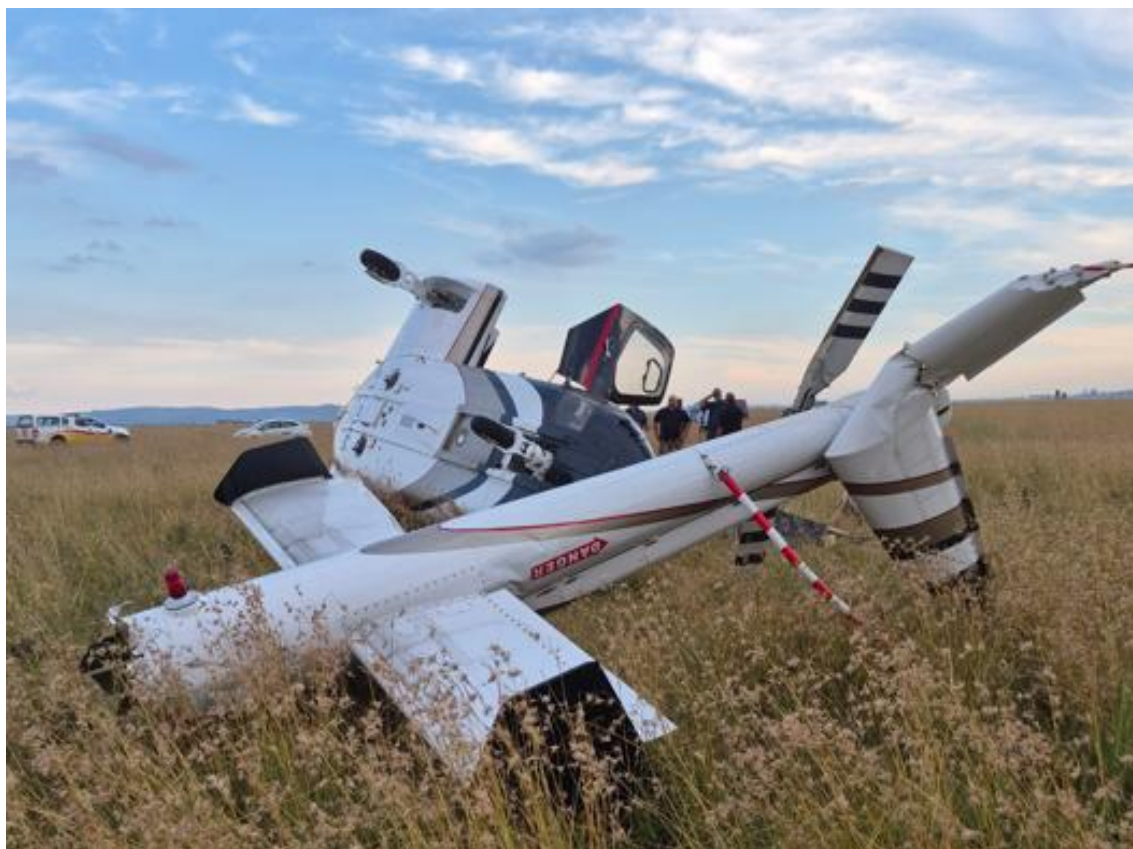
**Figure 3:** The helicopter with the severed tail boom.

1.12.2. The main rotor blade severed the tail boom during the accident sequence; it was found in proximity to the wreckage which indicated that there was low forward or rear kinetic energy. A ground mark associated with the main rotor impact was visible at the scene.

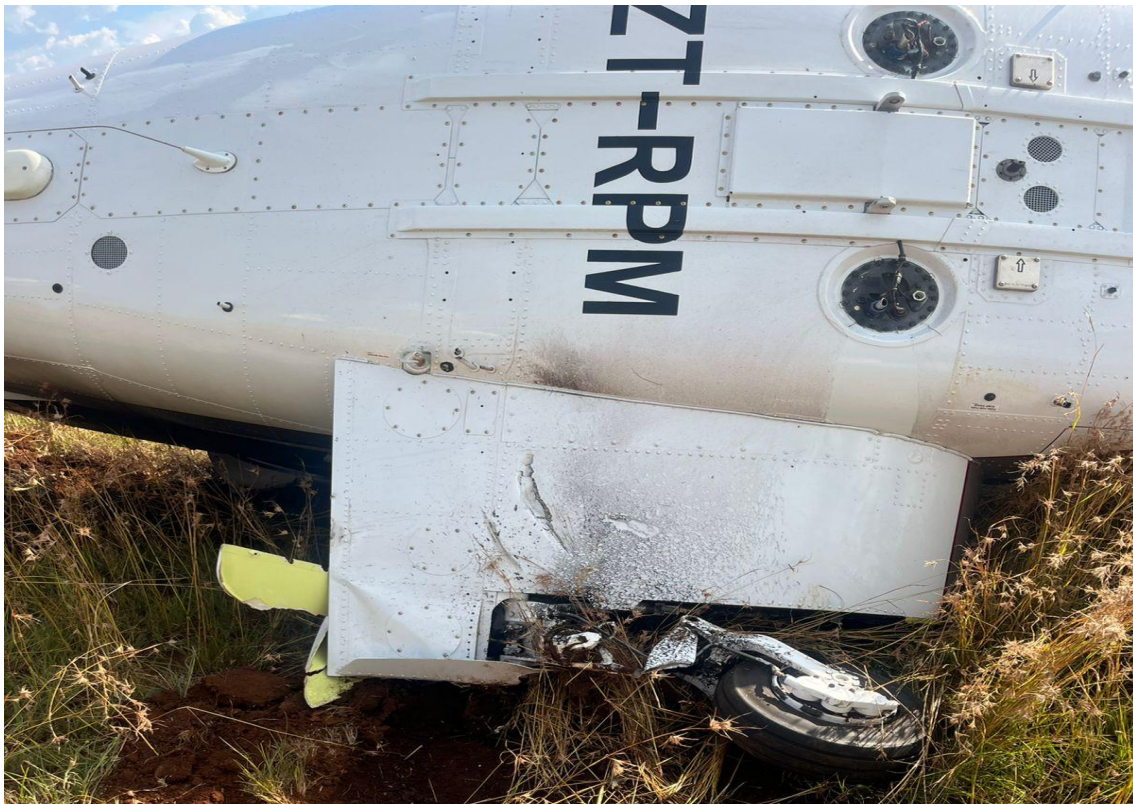
**Figure 4:** The damaged left main landing gear.

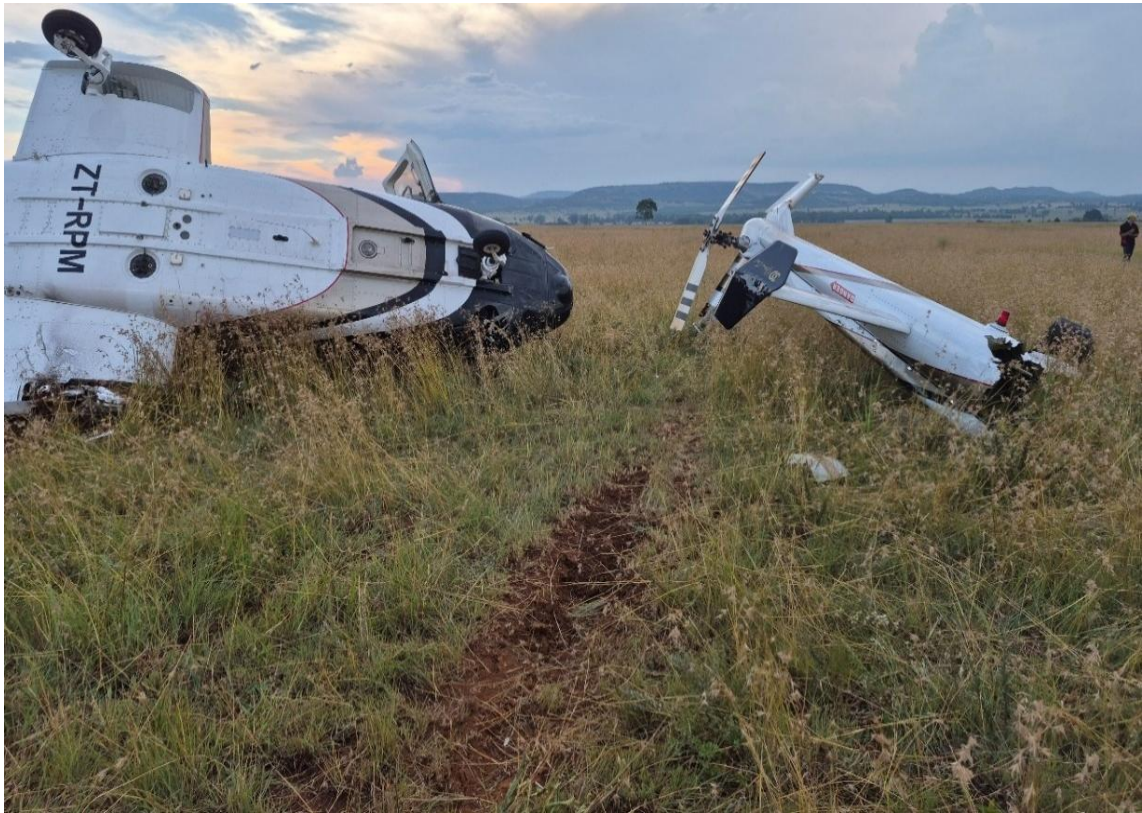
**Figures 5:** Ground scar made by the main rotor blades.

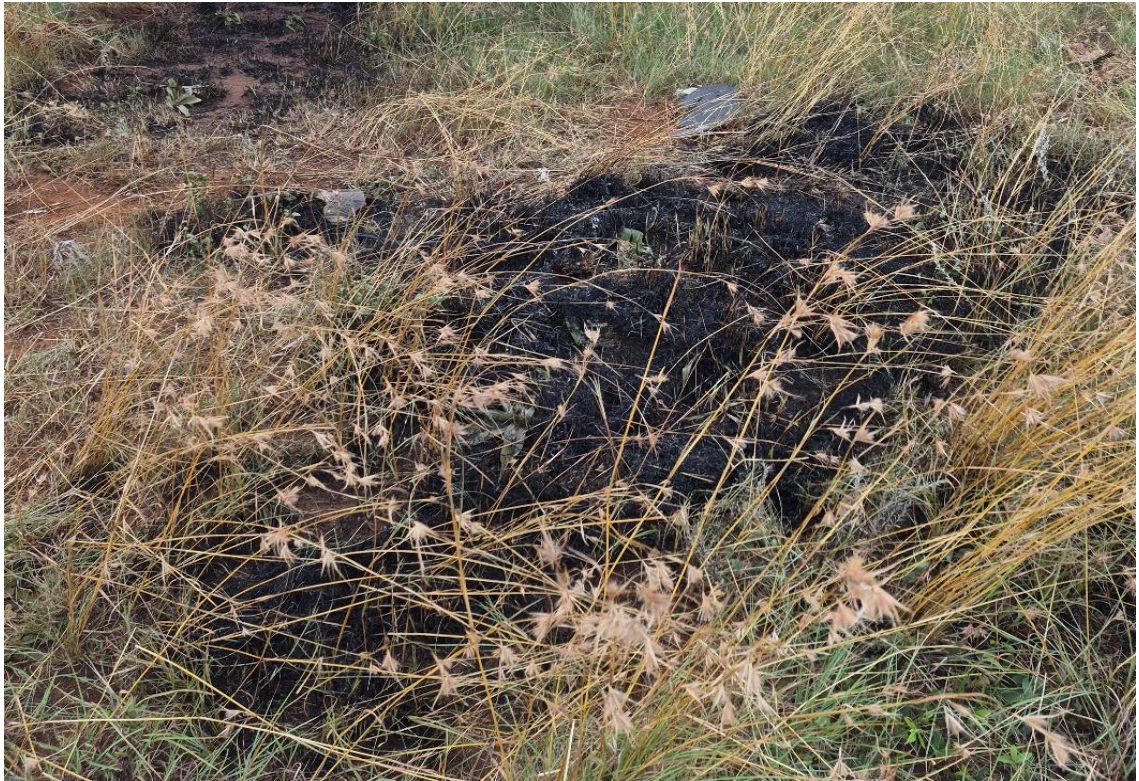
1.14.1. A post-impact fire ensued after the accident. The pilot used the helicopter's portable fire extinguisher to extinguish it.

**Figures 6:** Burnt grass due to post-impact fire.
