## AIRCRAFT ACCIDENT REPORT AND EXECUTIVE SUMMARY

| | | | | <b>Reference:</b> | | CA18/2/3/10634 | |
| <b>Aircraft Registration</b> | ZS-EXR | <b>Date of Accident</b> | 4 February 2026 | | <b>Time of Accident</b> | 0530Z | |
| <b>Type of Aircraft</b> | Piper PA-28-140 Cherokee | | <b>Type of Operation</b> | | Training (Part 141) | | |

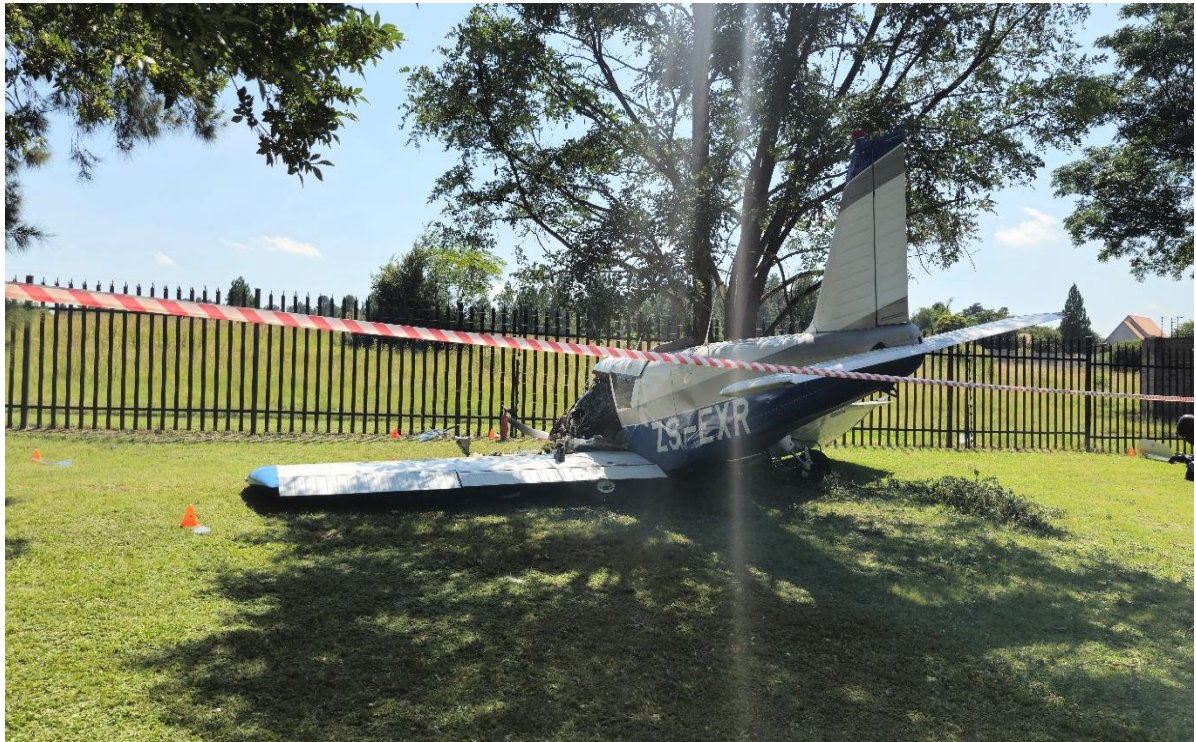
1.3.1. The damage was substantial, including the right-side wing, engine and its mountings, landing gears and the cockpit section.

**Figure 2:** The ZS-EXR at the accident site after it impacted a tree.

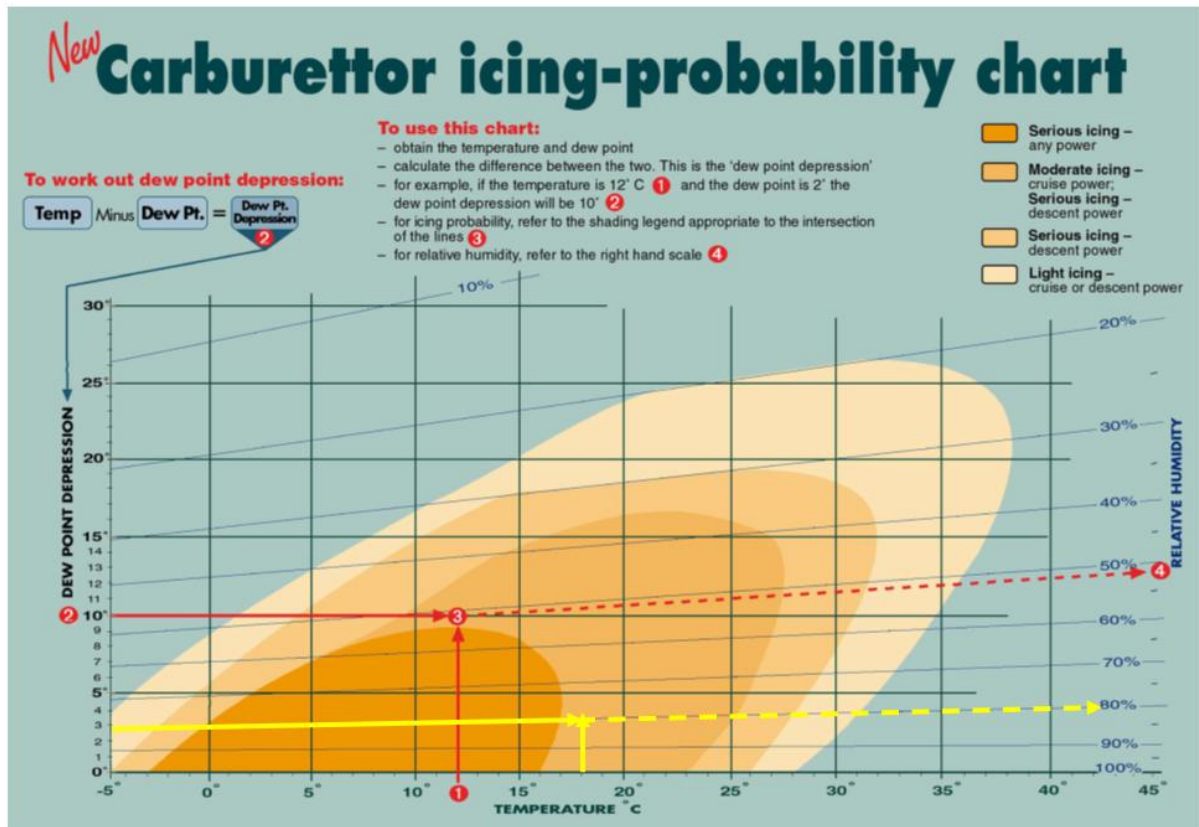
- 1.7.2. According to the icing probability chart, the given weather conditions were conducive for the formation of carburettor icing.

**Figure 4:** Carburettor icing probability chart calculations.

The weather conditions at the time of flight were conducive to an ice probability formation, indicated by the plotted yellow lines (Figure 4). The above icing probability chart indicates a relative 80% humidity, which is highly significant to cause serious icing during descending power settings in the carburettor.

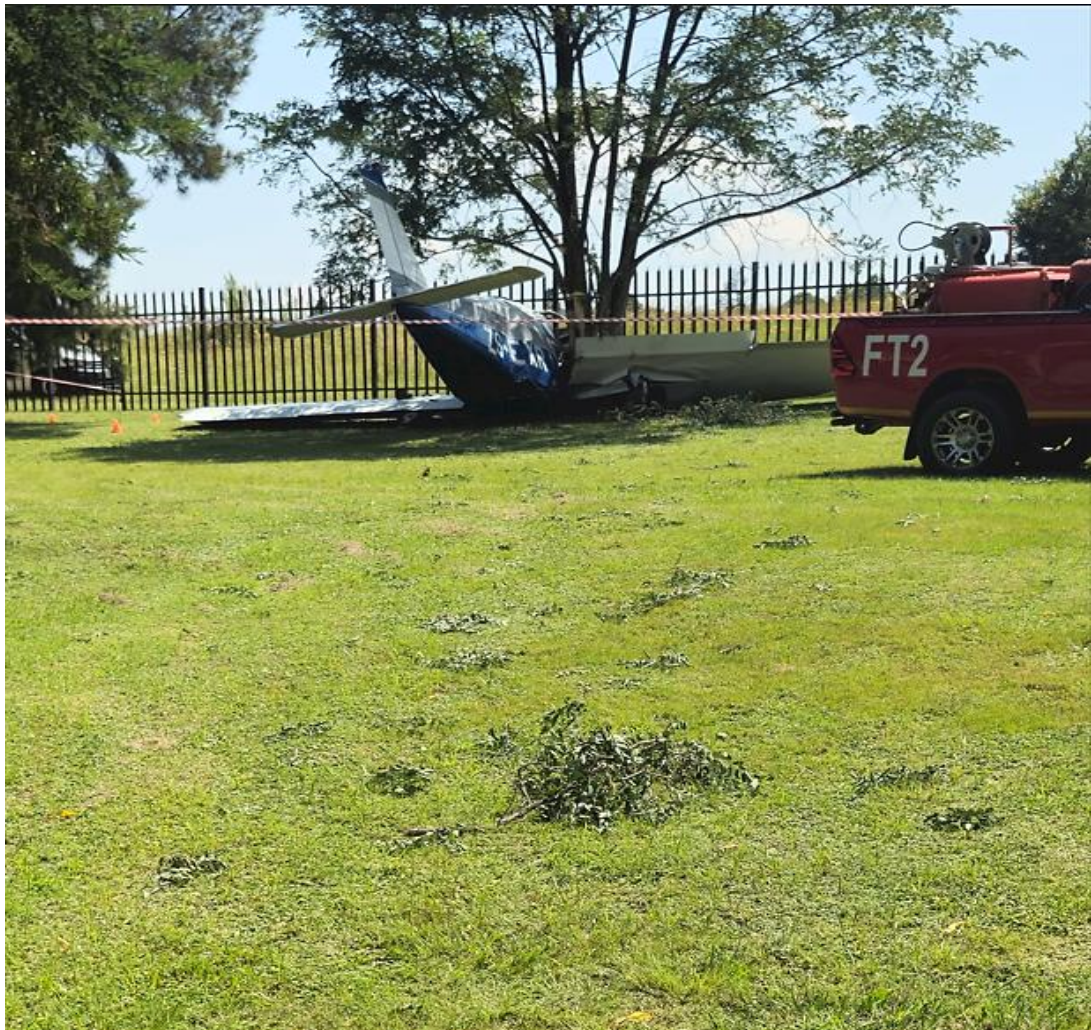
1.12.2. After the engine failed during the downwind leg, the FI opted to conduct a forced landing on an open field. However, the aircraft, which was descending, was unable to clear the residential property next to the field and it clipped the treetops in its path. This was evidenced by a trail of broken branches along its projected flight path as it continued in a downward trajectory.

**Figure 6:** Trail of tree branches clipped by the aircraft.

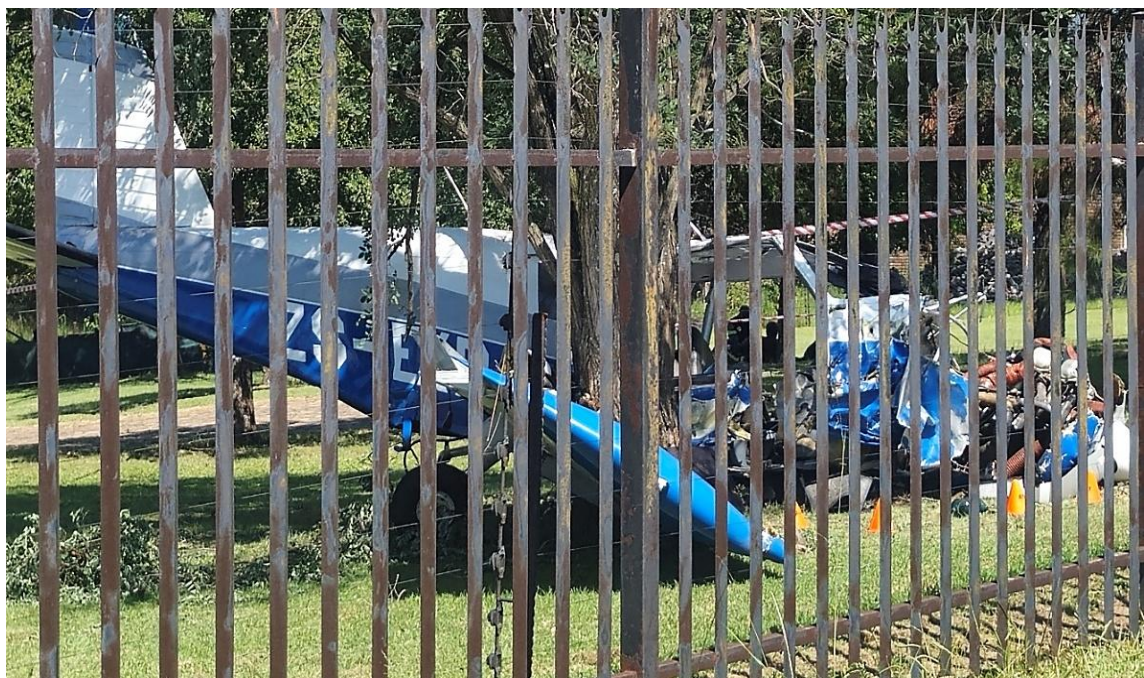
**Figure 7:** The aircraft in its final resting position after crash landing.

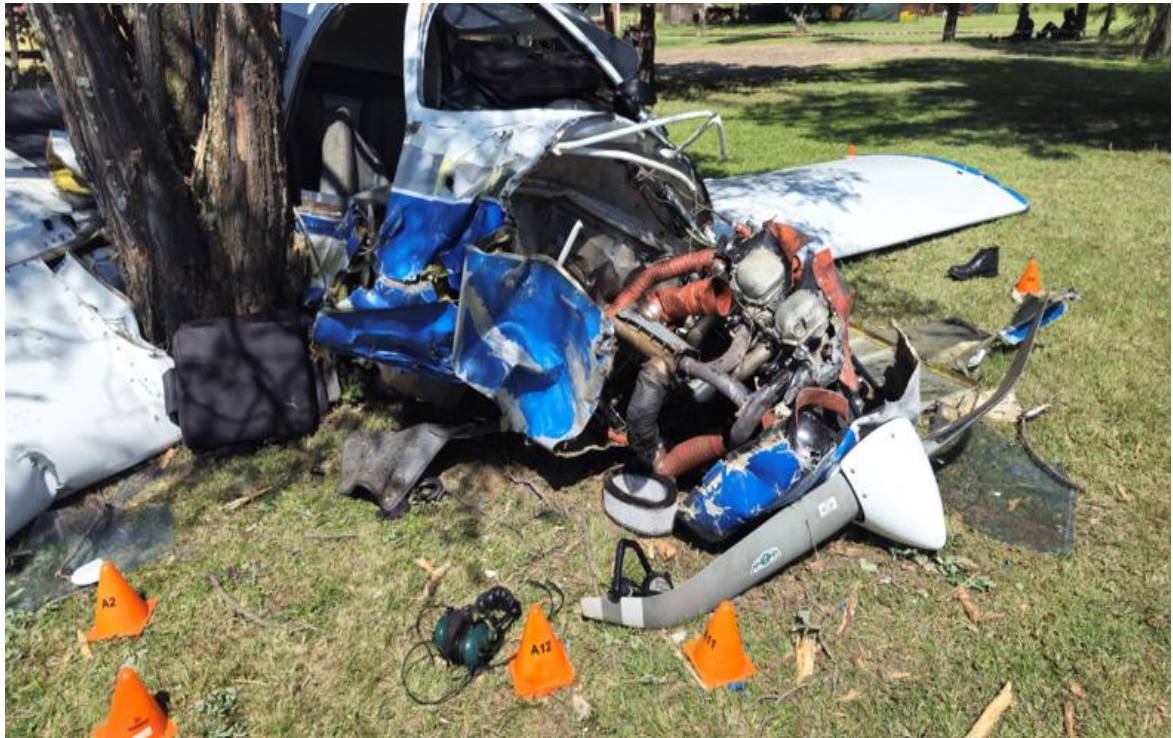
1.12.3. The aircraft impacted a larger tree close to the boundary fence. The point of impact was relatively low, indicating a significant loss of altitude at that stage. The aircraft's nose was also slightly pitched downward, consistent with a descending profile under reduced power.

**Figure 8:** Damage to the engine compartment, engine mountings and the right wing.

The aircraft struck the tree on the right side of the engine cowling, scraping against it until the right-wing leading edge made a more forceful impact. This impact caused the right wing to deform and separate from the airframe, with parts of it remaining wrapped around the tree. Marks on the right side of the engine cowling showed areas of shrivelled skin, consistent with frictional contact against the tree during the crash. In contrast, the left wing remained largely intact. Furthermore, the right-wing fuel tank was damaged with no evidence of fuel spillage or smell at the accident site. The left fuel tank still contained approximately 70 gallons of fuel.

After the impact, most of the wreckage was found concentrated near the main fuselage; the aircraft came to rest in a tail-high position. The engine compartment was heavily damaged, leading to the failure of the engine mountings. The engine compartment cowlings were removed by the first responders during the rescue operation. Despite this, both the engine and the propeller remained largely intact. The condition of the propeller indicated that it was not rotating at the time of impact; the blunt damage was consistent with contact against the tree or the ground during the crash (Figure 8).

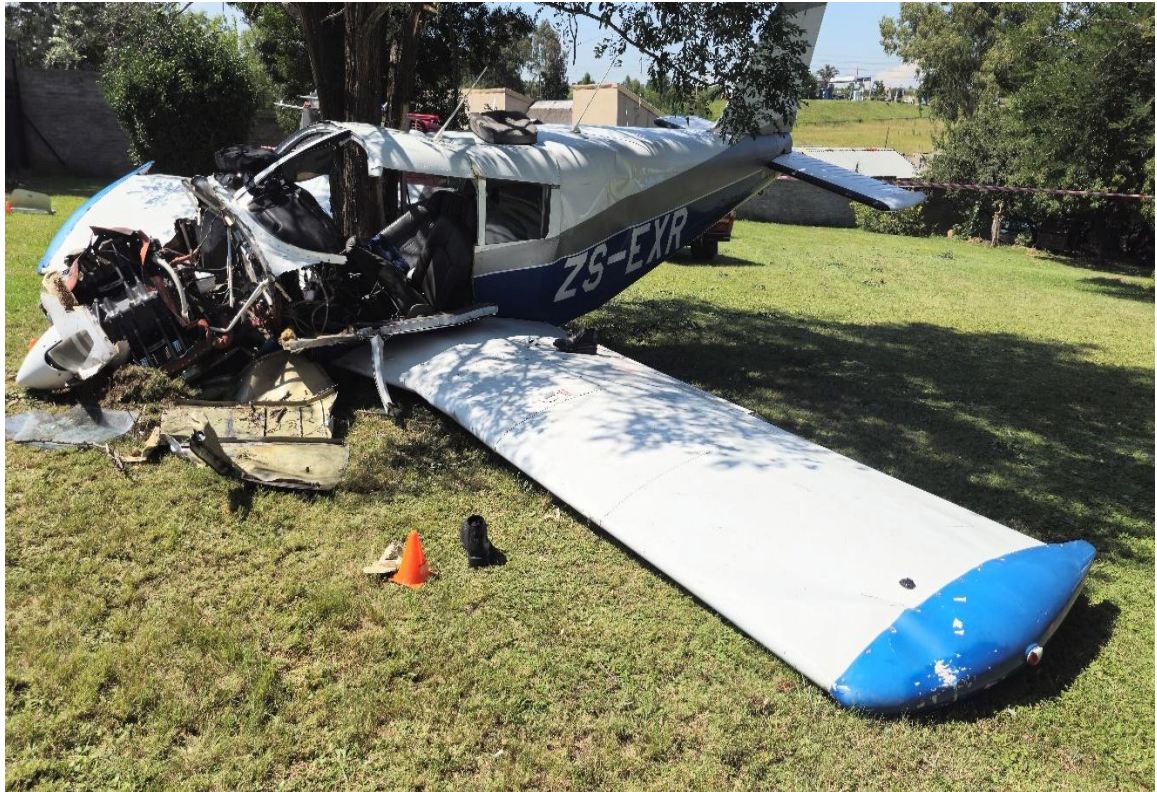
**Figure 9:** The wreckage.

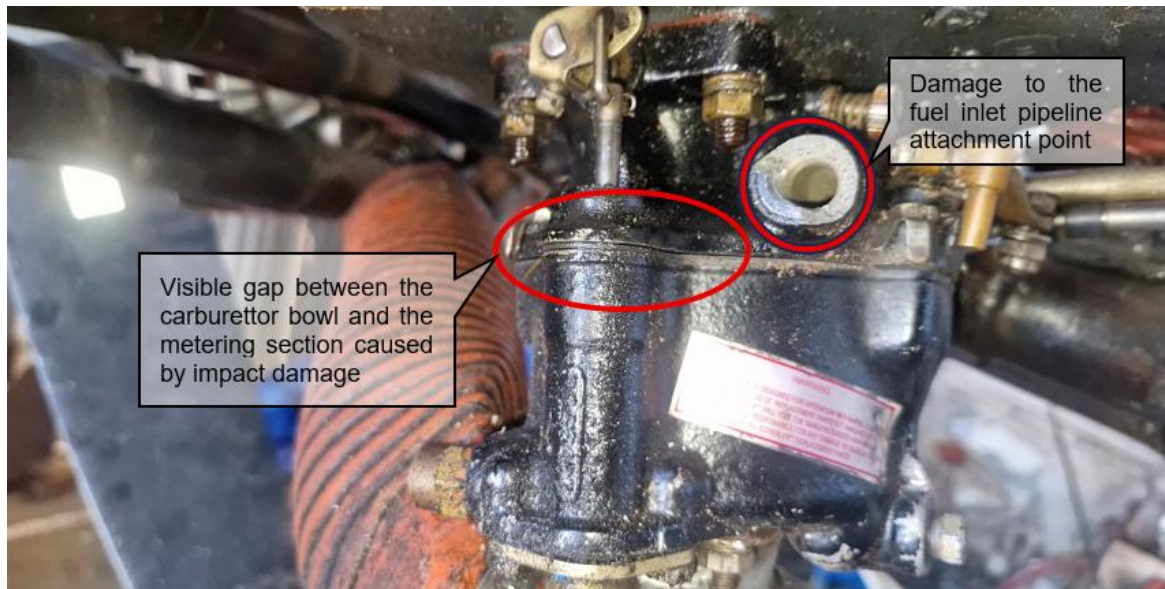
**Figure 12:** The damage to the carburettor's left side and the fuel inlet attachment points.

1.12.4. The carburettor exhibited impact damage. The fuel inlet pipeline attachment point was damaged and severed with further damage to the bottom attachment of the carburettor bowl and the metering section, resulting in a gap that could possibly leak fuel contained in the bowl. There was no fuel found in the engine carburettor fuel bowl (see Figure 12).

- 2.2.5. No fuel was found in the carburettor bowl, which supports a disruption in the fuel supply to the engine. Although the exact quantity of fuel in the damaged right tank could not be confirmed, there was insufficient evidence of fuel spillage at the accident site. The available evidence indicated that the aircraft was likely operated predominantly using the right tank.

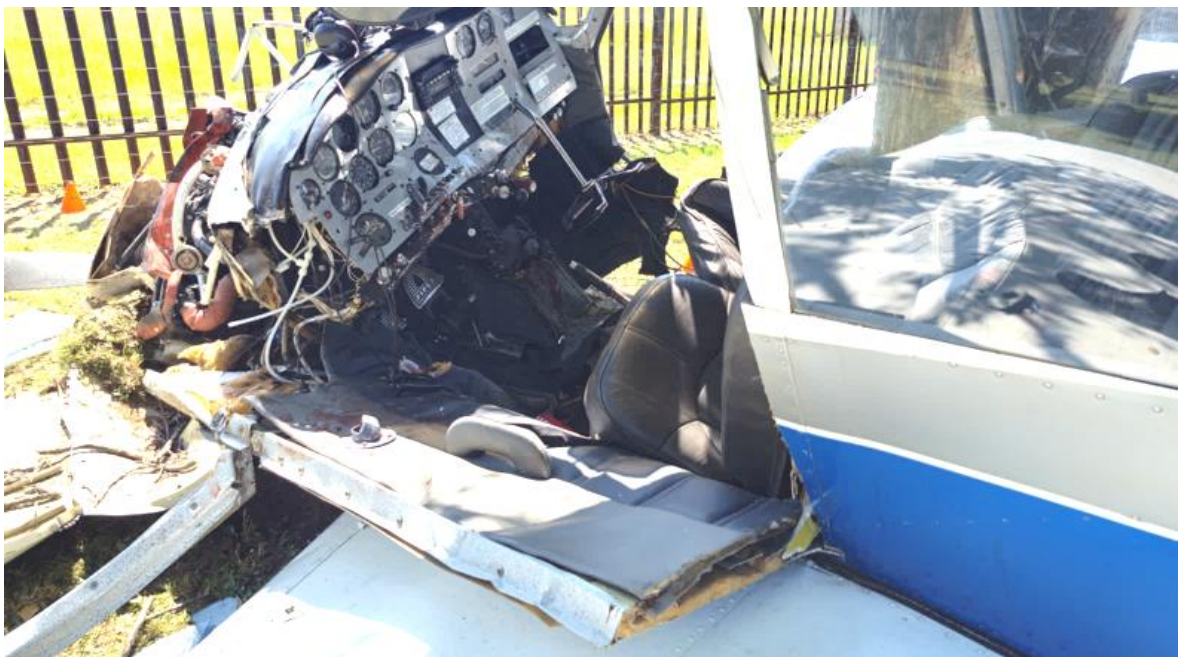
**Figure 13:** Cockpit instrument panel and the damaged control column.

1.12.5. The first responders reported that although the engine cowlings were already damaged, they were removed during efforts to rescue the occupants. The right-side door was jammed and had to be taken off to gain access and extract the FI. The cockpit area was disturbed during the rescue of the SP. Whilst the instrument panel appeared largely intact, the left-side control yoke had to be cut because it trapped the SP after impact. Airport Rescue and Firefighting

(ARFF) personnel at FAGC confirmed that removing the yoke was necessary to free the SP from the left seat.

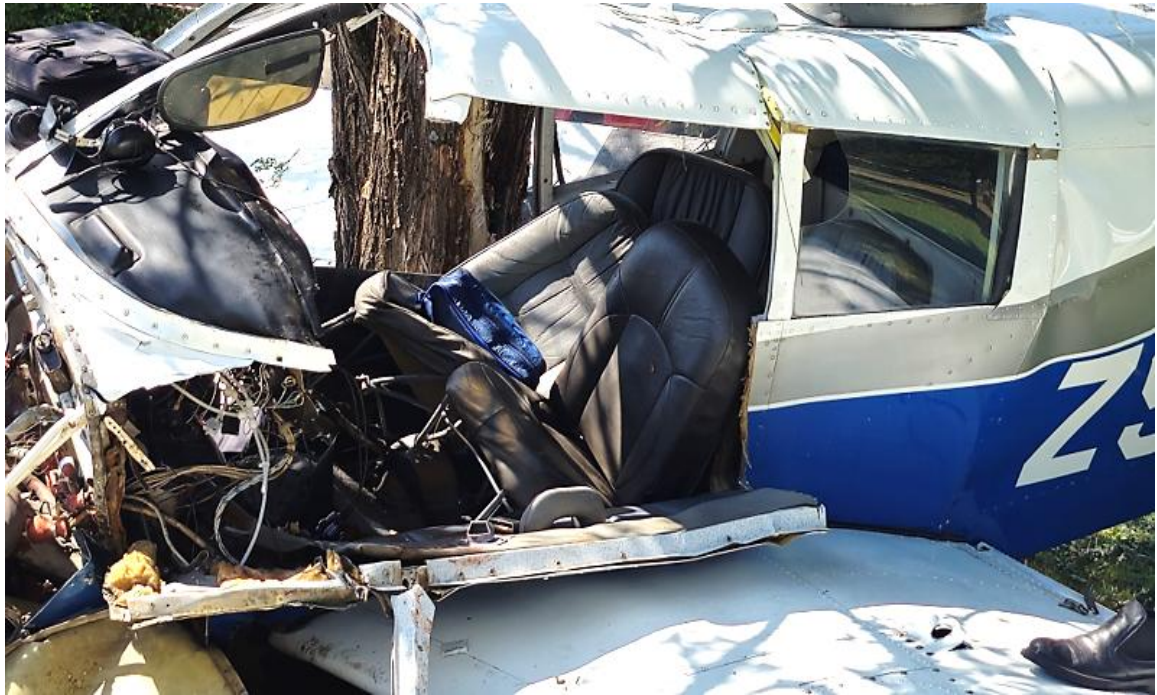
**Figure 14:** The aircraft seats after impact.

1.12.6. Both seats showed signs of deformation, consistent with the forces experienced during impact. The left-side wall of the cockpit had already sustained damage in the crash, but it was further torn and pushed downward during the rescue operation, resulting in additional damage.
