LIMITED OCCURRENCE INVESTIGATION REPORT – FINAL

Reference Number	CA/2/3/10635						
Classification	Accident		Date	9 February 2026		Time	0755Z
Type of Operation	Private (Part 94)						
Location							
Place of Departure	Hluhluwe Airfield, KwaZulu-Natal Province		Place of Intended Landing	Hluhluwe Airfield, KwaZulu-Natal Province			
Place of Occurrence	Phinda Game Reserve, KwaZulu-Natal Province						
GPS Co-ordinates	Latitude	27°52'32.7" S	Longitude	32°13'56.9" E	Elevation	338ft	
Aircraft Information							
Registration	ZU-TGG						
Make; Model; S/N	Bat Hawk (Serial Number: 0143)						
Damage to Aircraft	Substantial			Total Aircraft Hours	119.0		
Pilot-in-command							
Licence Type	National Pilot Licence (NPL)		Gender	Male		Age	52
Licence Valid	Yes	Total Hours	151		Total Hours on Type	151	
Total Hours 30 Days	12		Total Flying on Type Past 90 Days	20			
People On-board	1+1	Injuries	2	Fatalities	0	Other (on ground)	0
What Happened							
<p>On Monday morning, 9 February 2026, a pilot and a passenger on-board a Bat Hawk aircraft registered ZU-TGG took off on a private flight from Hluhluwe Airfield (FAHL) in KwaZulu-Natal province to Phinda Game Reserve with the intention to land at t

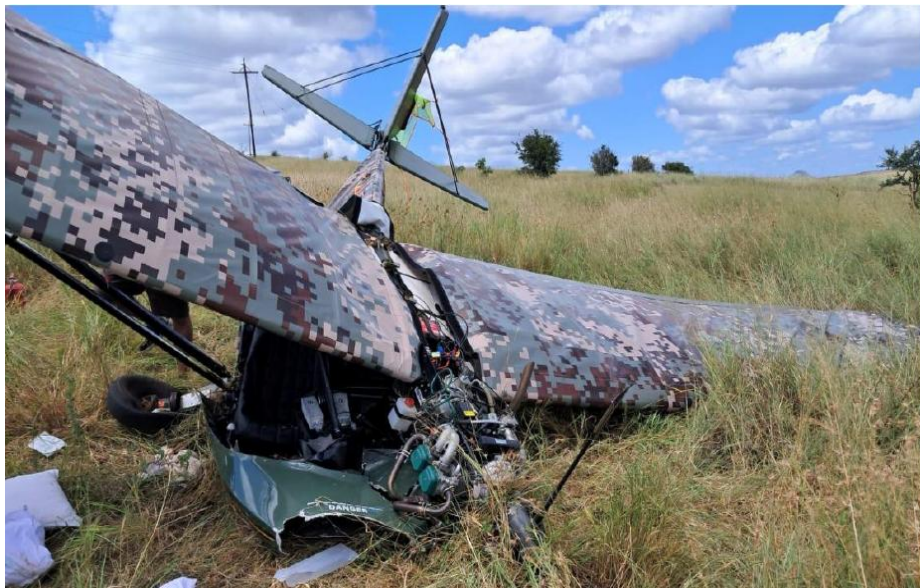
Figure 2: The front view of the aircraft at the accident site.

Post-accident examination of the aircraft indicated that the engine was delivering a substantial amount of power at the time of the crash. Investigation did not find any indication of mechanical or systems failure of the aircraft prior to the accident.

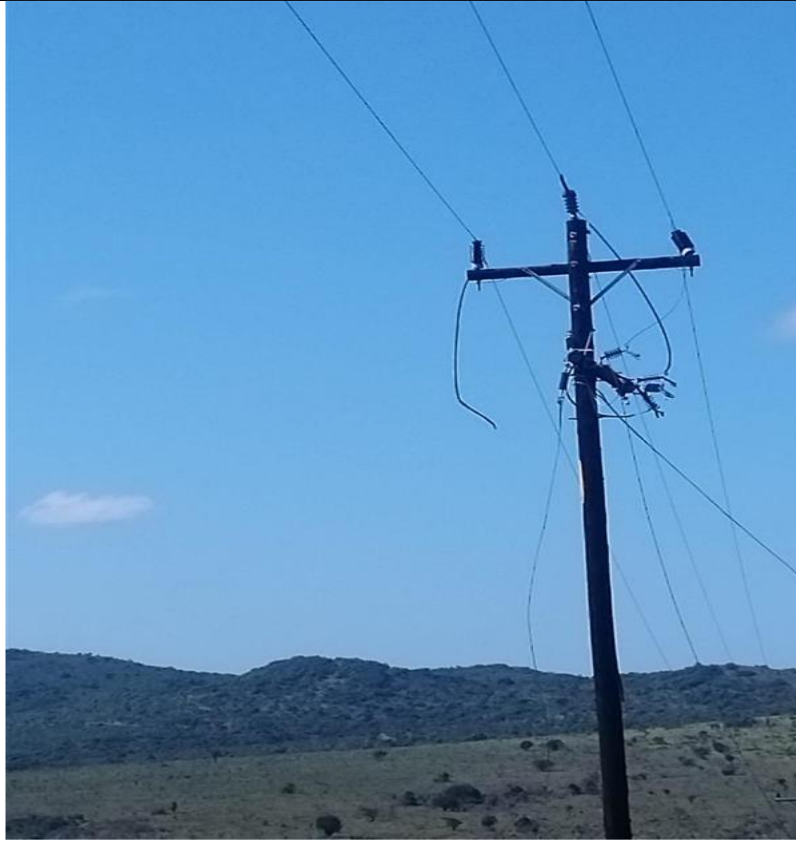
Figure 3: The severed powerlines.

Powerlines constitute a potential aviation hazard and may require marking or notification to aviation authorities due to the risk they pose to aircraft, particularly during low-level operations.

7. The pilot flew the aircraft approximately 10m AGL during a wildlife sightseeing flight which reduced his ability to detect obstacles. During climb, the aircraft impacted the unmarked powerlines about 14m AGL. The low-level manoeuvring and a likely reduced situational awareness contributed to this accident.

The aircraft impacted powerlines whilst being operated at low level; consequently, control was lost which rendered ground impact inevitable.
