## AIRCRAFT ACCIDENT REPORT AND EXECUTIVE SUMMARY

| <b>Aircraft Registration</b> | <b>ZS-PWN</b> | <b>Date of Accident</b> | 14 February 2026 | | <b>Time of Accident</b> | 0838Z | |
| <b>Type of Aircraft</b> | Cessna U206F | | | <b>Type of Operation</b> | Air Transport Operations (Part 135) | | |

| <b>Reference Number</b> | : CA18/3/2/10636 |

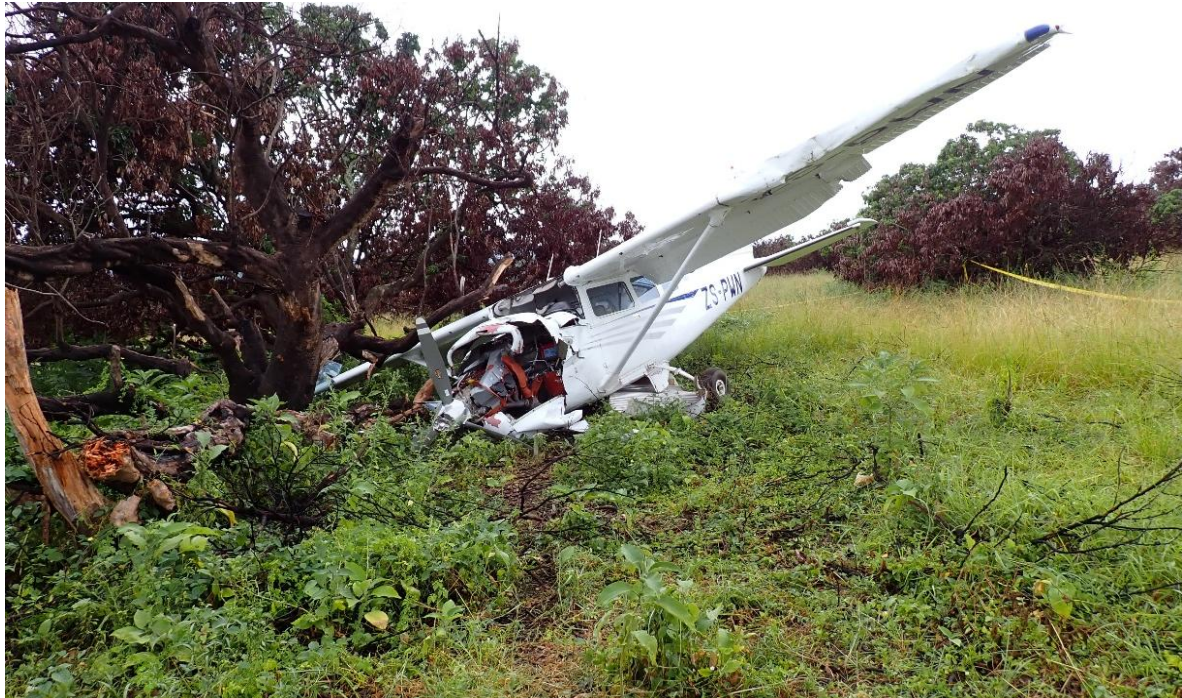
1.3.1 The damage to aircraft was substantial during forced landing.

**Figure 2:** The aircraft after impacting a tree following a forced landing.

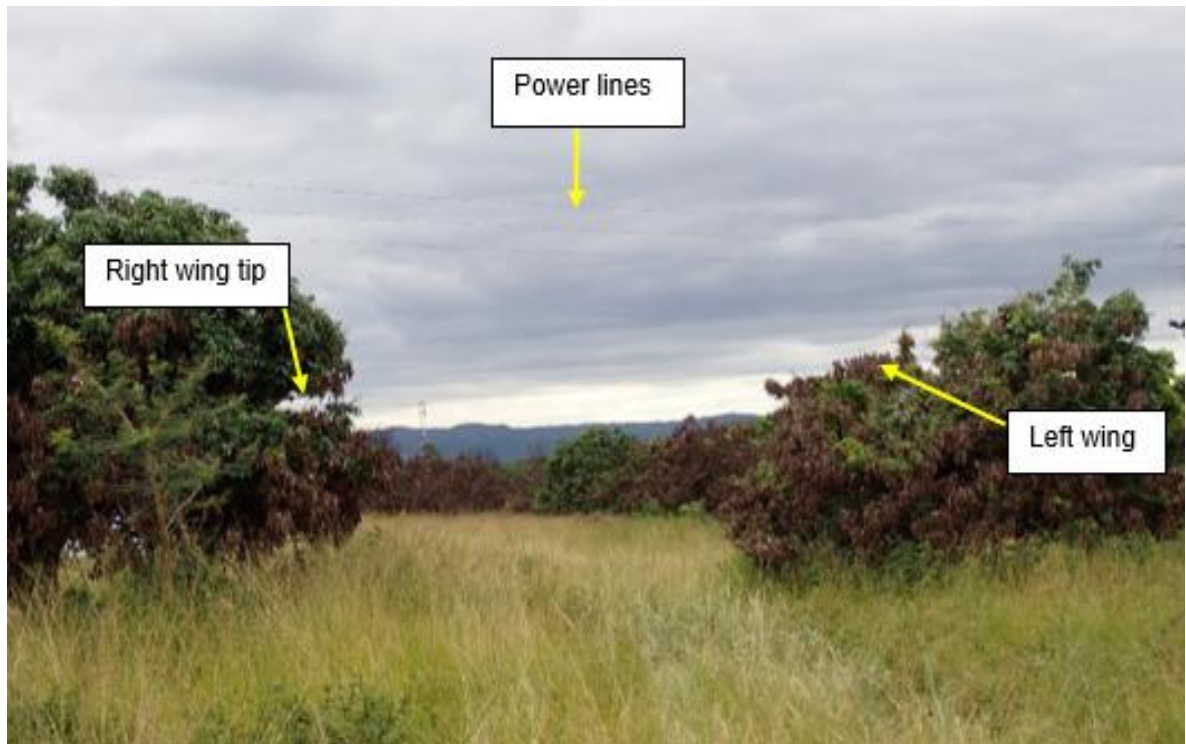
- 1.12.1 The pilot executed a forced landing on an abandoned litchi orchard whilst returning to FANS's Runway 22. He stated that he selected the wing flaps to full down (40°) and kept the aircraft just above stall speed. Shortly before touching down, he noticed a power line which was approximately 30ft above ground, and he opted to fly under it. However, the left-wing and the right-wing tips struck the litchi trees. The aircraft touched down approximately 8 metres (m) after impacting the trees on overgrown grass in a high nose-up attitude. Shortly thereafter, the aircraft impacted a litchi tree which rendered substantial damage to the front section of the aircraft and the right side of the engine. The aircraft ground-looped anticlockwise, and the nose gear and the right main wheel assembly broke off before the aircraft came to rest in a right-wing low attitude. The aircraft came to rest 0.84nm (1.55 kilometres) north-east of the threshold of Runway 22. After the accident, one of the propeller blade tips was bent likely during ground impact when the nose landing gear broke off. The other two propeller blades were intact.

**Figure 4:** The power lines cleared by the aircraft and the two trees impacted by the aircraft wings.

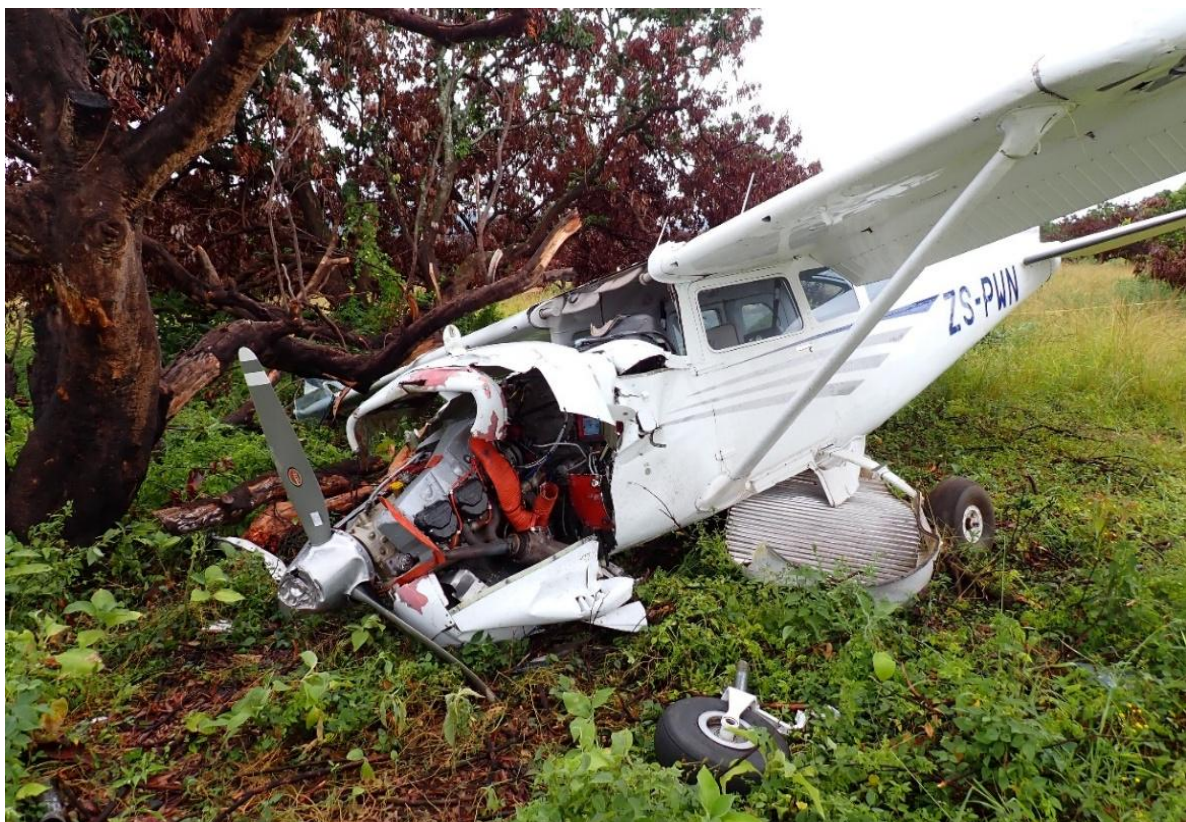
**Figure 5:** The aircraft in its resting position facing the direction from which it had come.

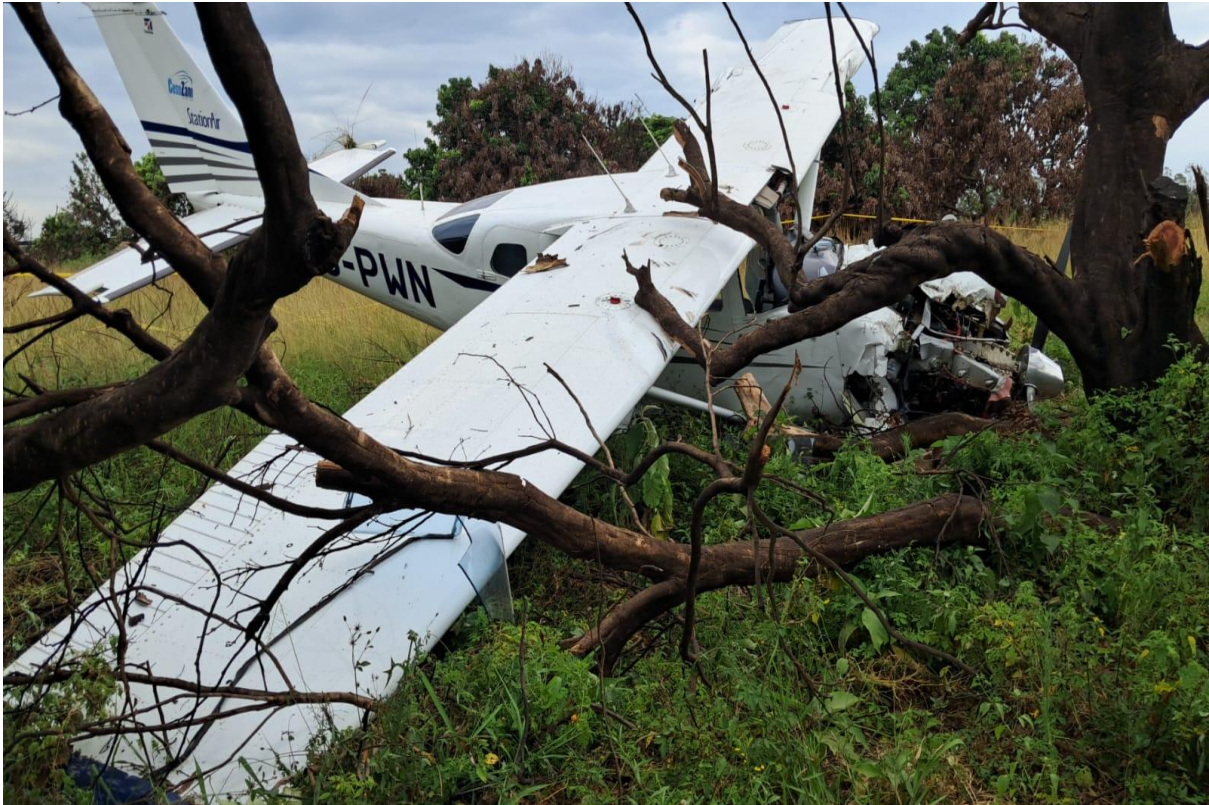
**Figure 6:** The aircraft in a right-wing low attitude.

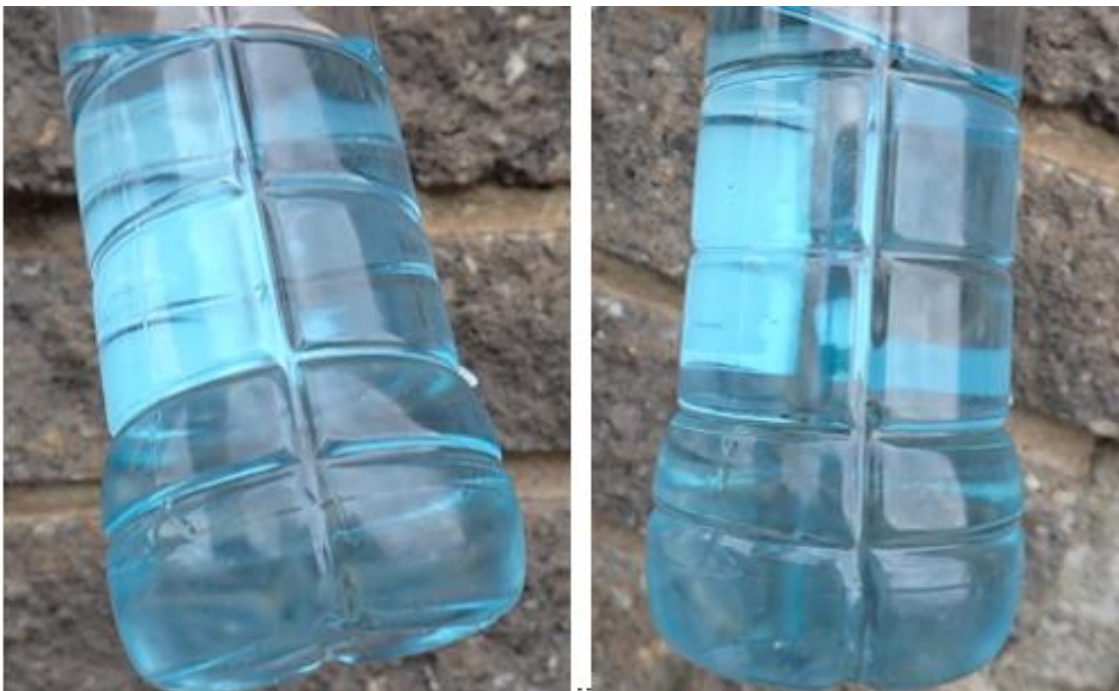
During the recovery of the aircraft, approximately 115 litres of Avgas was drained from both fuel tanks. An undetermined amount of fuel leaked from the right fuel filler cap after the accident, with the aircraft coming to rest in a right-wing low attitude as reported by the pilot. No evidence of contamination was found in the fuel drained from the tanks. Fuel samples were also taken from the two header tanks (post-recovery), with no fuel contamination found. *It should be noted that when an aircraft is fitted with a cargo pod, as was the case with ZS-PWN, the pilot needs to take fuel samples from the two header tanks via the cargo pod access door on the left side.* During the impact sequence, the cargo pod separated from the lower fuselage (see Figure 5).

**Figure 7:** Fuel samples taken from the left and right header tanks.

- 3.2.12 Fuel drained from both header tanks was free of contaminants. However, a small amount of sediment, including sand particles, was found in the fuel strainer. An unknown quantity of fuel was also reported by the pilot to have leaked from the right-wing tank fuel cap.

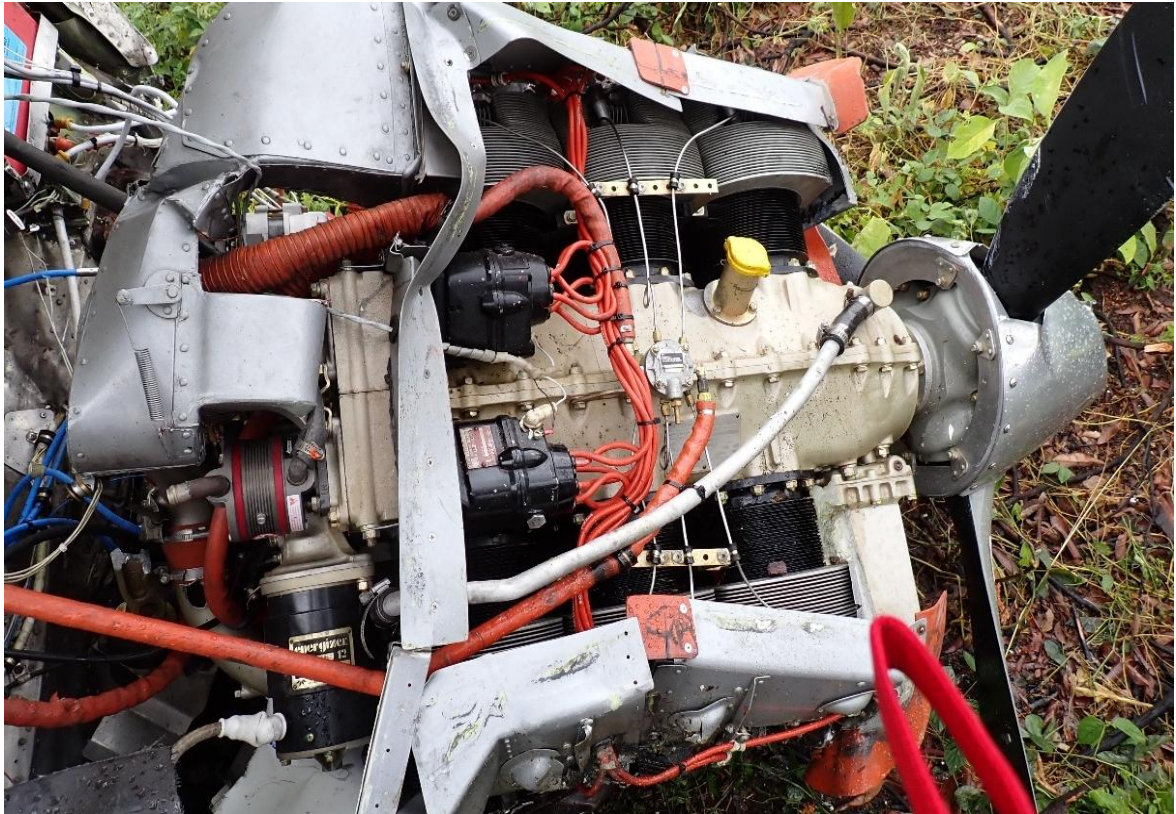
The engine, a Teledyne Continental IO-520L-CF with serial number 294912-R, was removed from the airframe for further investigation. The engine has been in service for 302.8 hours after it was overhauled. A teardown inspection was conducted at an engine overhaul facility on Monday, 2 March 2026 during which the engine was found to have sustained damage on its right side with all three tappet covers fractured.

**Figure 8:** The engine, before it was recovered.

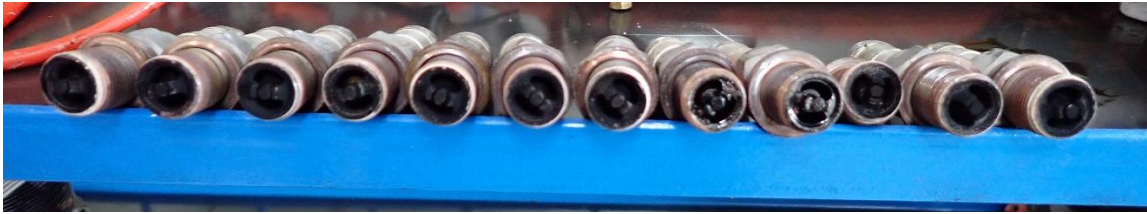
- The engine-driven fuel pump was inspected, and it showed no evidence of wear or malfunction. It rotated freely by hand.
- The fuel control unit (FCU) filter was clean, and the FCU passed the bench test.
- All six fuel injectors were inspected and found free of defects that could have restricted fuel flow to the cylinders.
- Both magnetos were bench-tested and produced normal firing intensity.
- The fuel divider (fuel manifold valve) was disassembled and inspected. The diaphragm was intact, the filter screen was clean, and no fuel leaks were identified in the associated feed lines.
- The exhaust system and all 12 spark plugs exhibited heavy carbon fouling, indicating prolonged operation with an excessively rich fuel/air mixture. Two spark plugs also showed evidence of oil fouling.

**Figure 9:** The heavily fouled 12 spark plugs.

- 3.4.1 During the engine restart procedure, excessive fuel input likely resulted in an overly rich mixture, leading to heavy spark plug fouling, impaired ignition and failure to restore normal engine operation.

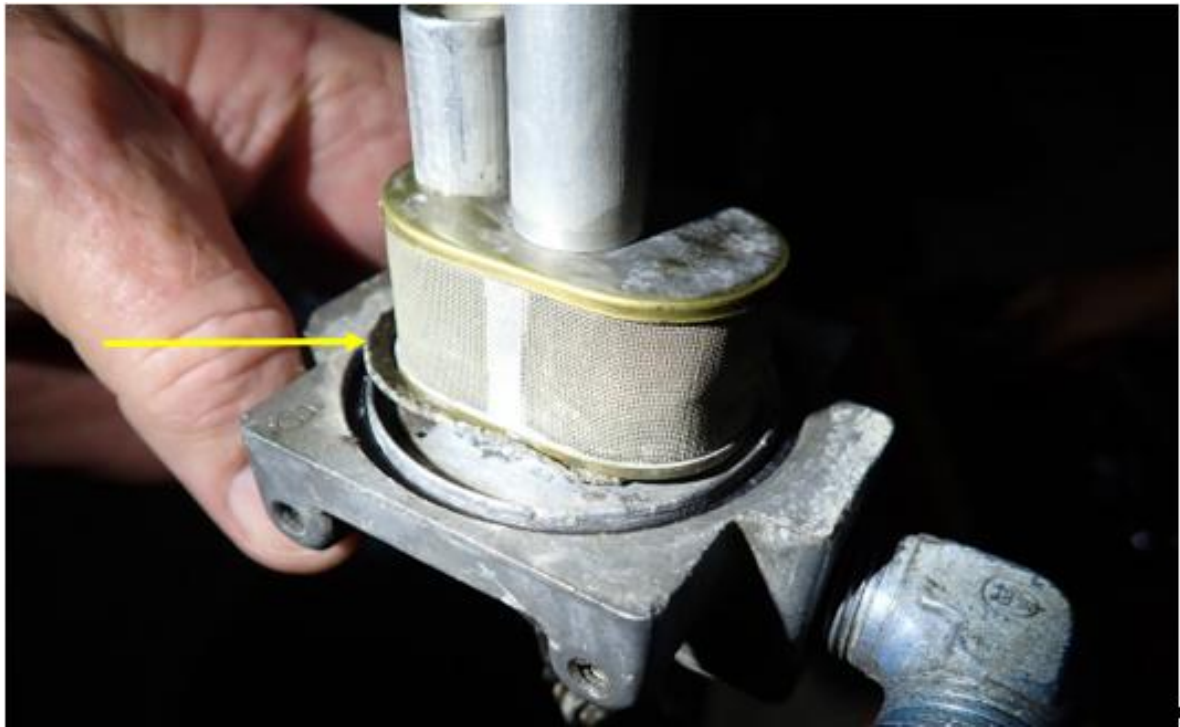
The fuel strainer was removed and inspected; the bowl contained fuel and a small amount of sediment. The filter assembly gasket was found misaligned (see Figures 11 and 12), partially restricting fuel passage to the engine-driven fuel pump.

**Figure 11:** The fuel filter assembly fitted inside the strainer, seated on a gasket (yellow arrow).  
 NOTE: *The unit is upside-down for illustration purposes.*

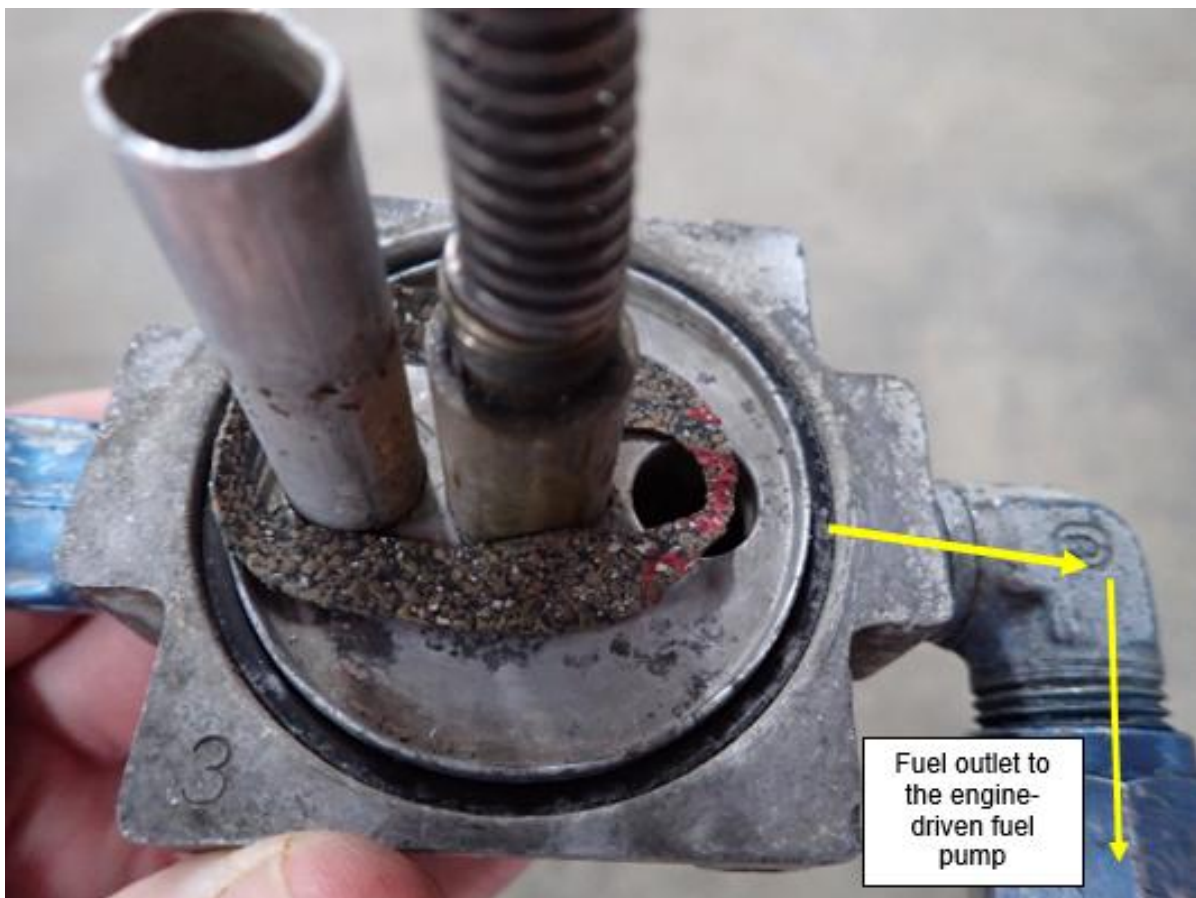
**Figure 12:** Removed fuel filter assembly shows the gasket restriction to the hole that feeds fuel to the engine-driven fuel pump. NOTE: *The unit is upside-down for illustration purposes.*

- 3.2.13 The investigation found that the fuel strainer gasket was incorrectly installed, which may have restricted fuel flow. No mechanical defects capable of causing engine stoppage were identified.

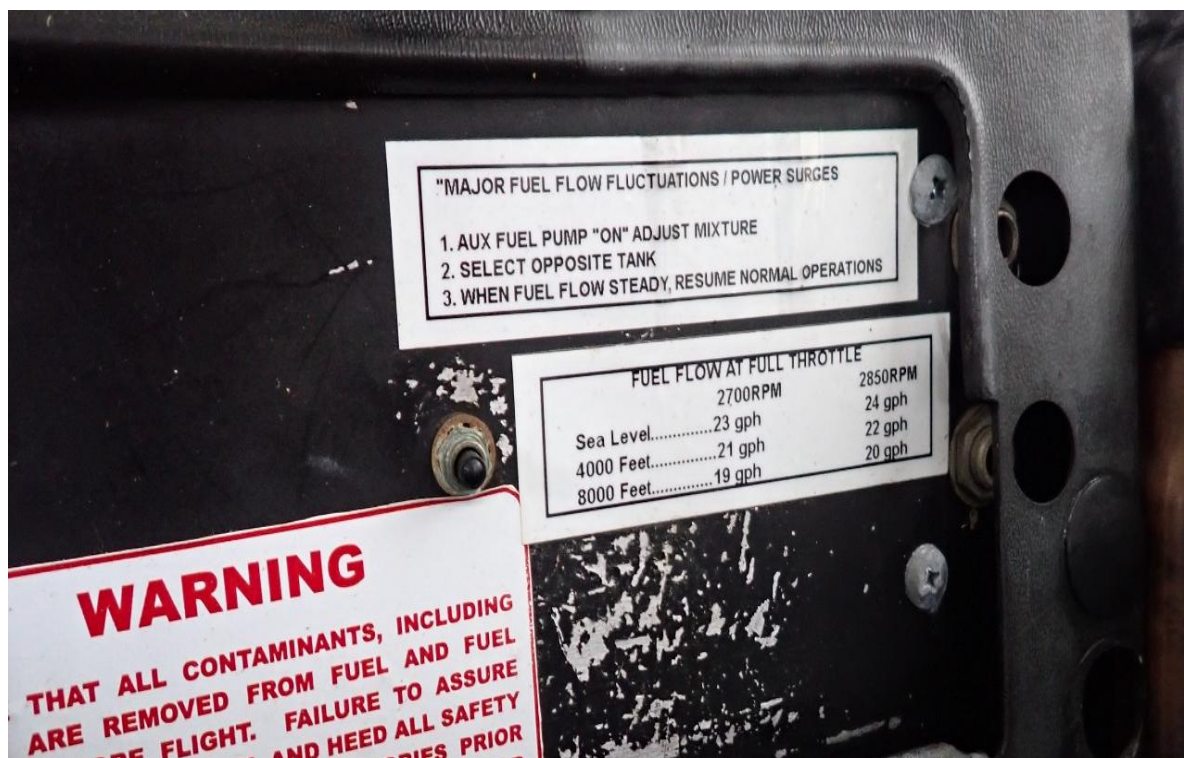
**Figure 14:** The fixed placard that was on the instrument panel of ZS-PWN as required by the Cessna SIL and the FAA AD 79-15-01.

Although the pilot followed the procedure as indicated on the placard, engine restart could be achieved, but normal engine operation could not be restored. What was required was a new supply of 'cool' fuel which could only be achieved by switching tanks. If the tanks are not switched, the hot fuel gets recirculated, which will continue to contribute to the problem.
