## AIRCRAFT ACCIDENT REPORT AND EXECUTIVE SUMMARY

| | | | | <b>Reference:</b> | | <b>CA18/2/3/10637</b> | |
| <b>Aircraft Registration</b> | <b>ZU-VHB</b> | <b>Date of Accident</b> | 19 February 2026 | | <b>Time of Accident</b> | 0545Z | |
| <b>Type of Aircraft</b> | Jabiru J400 | | | <b>Type of Operation</b> | Private (Part 94) | | |

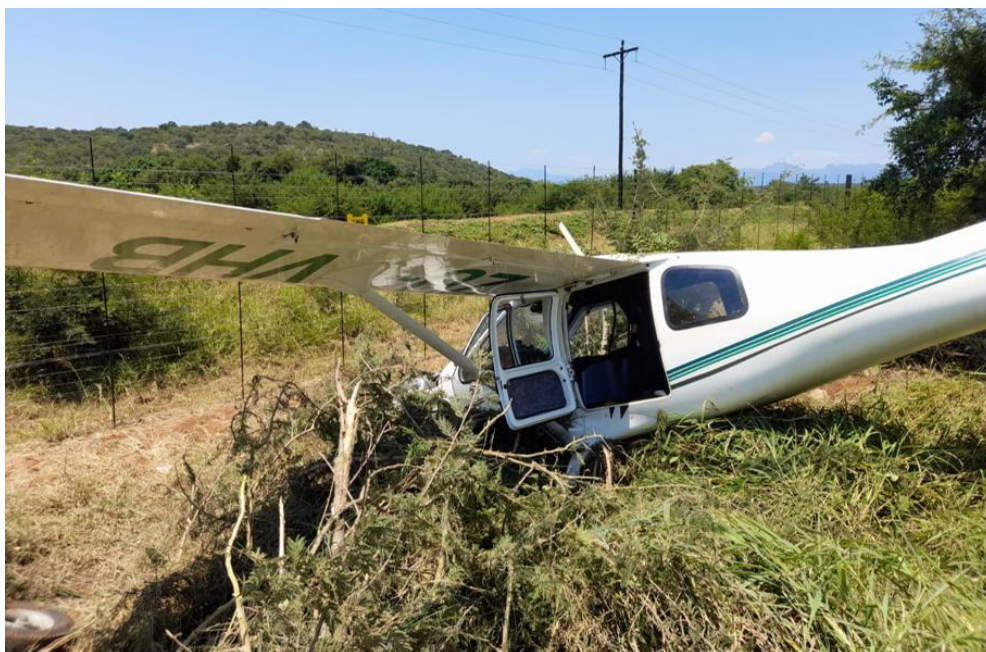
- 1.3.1. The aircraft sustained damage to the wings, landing gear and propeller blades.

**Figure 2:** The ZU-VHB facing south on R530 embarkment. (Source: Owner)

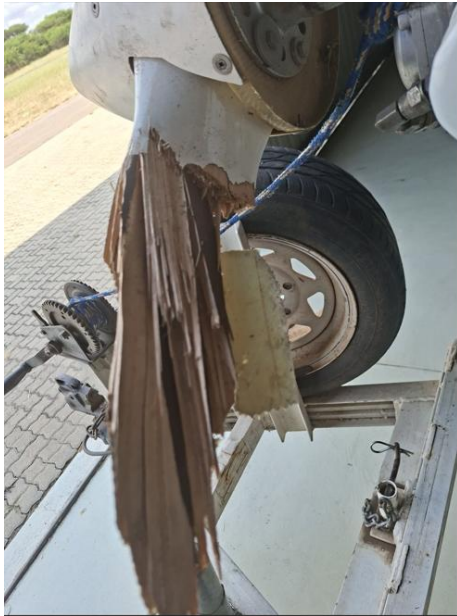
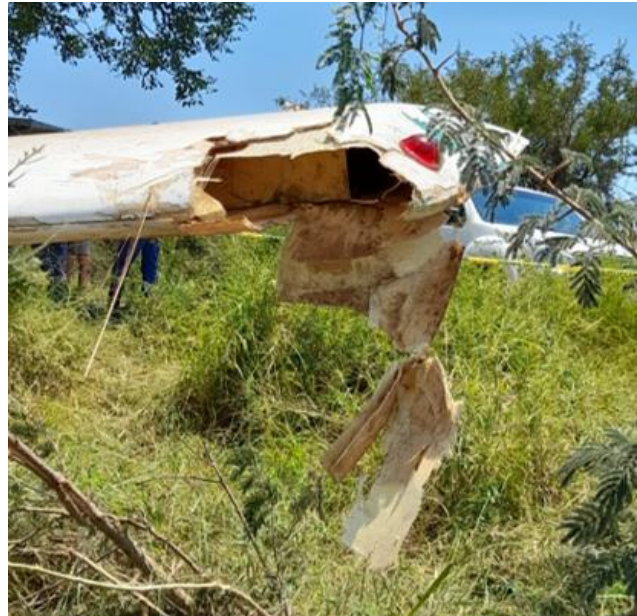
1.12.1. The aircraft sustained damage to one of the wooden propeller blades during the accident. The main landing gear (MLG) frame was twisted, and the left main landing gear wheel was found a few metres behind the main wreckage after separating from the MLG frame. The left-wing tip was damaged during contact with the treetops during the forced landing.

**Figures 3 and 4:** The damaged propeller (left) and left-wing tip (right).

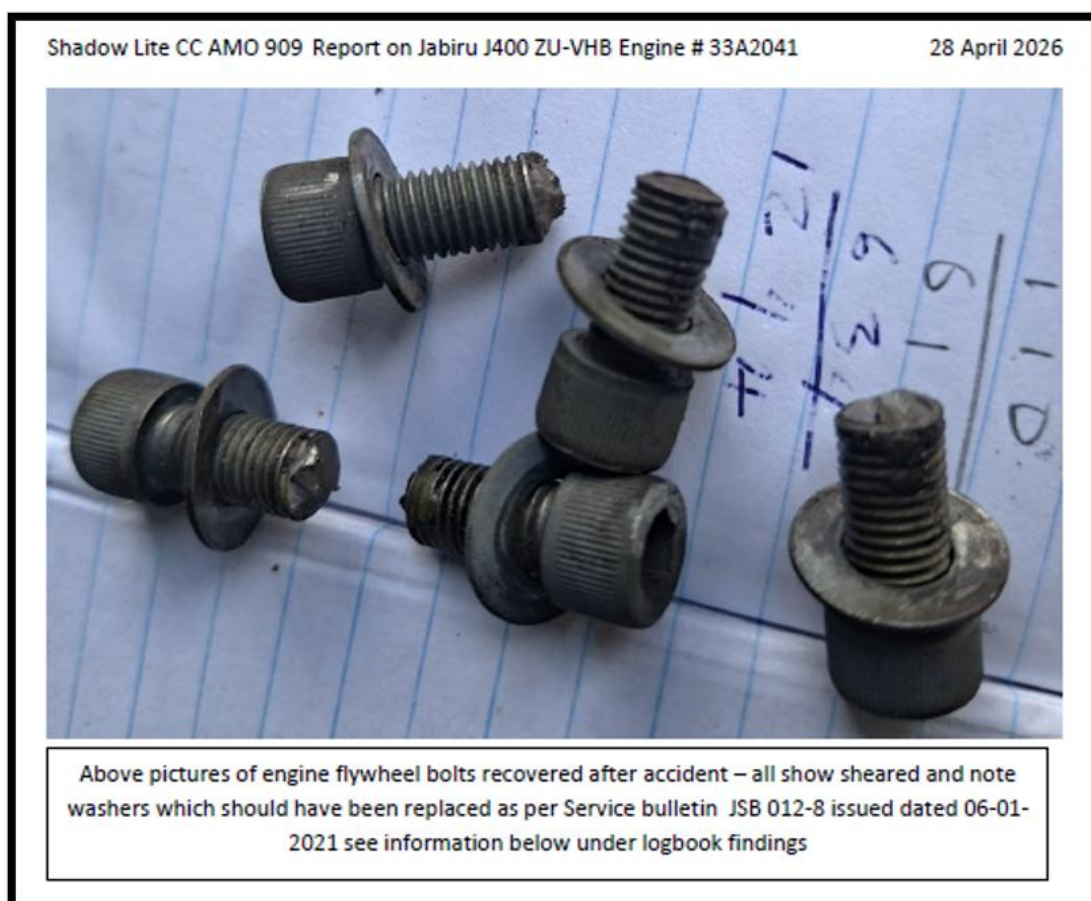
**Figure 7:** The sheared flywheel screws that were removed; the sixth screw was stuck to the engine.  
(Source: Jabiru Agent)

2.2.7. Section 8 of the Engine Maintenance Manual JEM00012-2 (Appendix A) states that the flywheel screws must be replaced at 500 hours. All flywheel screws (in Figure 8) that were sheared during the engine failure had Loctite residue and did not have any indication of fatigue or fracture propagation. Their condition indicated a sudden overload failure rather than deterioration over time.

2.2.8. The agent found that all six flywheel screws in the engine likely sheared during the initial climb which resulted in a loss of engine power and the subsequent engine stoppage. The engine was the second replacement to this aircraft and had completed 393.5 hours since installation; it had not yet reached the 500-hour screws replacement. The failure occurred before the scheduled screws replacement interval, and the investigation could not determine the exact reason for the simultaneous screws' failure. However, evidence indicated that a sudden mechanical failure initiated the accident sequence.

- Check the flywheel screws as detailed in Section 5.3. If any loose or broken screws are found, replace all the screws in accordance with the procedure given in Section 5.4.
- Maintain the engine in accordance with the instructions detailing flywheel connection maintenance from the latest issue of the Engine maintenance manual JEM0002

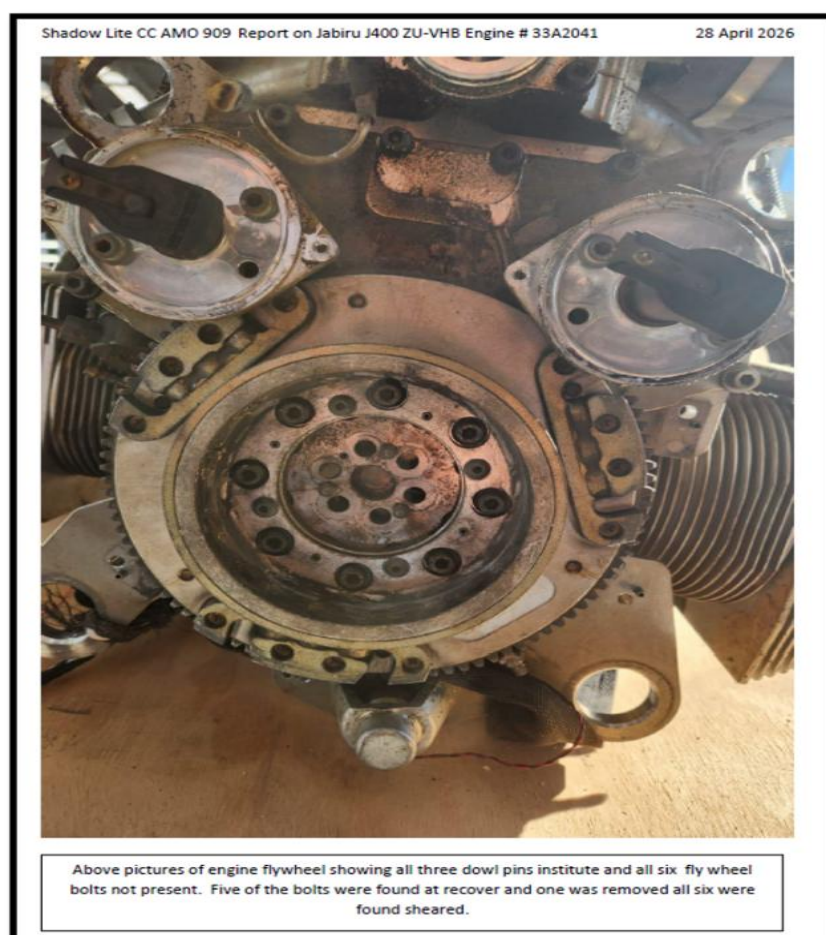
1.16.1. After the accident, the aircraft was recovered to the hangar of an aircraft maintenance organisation (AMO) at FAHT. After thorough inspection, it was discovered that the engine's flywheel was loose with its screws sheared. Thereafter, the engine was transported to the Jabiru Distribution Agent, the sole distributor of Jabiru aircraft in South Africa, situated at George Airport (FAGG), Western Cape province. The crate which contained the engine was opened in the presence of the investigator on 23 April 2026.

**Figure 9:** Picture of the engine without the flywheel. (Source: Jabiru Agent)

1.16.7. “If the flywheel screws fail, the flywheel will separate from the crankshaft. This will result in loss of power and damage to the alternator and ignition coils, and will result in stoppage of the engine,” states the report.

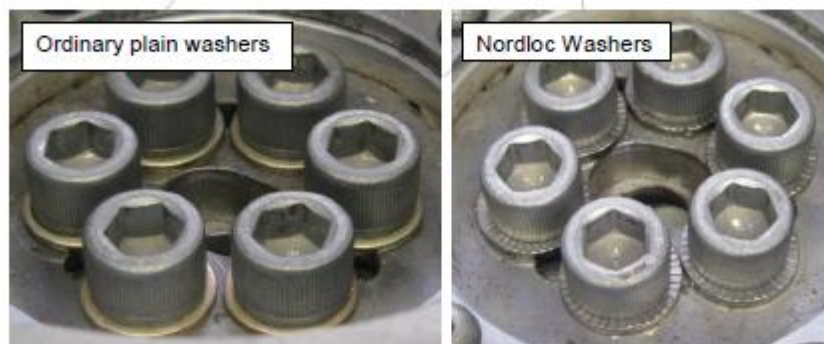
Figure 2 - Plain washers compared to Nordloc washers (flywheel with steel centre).

This service bulletin also acts to inform maintainers and operators of a design change to the flywheel connection which **must** be implemented on existing engines whenever flywheel bolts are replaced (i.e. at the intervals specified in JEM0002 or at overhaul).

Refer to the Legacy Jabiru Engine overhaul manual JEM0001 and the Gen 4 Jabiru Engine overhaul manual JEM0002 (always check for the latest revision) for the installation procedure of flywheel capscrews using Nordloc washers. The major difference in installation is that bolts installed with Nordloc washers **must not be installed with Loctite**. The torque setting is also different for capscrews installed with these washers.

When Nordloc washers are used on an aluminium surface a steel plate must be used to protect the aluminium surface. These are available from Jabiru.
