## LIMITED OCCURRENCE INVESTIGATION REPORT – FINAL

| <b>Reference Number</b> | CA18/2/3/10645 | | | | | | |
| Registration | ZU-CKU | | | | | | |
| Make; Model; S/N | Jabiru SP (Serial Number: 421) | | | | | | |

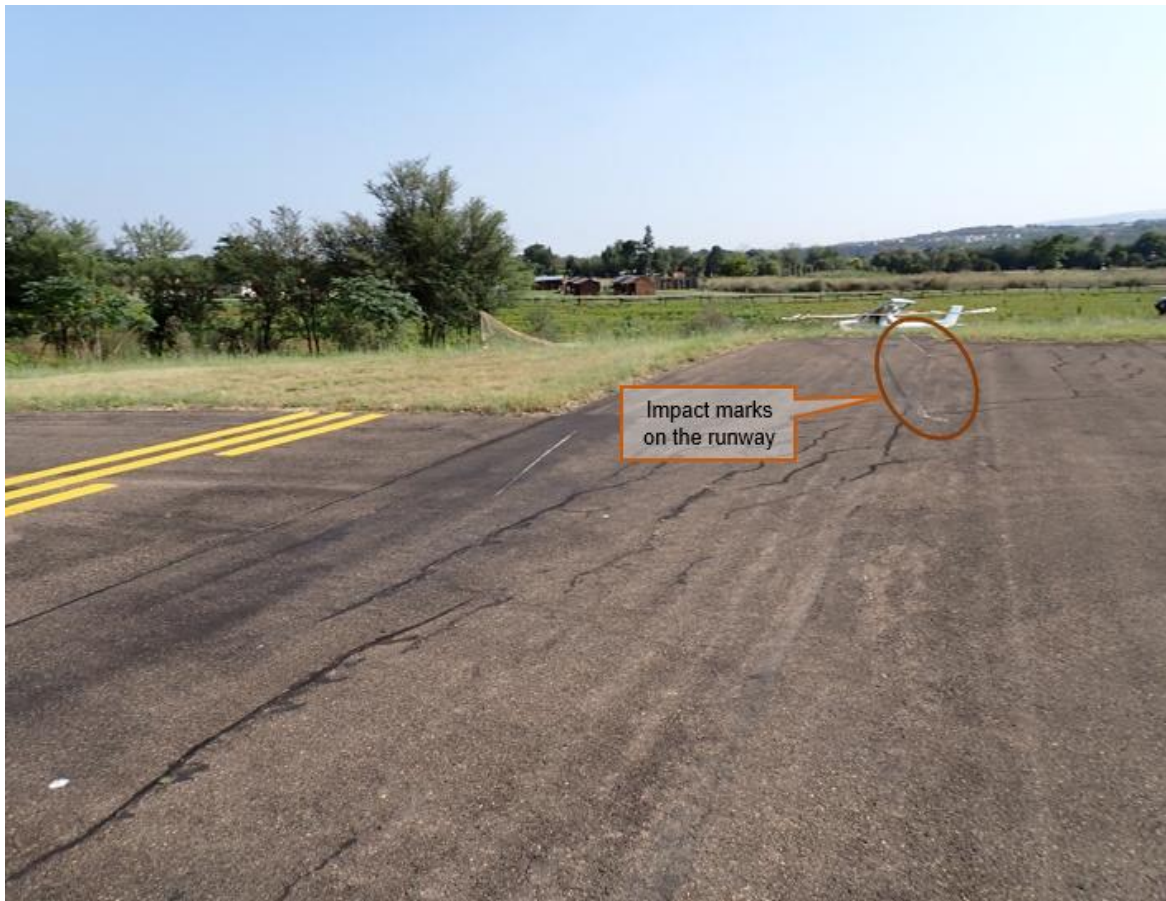
**Figure 2:** Impact marks on the runway with the aircraft in the background.

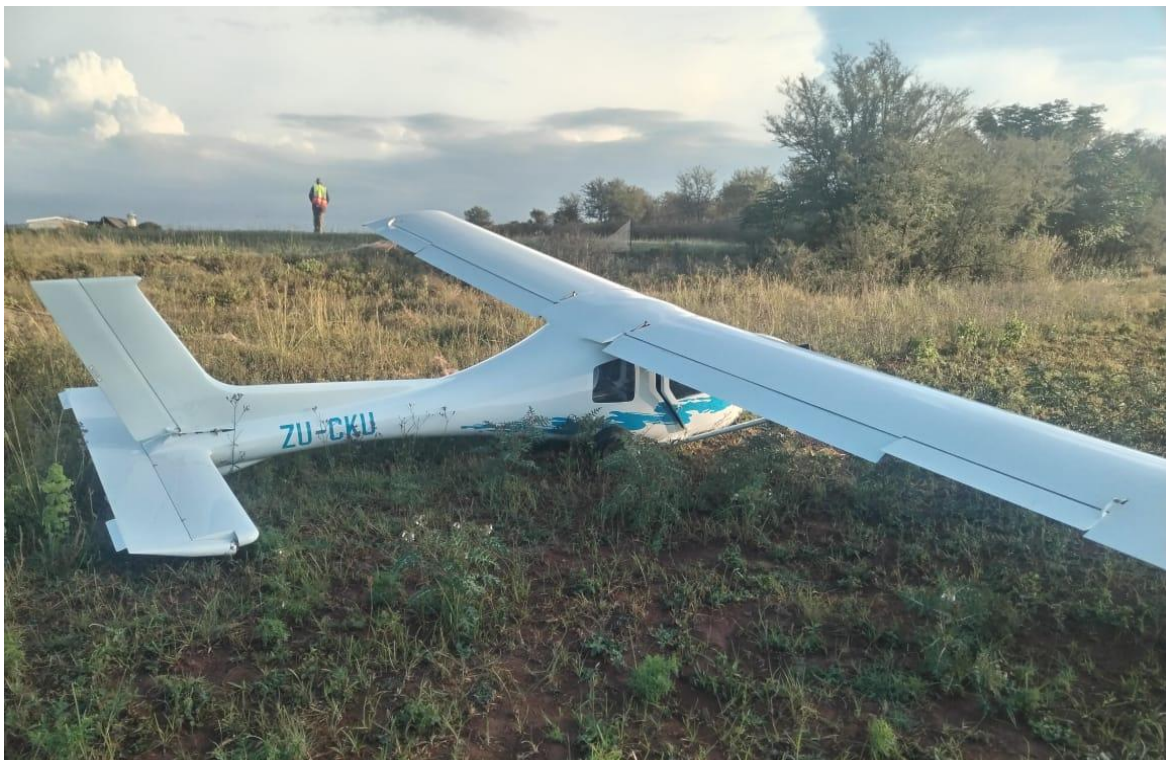
The aircraft was substantially damaged during the impact sequence, including the collapse of the landing gear.

**Figure 3:** The aircraft after it had stopped. (Source: Manager at FAKT)

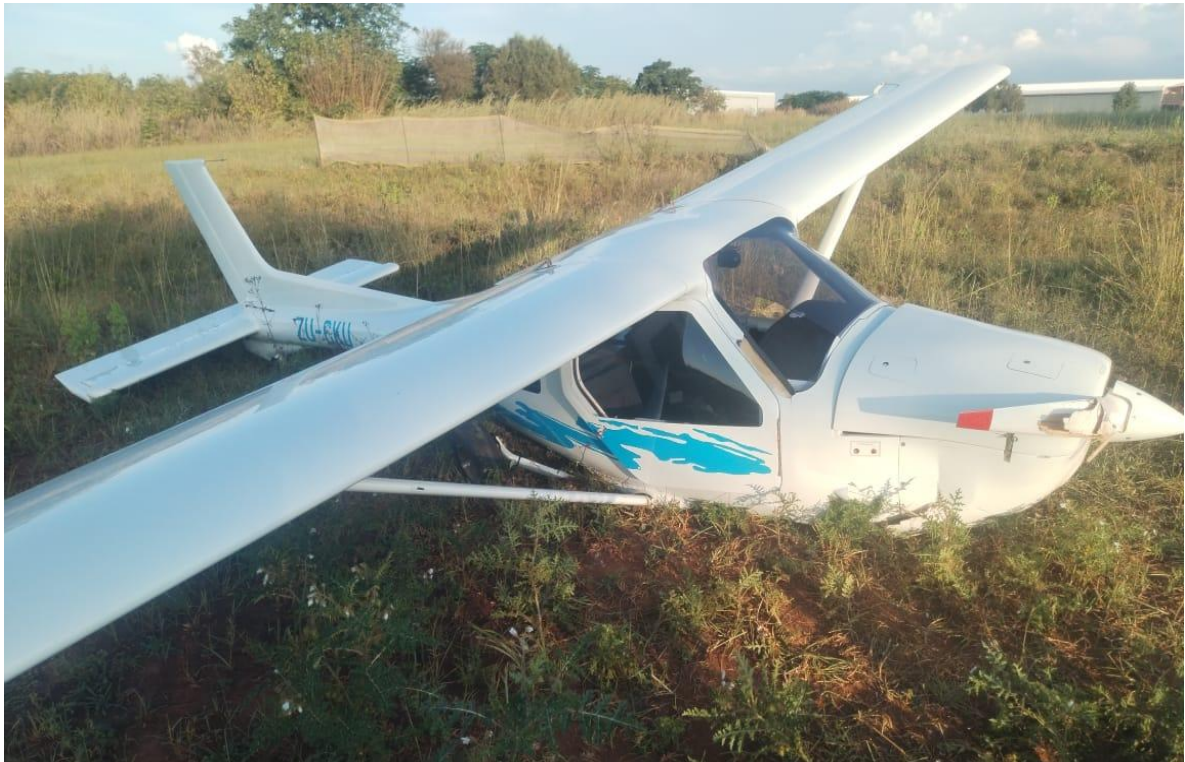
**Figure 4:** A side view of the aircraft post-accident. (Source: Manager at FAKT)

The aircraft was recovered to an aircraft maintenance facility the next day to determine whether the engine, a Jabiru 2200A with serial number A22787, had sustained damage that might prevent a test run. The engine was found undamaged, but the originally installed propeller was damaged (Figure 4). Therefore, a loaner propeller was installed, and an external battery pack was used as the power source during the engine test run.

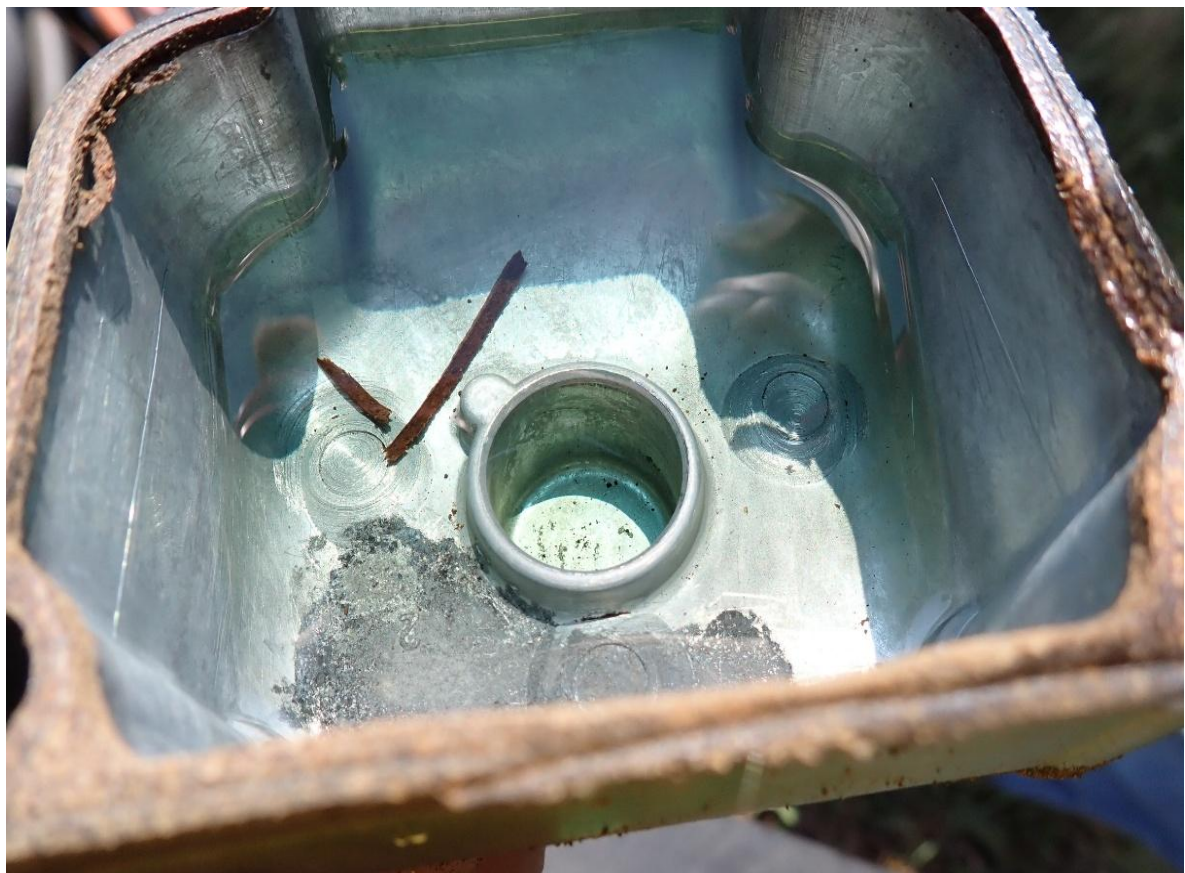
**Figure 5:** The fuel carburettor bowl.

The fuel carburettor bowl was removed by maintenance personnel in the presence of the investigating team. The fuel was found clean and free of contaminants. (The two brown pieces visible in the bowl in Figure 5 are fragments of the gasket sealant used around the bowl's circumference.) These fragments fell into the bowl during disassembly.

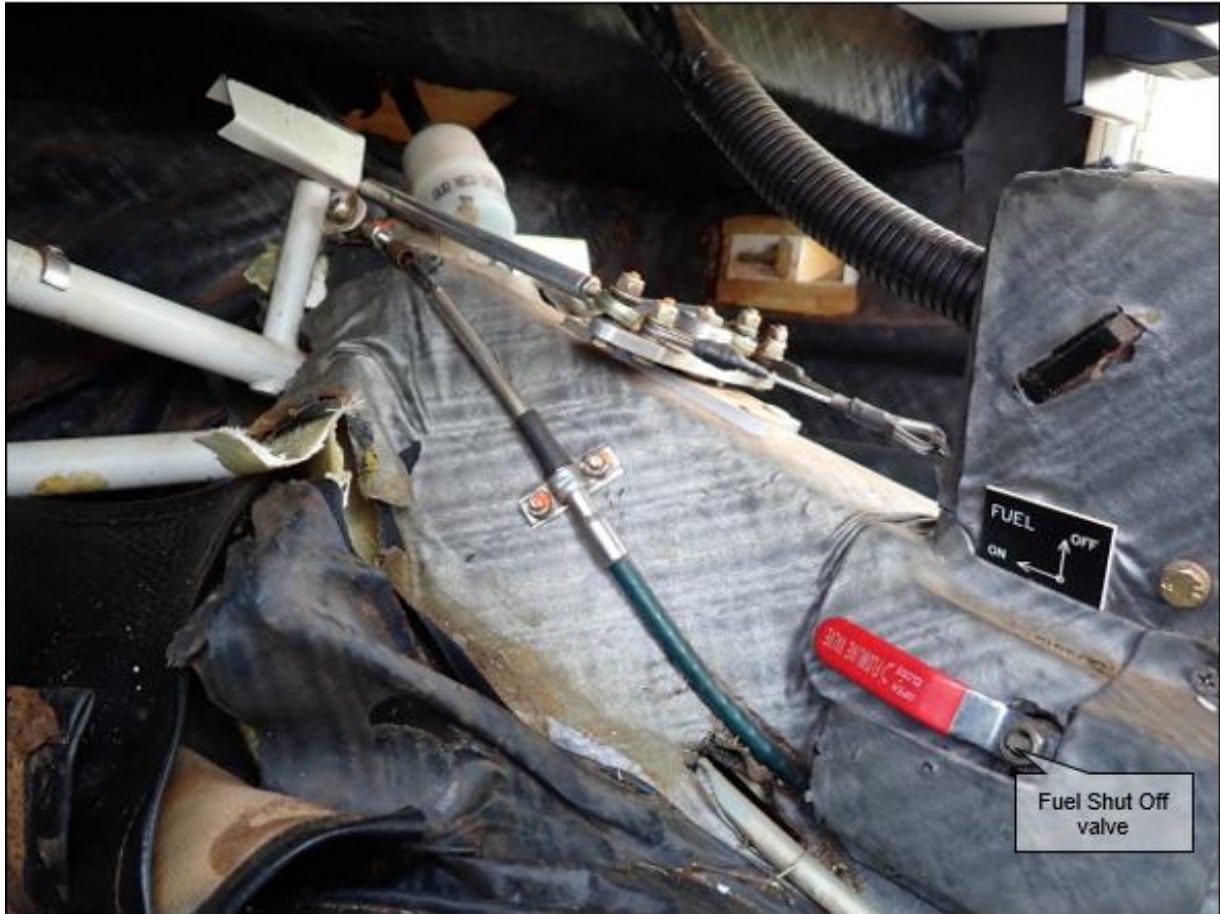
**Figure 6:** The fuel shut-off valve was found in open (ON) position.

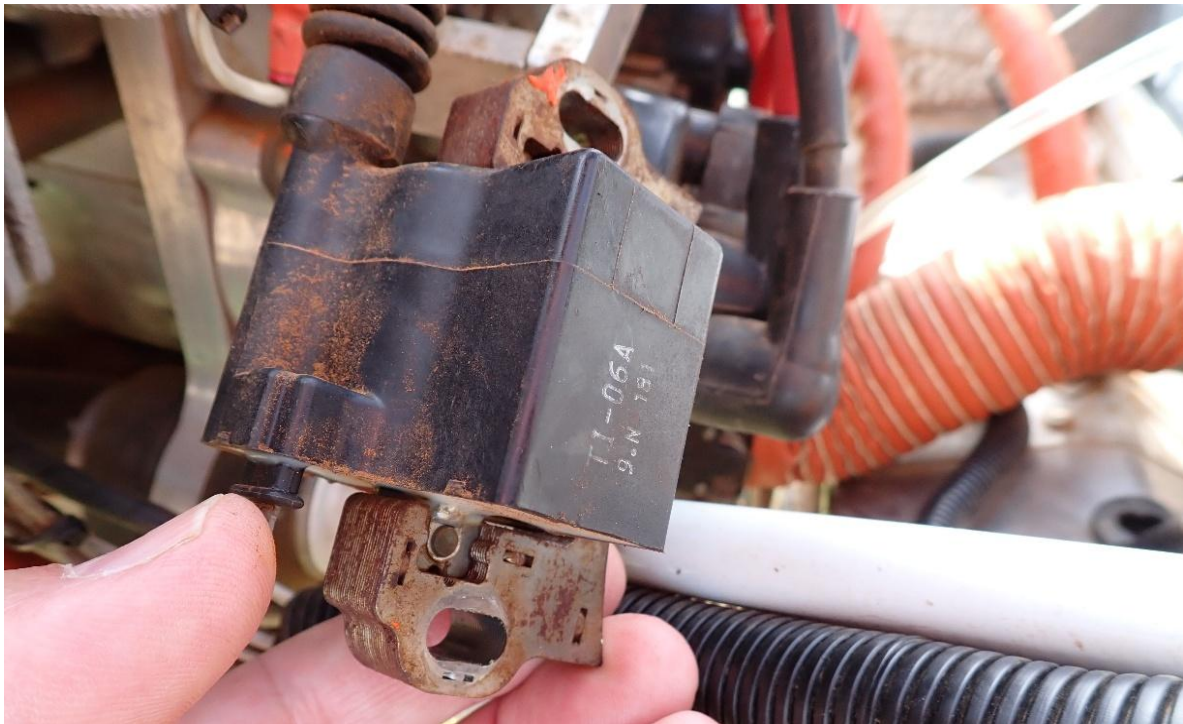
**Figure 8:** The left coil that was removed and replaced with a loaner unit.
