## LIMITED OCCURRENCE INVESTIGATION REPORT – FINAL

| <b>Reference Number</b> | CA18/2/3/10651 | | | | | | |
| Registration | ZU-MND | | | | | | |
| Make; Model; S/N | Sling 4 TSI (Serial Number: 432) | | | | | | |

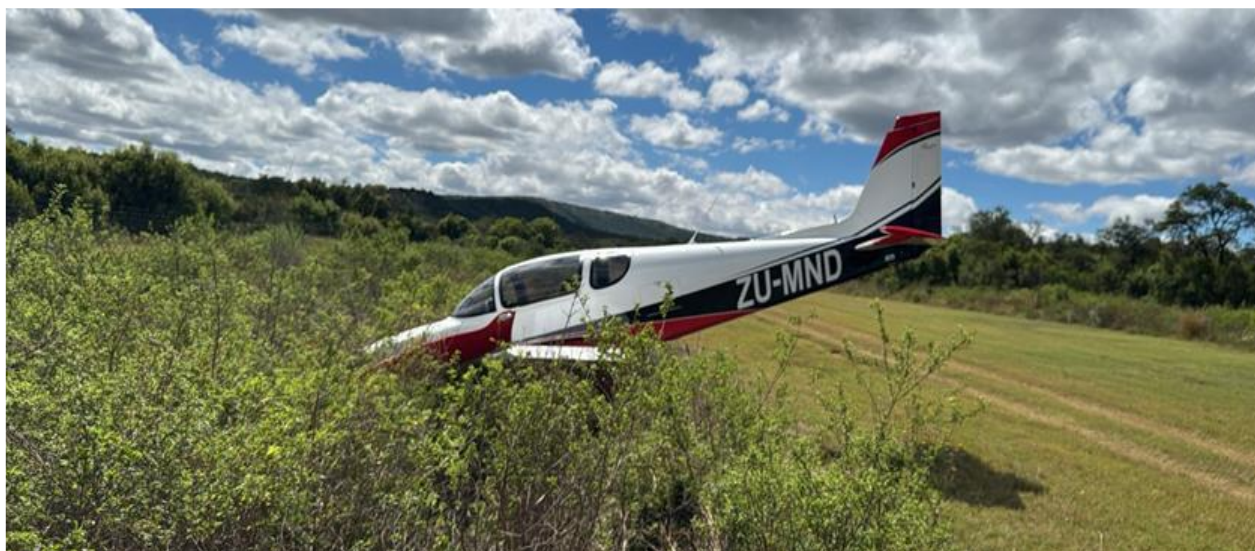
**Figure 2:** The aircraft at the accident site. (Source: Operator)

| <p>8. The aircraft was maintained in accordance with the prescribed Regulatory and manufacturer's procedures and no defects were identified before the flight.</p> <p>9. During landing, the aircraft's speed was approximately 75 knots (kts) with flaps set at 20 degrees; the Pilot's Operating Handbook (POH) recommends a speed of 70 kts and full flaps setting. Therefore, the aircraft was unstable during approach.</p> <p>10. The aircraft landed hard with the left landing gear first; as a result, the left landing gear wheel assembly detached, and the aircraft veered to the left after the pilot lost control.</p> |
| An unstable approach due to high speed and incorrect flaps setting during landing which resulted in a hard landing, followed by the failure of the left landing gear wheel assembly and loss of directional control. |
