## LIMITED OCCURRENCE INVESTIGATION REPORT – FINAL

| <b>Reference Number</b> | CA18/2/3/10652 | | | | | | |
| Registration | ZS-ISU | | | | | | |
| Make; Model; S/N | Piper Cherokee, PA-28-180 (Serial Number: 28-7305561) | | | | | | |

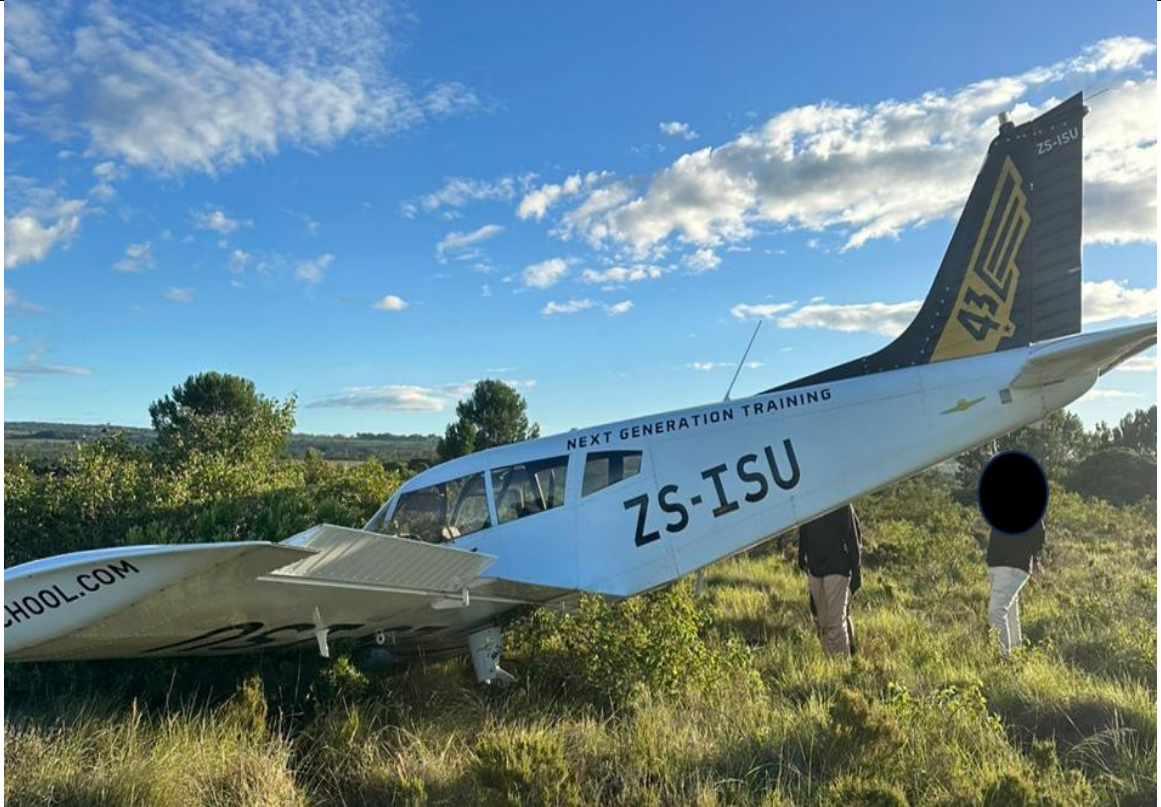
**Figure 2:** The resting position of the aircraft. (Source: Operator)

| 5.4. | After touch down, the SP lost directional control and the aircraft veered off to the right before it came to a stop. The nose landing gear was damaged as a result. |

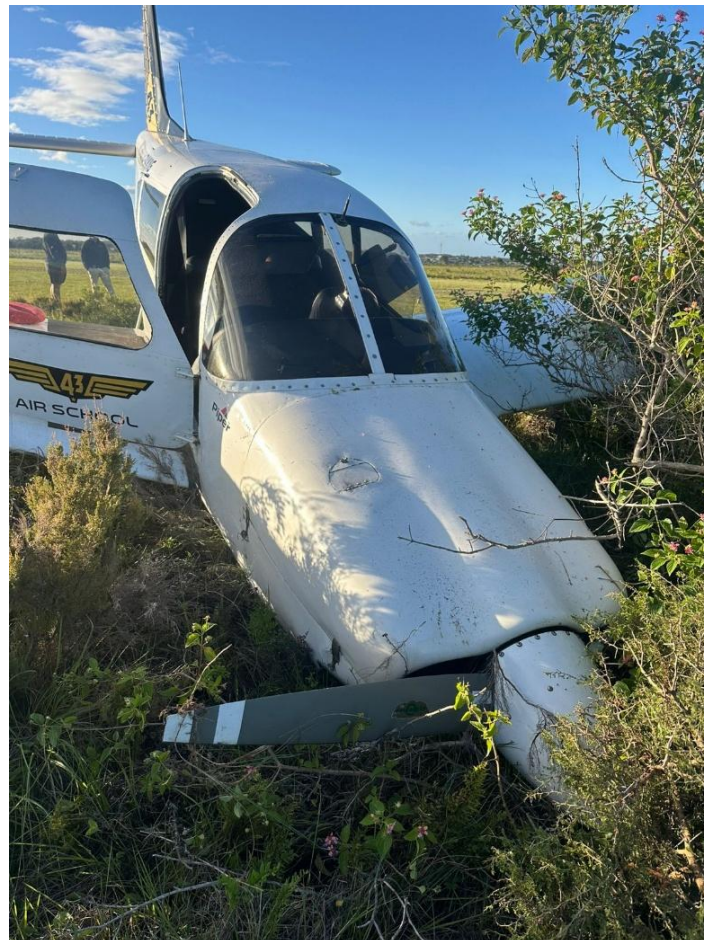
**Figure 3:** The front view of the aircraft after the accident. (Source: Operator)

An instructor who conducted a walk-about after the accident noticed that the nose oleo and nose gear had collapsed, the propeller had also slightly bent backwards. The right-side wing had sustained damage to the leading and trailing edges; the left-side wing had minor damage. The airframe also sustained damage. The rudder trim was set fully to the right. The free movement and travel of the controls was checked and found satisfactory. Later, the aircraft was moved closer to a hangar where an engine inspection was to be conducted. The engine was started without difficulties (as the propeller was not damaged); all engine parameter readings were found to be within the normal operating range. A magneto drop check was performed, and the outcome was normal. The engine was removed and placed on the test bench for a full ground run test; no abnormalities were detected.

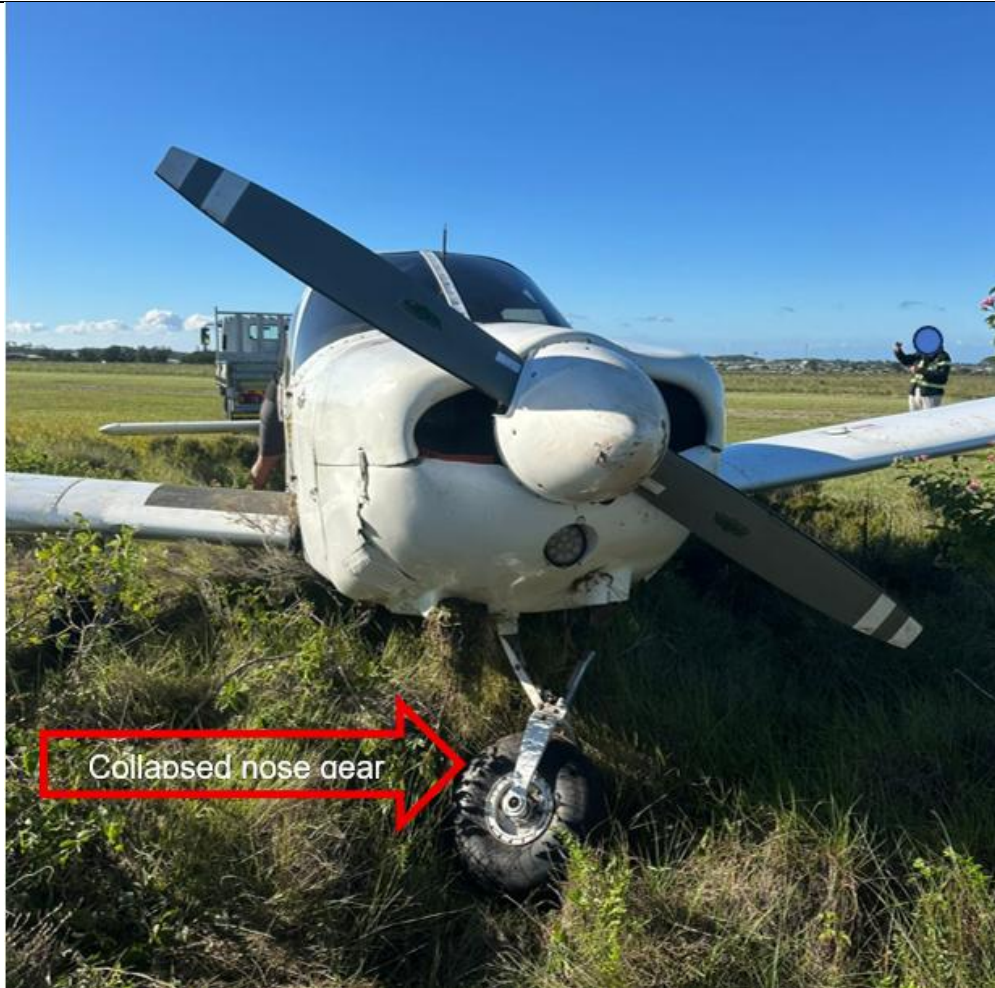
**Figure 4:** The collapsed nose gear. (Source: Operator)

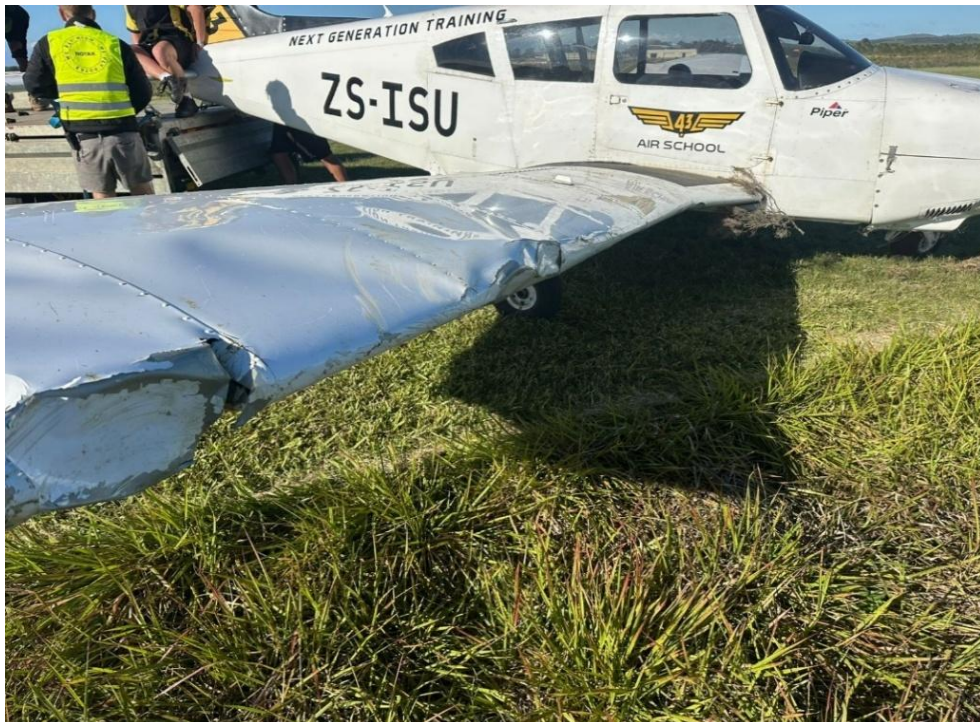
**Figure 5:** The damaged right wing. (Source: Operator)

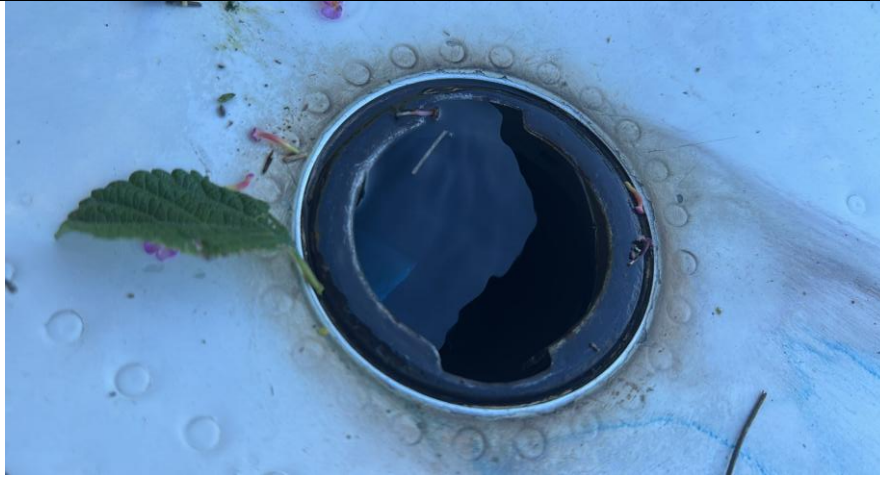
**Figure 6:** The aircraft had adequate fuel in the tank. (Source: Operator)

| 2.6 | The aircraft had adequate fuel for the flight. |

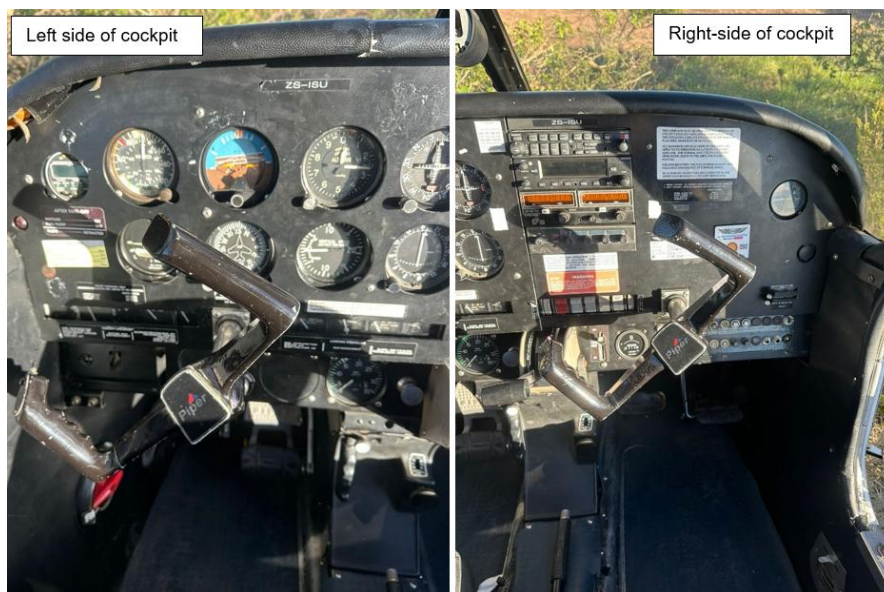
**Figures 7 and 8:** The cockpit view after the accident. (Source: Operator)

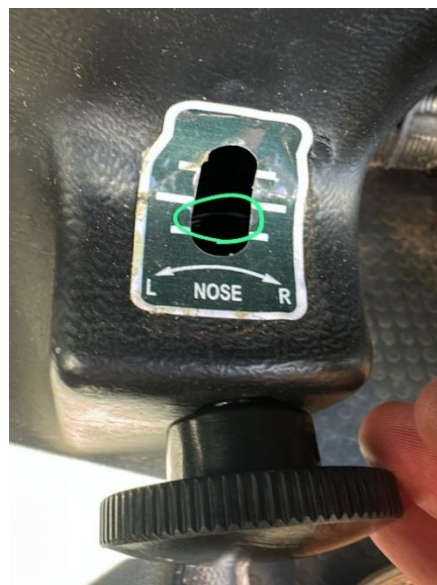
**Figure 9:** The trim control indicator as it was found set to the right. (Source: Operator)

The trim control was set towards the right, which caused the aircraft to yaw to the right after take-off.

| 5.3. | The aircraft's rudder trim was found fully set to the right, which likely contributed to the right yaw during the downwind leg. |
