## LIMITED OCCURRENCE INVESTIGATION REPORT – FINAL

| <b>Reference Number</b> | CA18/2/3/10654 | | | | | | |
| Registration | ZS-VET | | | | | | |
| Make; Model; S/N | Cessna, 172M Skyhawk (Serial Number: 172-60769) | | | | | | |

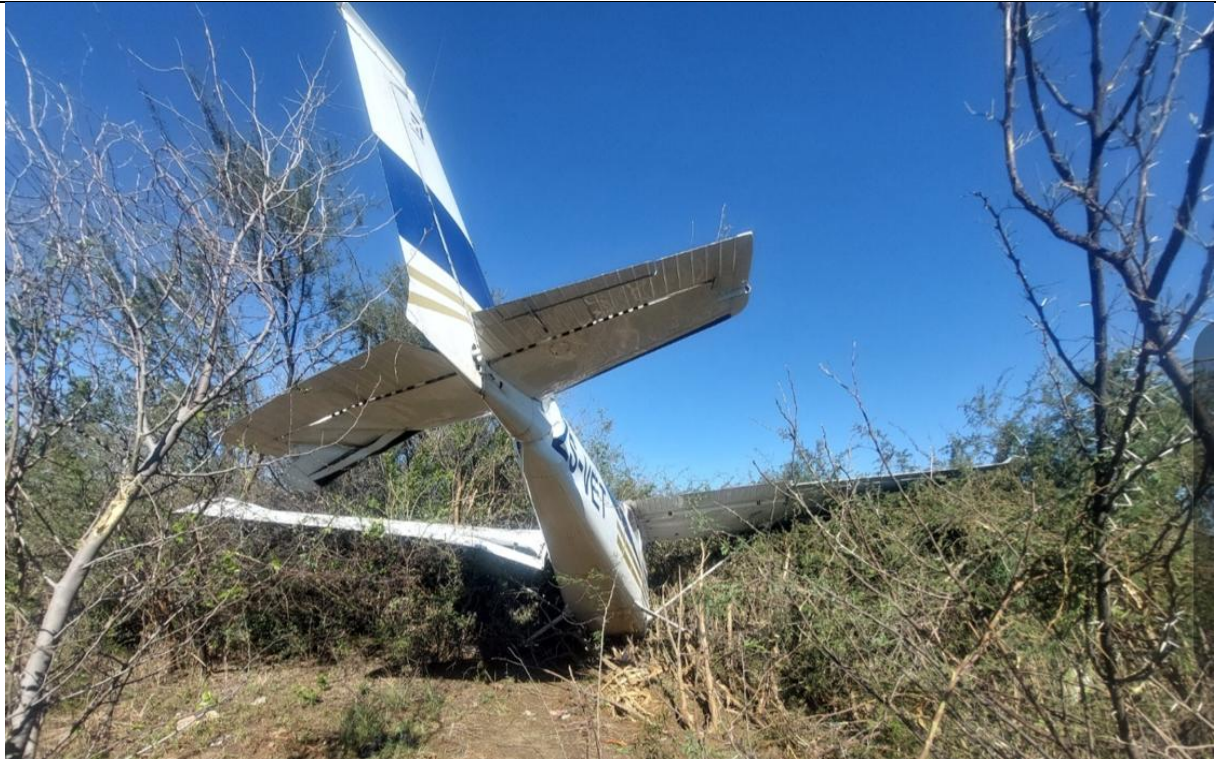
of the fence to conduct a forced landing. The FI stated that there was insufficient time to complete all the engine failure after take-off (EFATO) checks, thus, he shut off the fuel supply by moving the fuel selector to the 'OFF' position and aimed to land on top the treetops. However, the aircraft missed the trees and came to rest on a bush-type terrain approximately 200 metres (m) west of Runway 16 threshold. The aircraft was substantially damaged. The FI sustained minor injuries, and the SP was not injured.

**Figure 2:** The aircraft after the accident. (Source: Operator)

| The engine stopped during the initial climb, which resulted in a forced landing on a bushy terrain. The cause of engine stoppage could not be determined. |
