Section/division **Accident and Incident Investigations Division**

## LIMITED OCCURRENCE INVESTIGATION REPORT – FINAL

| <b>Reference Number</b> | CA18/2/3/10660 | | | | | | |
| <b>Registration</b> | ZS-EGL | | | | | | |

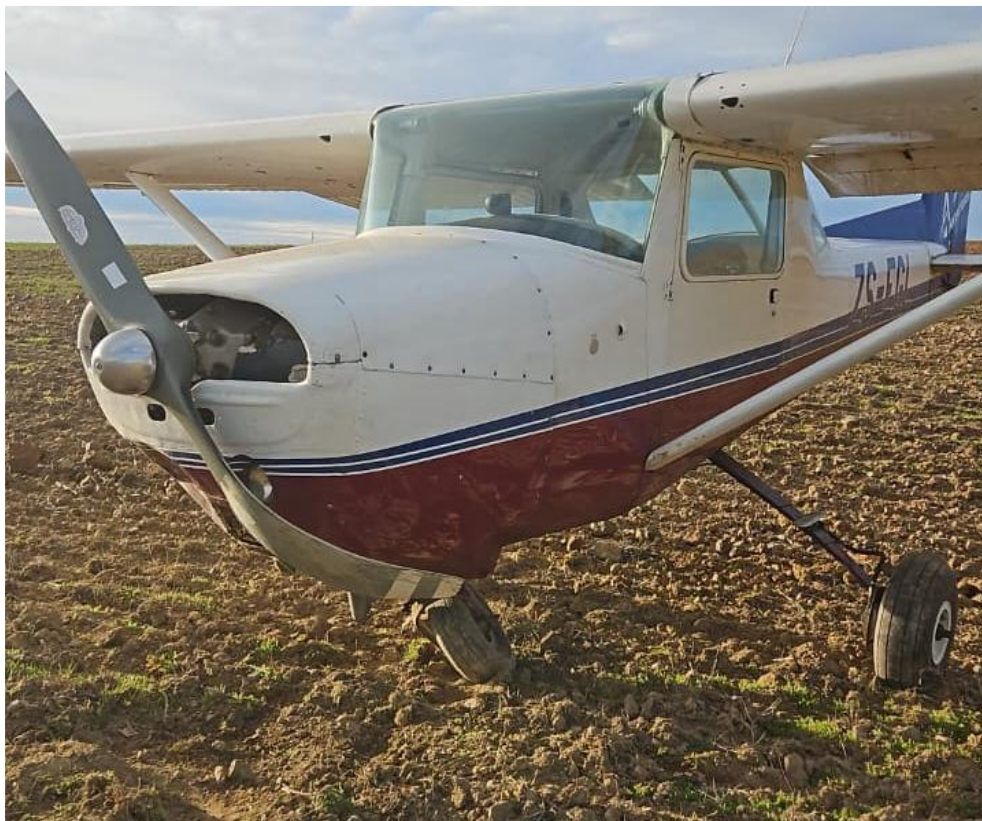
ground. The aircraft sustained damage to the right-wing tip, nose landing gear and propeller. The SP was not injured during the accident sequence.

**Figure 2:** The aircraft at the accident site. (Source: Pilot)

| 3.4. | During the forced landing, the aircraft was unstable. The right wing struck the ground, followed by the nose landing gear which impacted the berm and, thus, the propeller struck the ground. |

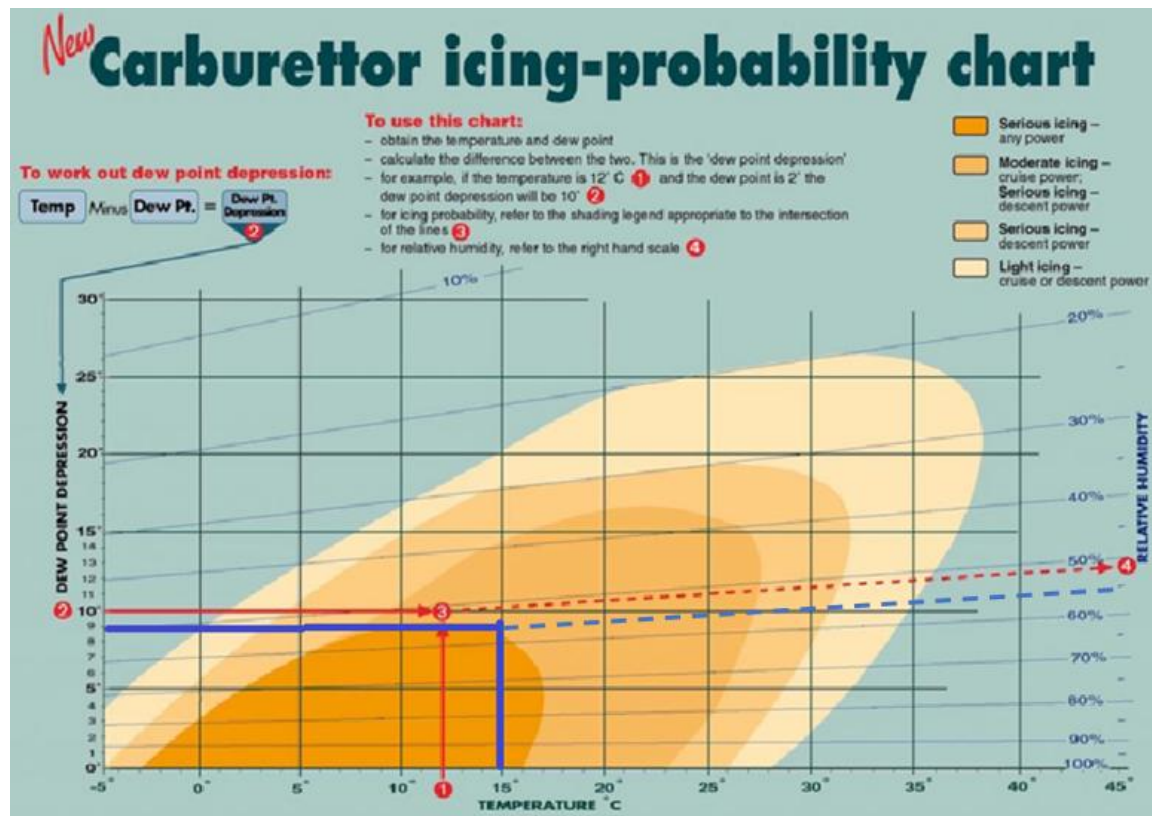
**Figure 3:** The blue lines indicate the dew point depression and temperature.

The temperature at the time of the accident was 15°C and the dew point was 6°C, which equated to a dew point depression of 9°C. The probability of icing would have been moderate at cruise power setting and serious at descent power setting.

| 3.2. | The carburettor icing probability chart indicated a high level of atmospheric humidity with a moderate probability of icing at cruise power and a serious probability during descent power settings. |
