## LIMITED OCCURRENCE INVESTIGATION REPORT – FINAL

| <b>Reference Number</b> | CA18/2/3/10666 | | | | | | |
| <b>Registrations</b> | ZU-MCA and ZS-LVM | | | | | | |
| <b>Make; Model; S/N</b> | Sling 2 (Serial Number: 022); Cessna 210 (Serial Number: 21060698) | | | | | | |

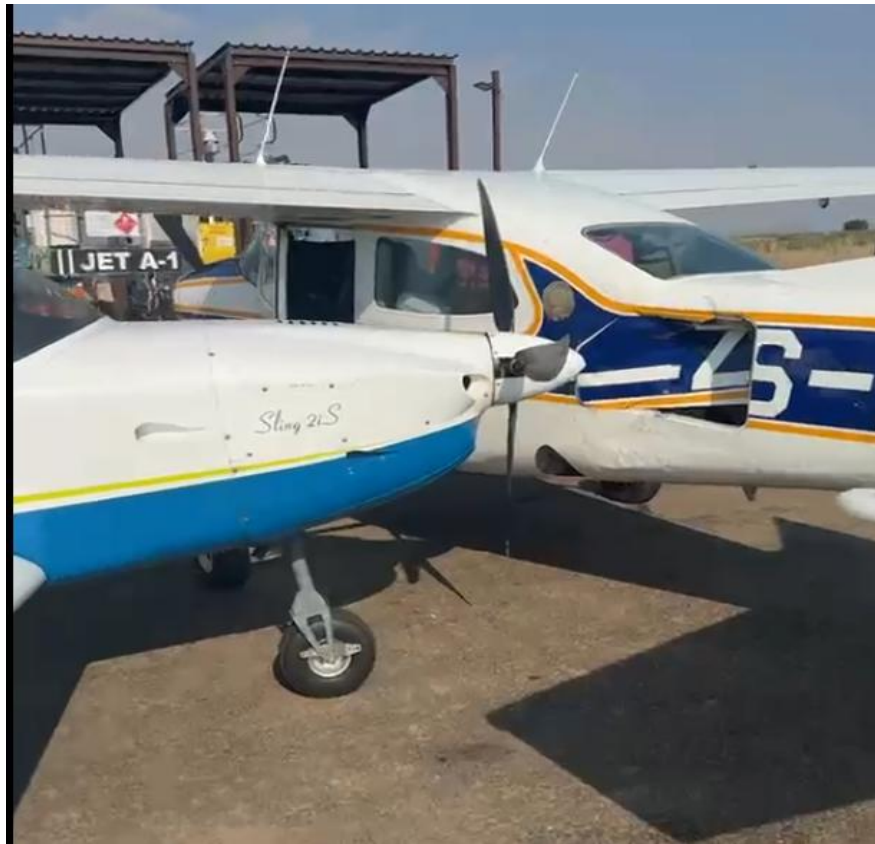
**Figure 1:** The two aircraft after impact. (Source: Operator)

The aircraft rolled forward post after-start checks and impacted the stationary ZS-LVW whilst it was being refuelled.

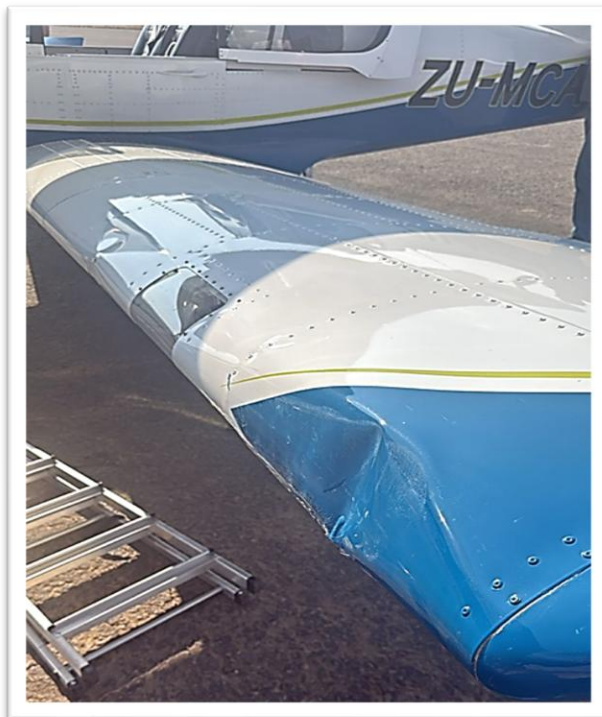
No person was injured. The ZS-LVW aircraft sustained substantial damage to the rear left baggage door and frame. The ZU-MCA sustained minor damage to the propeller blades, spinner cone and left-wing leading edge.

**Figure 2:** Damage to the left-wing leading edge.

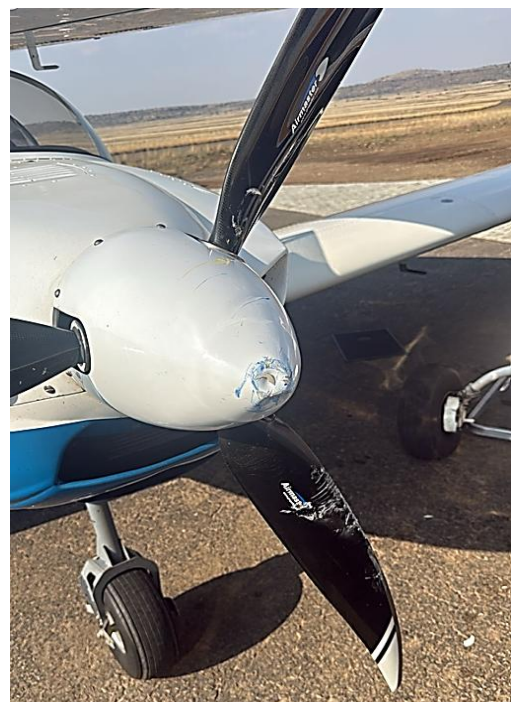
**Figure 3:** Damage to the propeller blades and spinner.
