## LIMITED OCCURRENCE INVESTIGATION REPORT – FINAL

| <b>Reference Number</b> | CA18/2/3/10671 | | | | | | | |
| Registration | ZS-JGD | | | | | | | |
| Make; Model; S/N | Piper; PA28-180 Cherokee (S/N: 28-7405169) | | | | | | | |

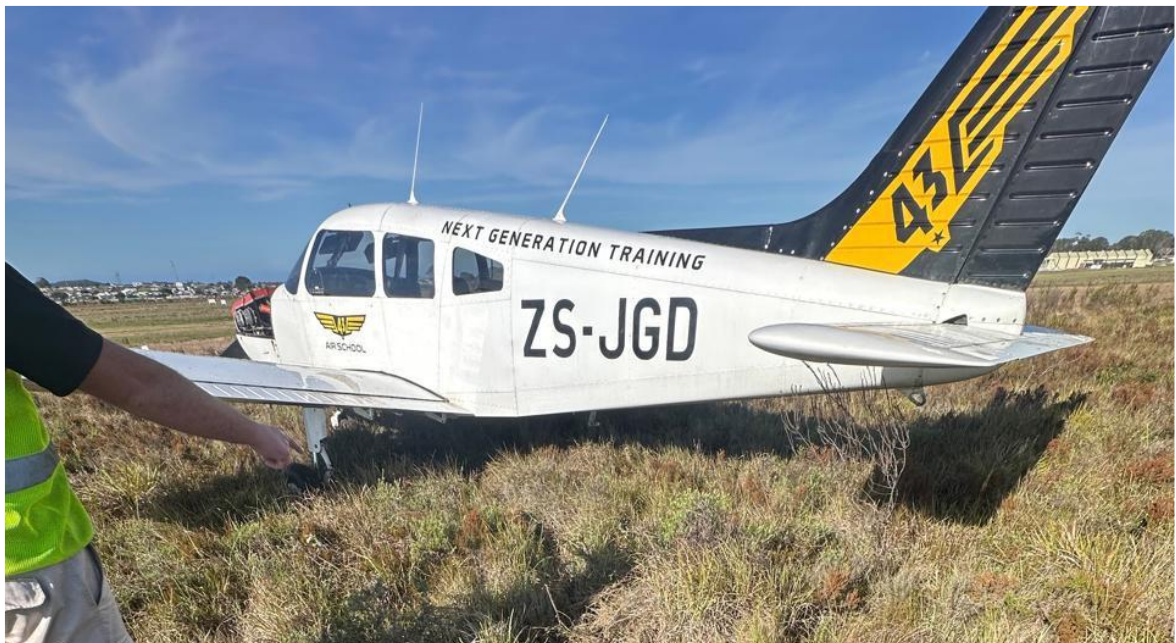
**Figure 2:** The aircraft after it came to a stop. (Source: Operator)

7. The SP lost directional control of the aircraft before it rested on the overgrown grass area on the left side of the runway.

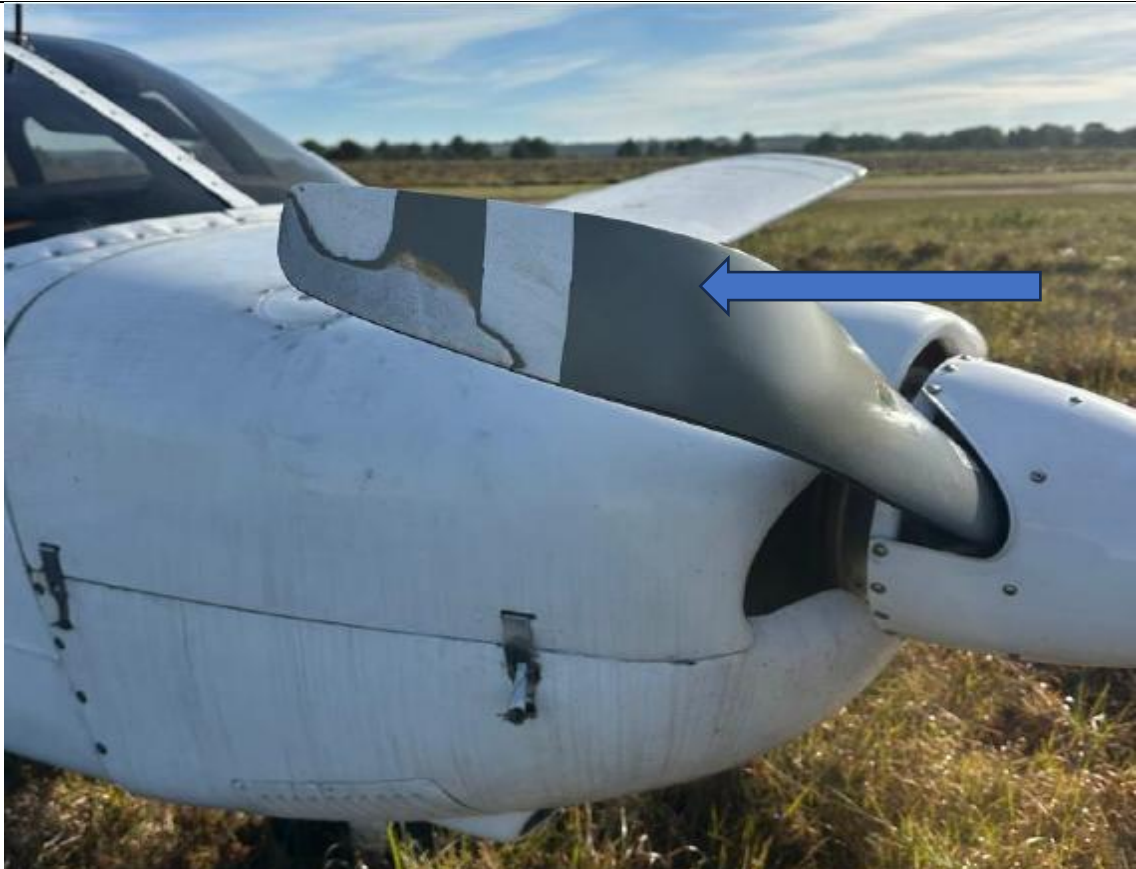
**Figure 3:** The blue arrow points to the damaged propeller blade. (Source: Operator)

5. The SP initiated the flare too high which resulted in an excessive rate of descent; the aircraft landed deep and hard, and it porpoised during which nose wheel strut bent slightly rearwards, causing the propeller to strike the runway surface.

| Unstable approach resulted in the aircraft touching down deep and hard with the nose wheel first and porpoised, consequently, the nose gear strut bent slightly rearwards, and the propeller struck the runway. |

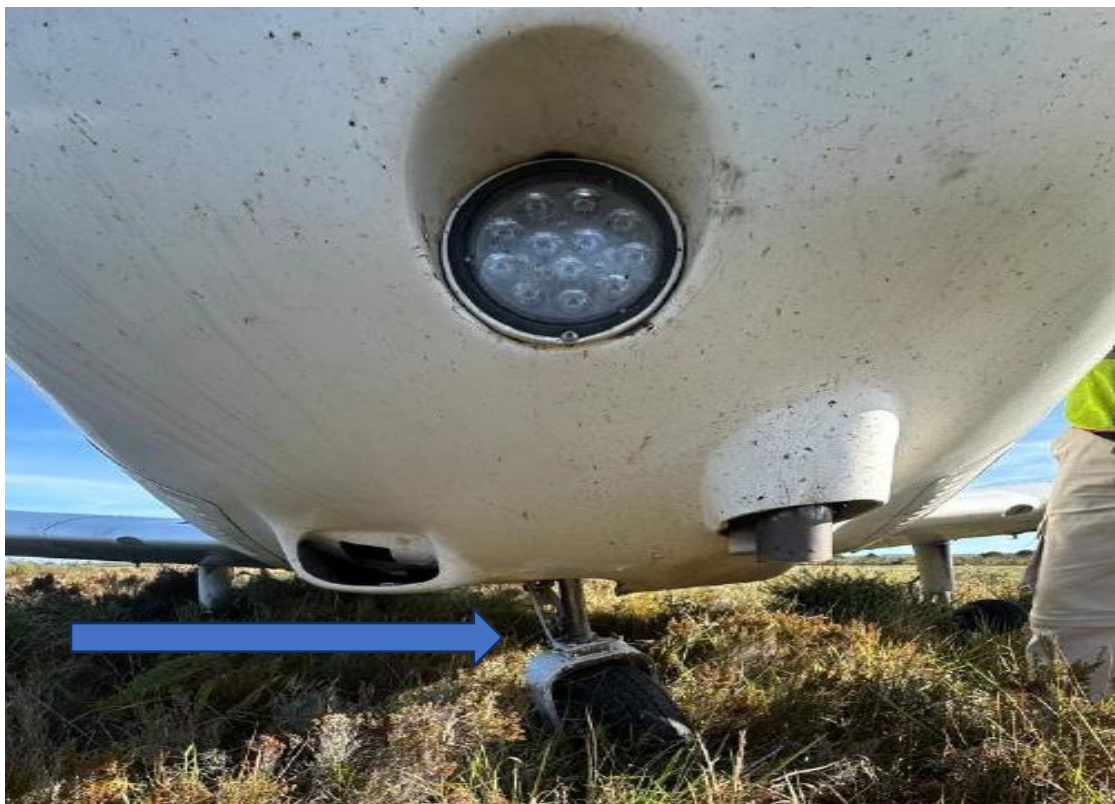
and hard with the nose landing gear first and porpoised; as a result, the nose landing gear strut bent slightly rearwards. When the SP attempted a go-around, the throttle was stuck in the forward position. The SP lost directional control and the aircraft veered to the left of the runway and came to rest on the overgrown grass area. The SP was not injured; he disembarked from the aircraft without assistance.

**Figure 4:** The arrow points to the damaged nose gear. (Source: Operator)
