AIRCRAFT INCIDENT REPORT AND EXECUTIVE SUMMARY

Reference:		CA18/3/2/1339	
Aircraft Registration	ZS-DDT	Date of Incident	3 March 2021			Time of Incident	1655Z
Type of Aircraft	Hawker 4000			Type of Operation		Private (Part 91)	
Pilot-in-command Licence Type	Airline Transport Pilot Licence (ATPL)		Age	49		Licence Valid	Yes
Pilot-in-command Flying Experience	Total Flying Hours		6 615			Hours on Type	1 000
Last Point of Departure		Cape Town International Airport (FACT), Western Cape Province					
Next Point of Intended Landing		Plettenberg Bay Airport (FAPG), Western Cape Province					
Damage to Aircraft		Minor					
Location of the incident site with reference to easily defined geographical points (GPS readings if possible)							
Approximately 80 metres from the threshold of Runway 30 at Global Positioning System coordinates determined to be 34°05'20.59" South 023°20'13.97" East at an elevation of 470 feet							
Meteorological Information		Surface wind 200°/1kt; temperature: 21° C; dew point: 17° C; QNH 1014 hPa;

Reference Number : CA18/3/2/1339
Name of Owner/Operator : Rocklight Investments (PTY) LTD
Manufacturer : Hawker Beechcraft
Model : 4000
Nationality : South Africa
Registra

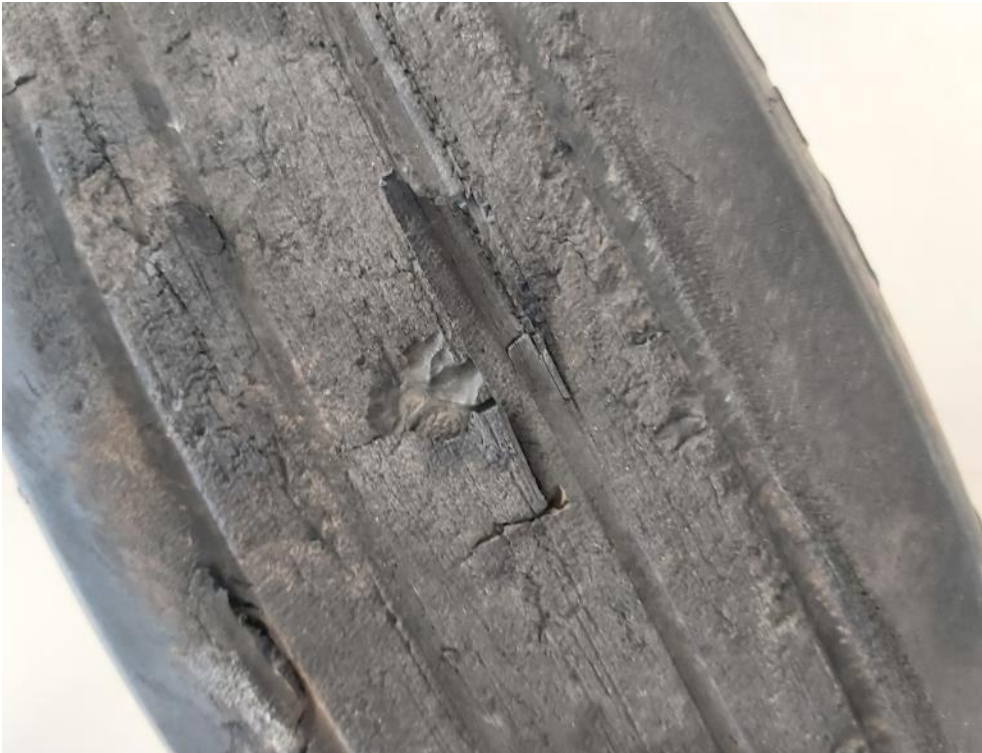
1.3.1 The aircraft sustained damage to the nose wheel tyre and left outboard tyre.

Figure 2: Wear damage on the left-side outboard tyre. (Source: AMO)

- 1.6.5 A general visual inspection of the main landing gear attachment structure was conducted and there were no anomalies found. The outer wheel assembly on the left main gear was replaced due to FOD (PN: 90000233-1 SN: APR08-0222 was removed and replaced with SN: JUN08-0262); all work carried out was in accordance with Hawker 4000 AMM CH32-40-07 rev A, dated 19 October 2016.

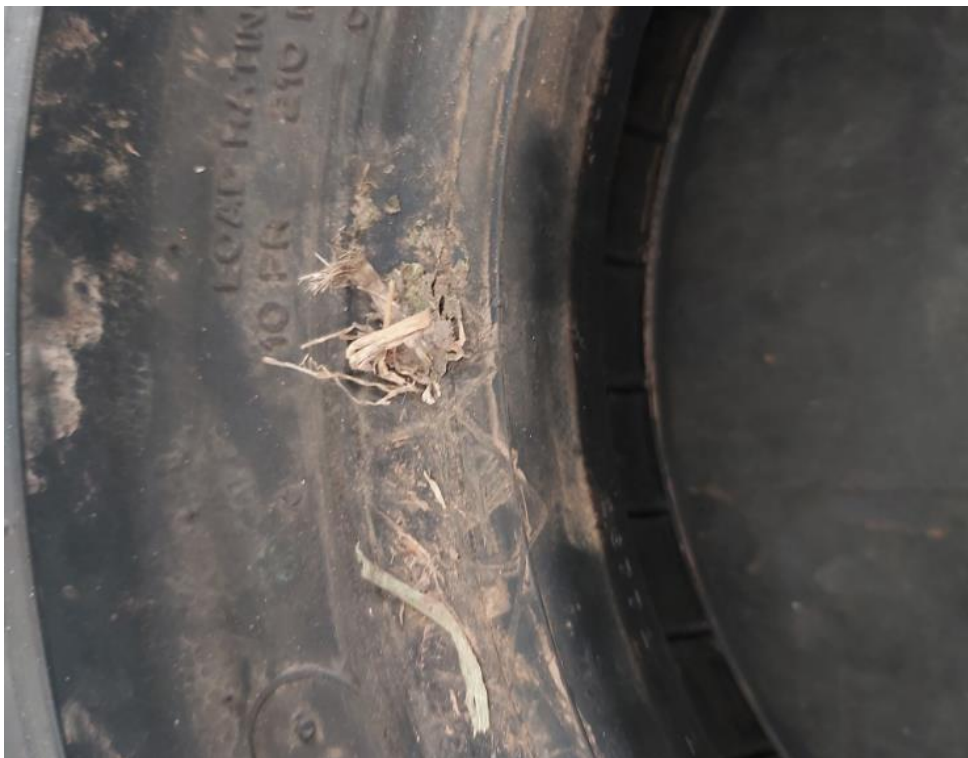
Figure 3: Dirt and dry grass on the nose tyre. (Source: AMO)

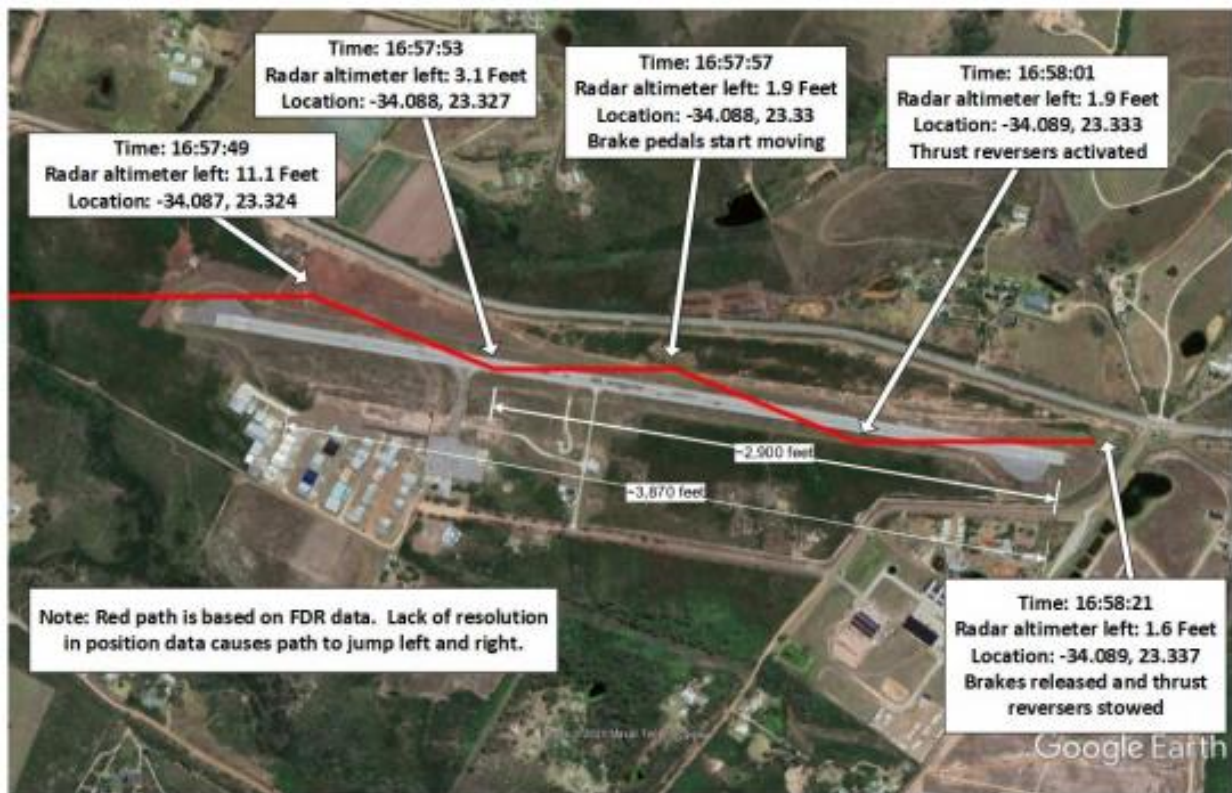
Figure 4: Flight data timeline. (Source: FDR data received from the Aircraft Manufacture)

- *The brake pedals were not activated until almost halfway down the runway. The thrust reversers were not activated until the last quarter of the runway.*
- *Pressure was not applied to the brake pedals until almost halfway down the runway. The aircraft's ground speed decreased after the brakes were applied. The aircraft's rate of deceleration increased after the thrust reversers were deployed.*
- *The second and third charts (Figures 5 and 6 below) show the spoiler positions. The spoilers did not deploy upon landing. This could have been caused by the flight crew not arming the ground spoilers before landing.*

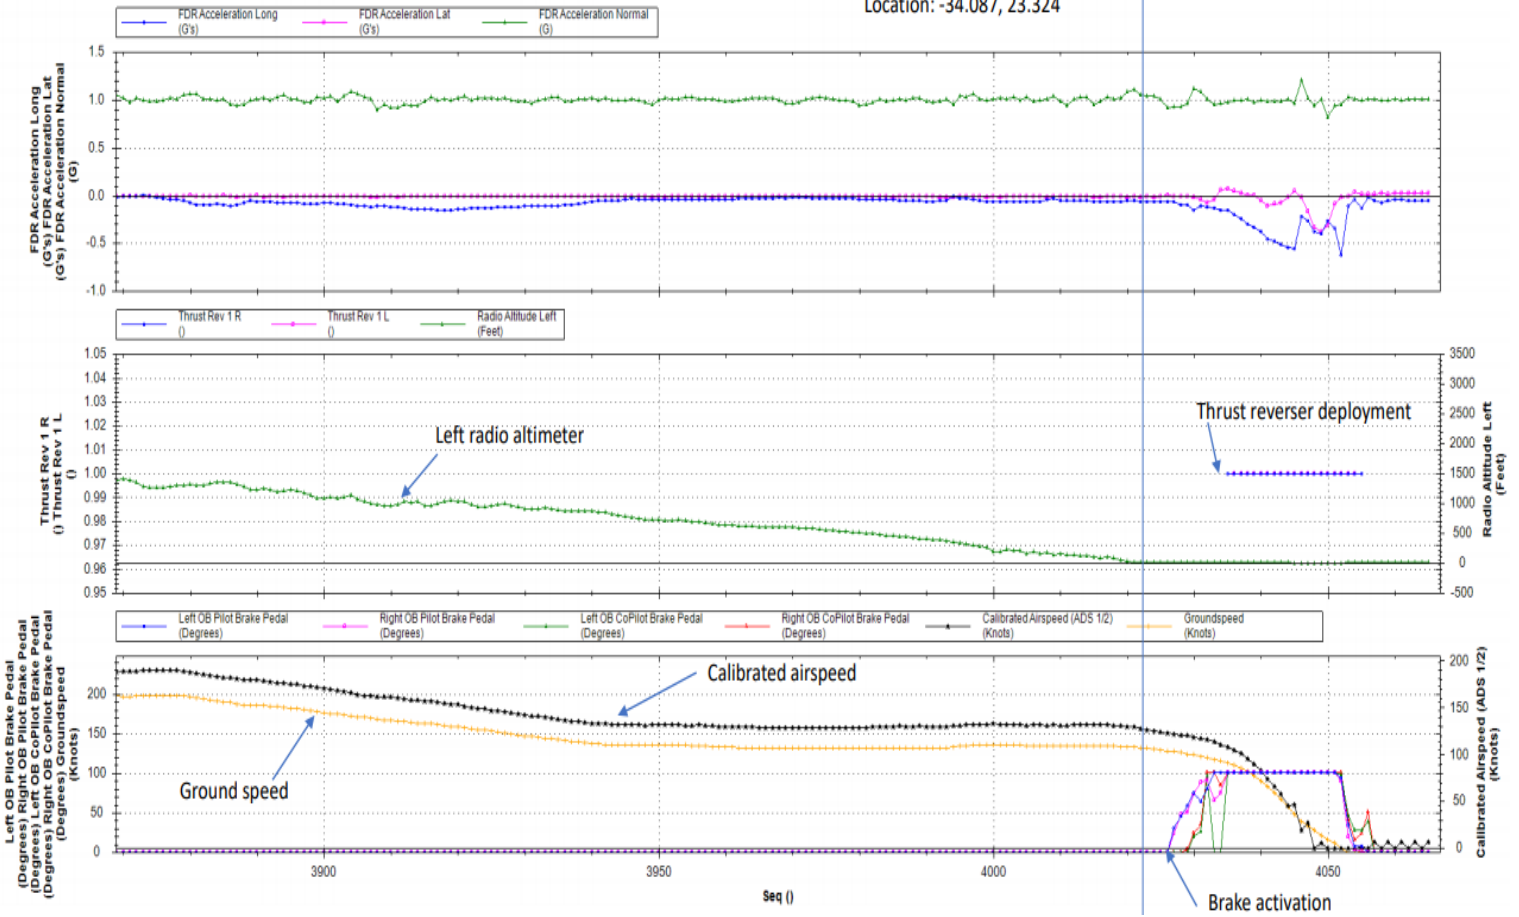
Graph 1: The graph depicts the FDR data parameters. (Source: FDR data received from the Aircraft Manufacturer)

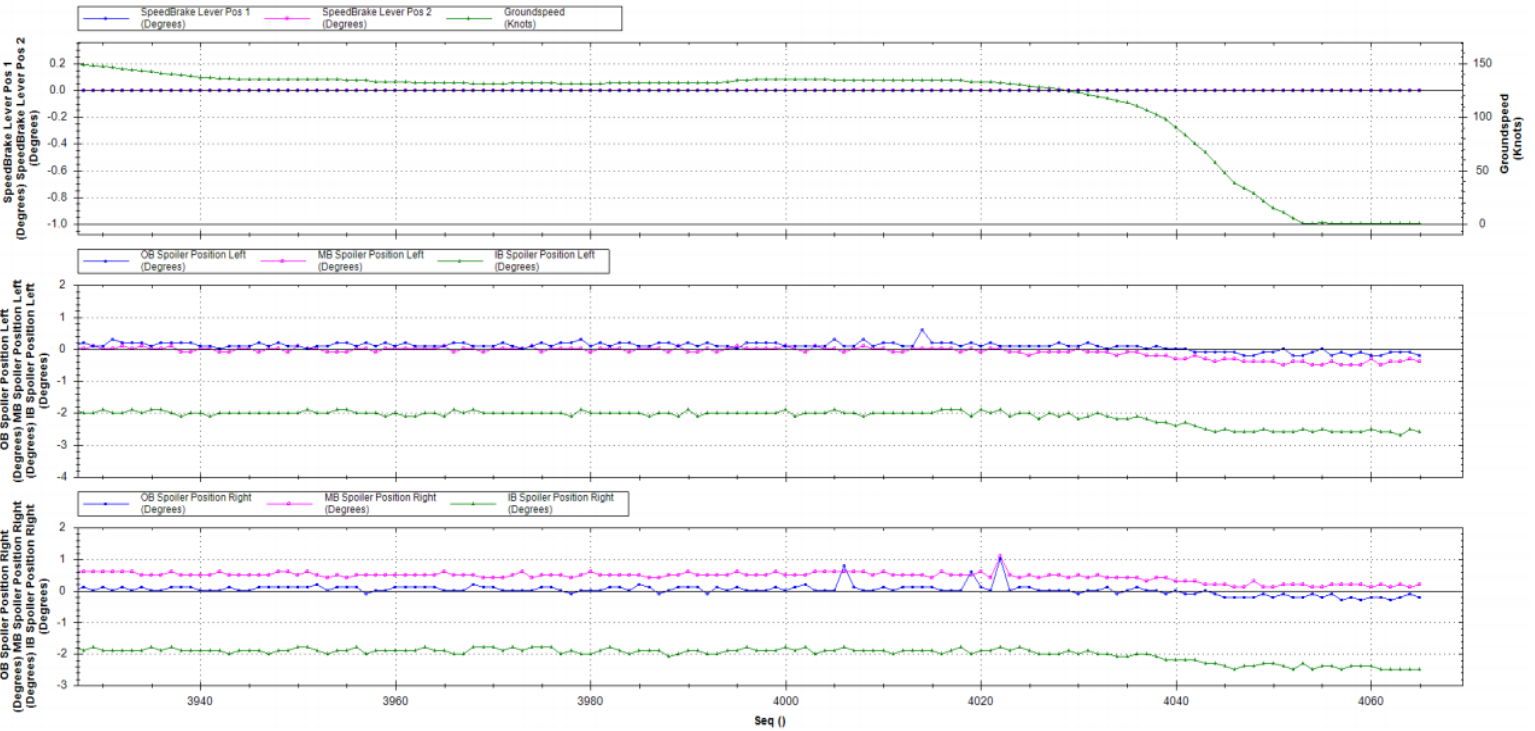
Graph 2: Graph depicts FDR data parameters. (Source: FDR data received from the Aircraft Manufacturer)

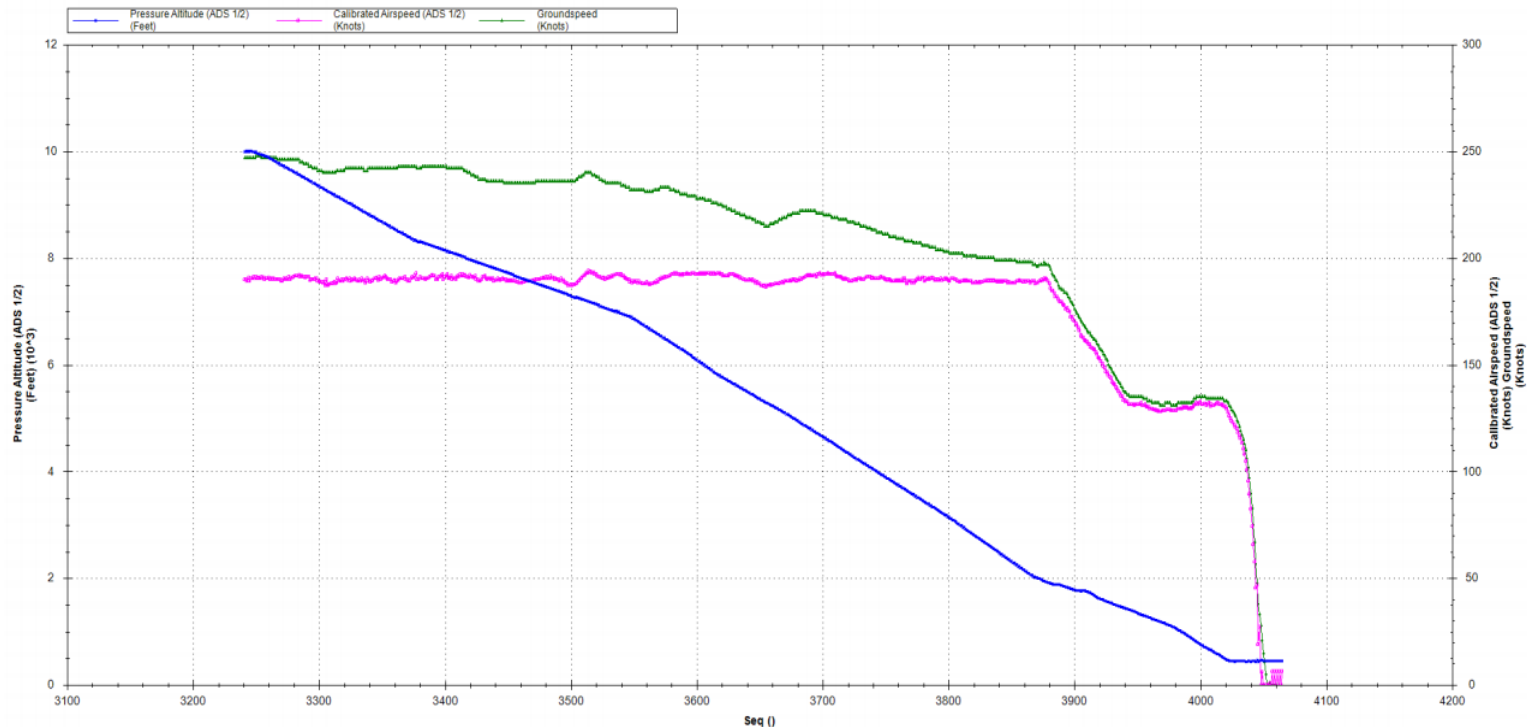
Graph 3: FDR data parameter traces indicating pressure altitude. (Source: FDR data received from the Aircraft Manufacturer)

- *The graph above shows the aircraft’s altitude (blue line) along with airspeed (pink line) and ground speed (green line) from 10 000’ to landing. The descent rate appears consistent from 10 000’ to about 2 000’ where it reduces a bit but remains consistent. The airspeed is consistent until the change in descent rate at 2 000’. When the descent rate changes, the aircraft speed also decreases until it stabilises again at approximately 130 knots. This speed is maintained until just before touchdown at which point the aircraft starts to slow down. According to the aircraft flight manual, approach speed (Vapp) is 135 knots and reference speed (Vref) is 123 knots. Based on the data, the aircraft’s speed and descent rate were consistent during approach.*

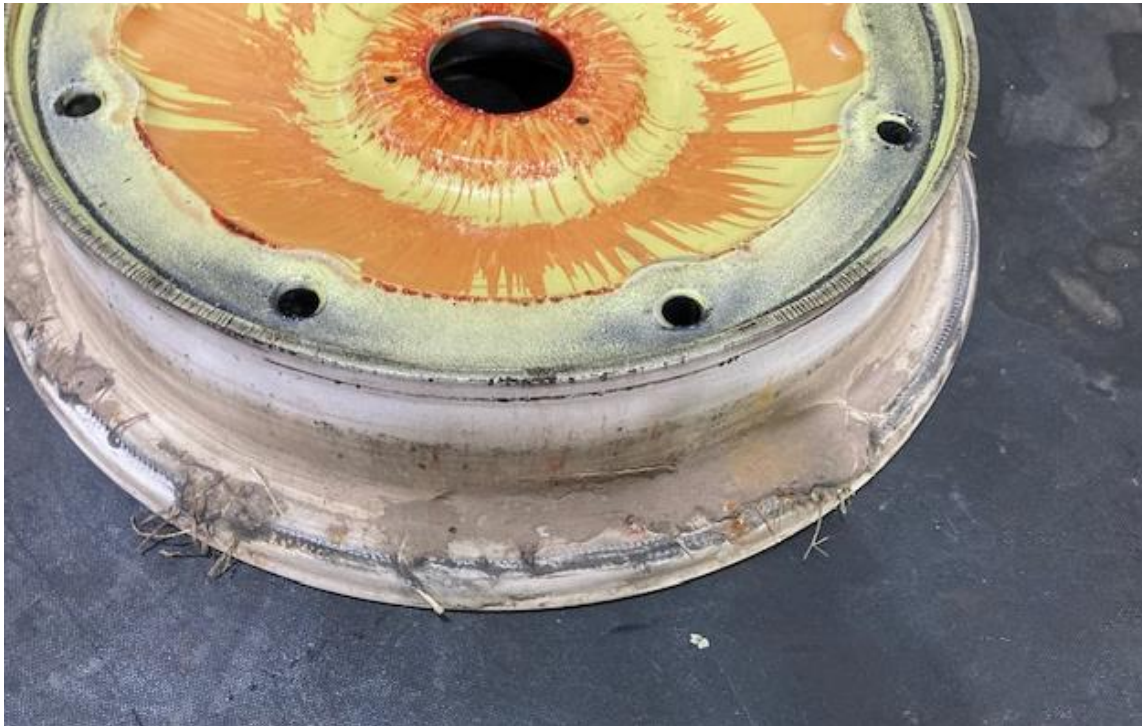
Figure 5: Nose wheel hub from the incident aircraft. (Source: AMO)

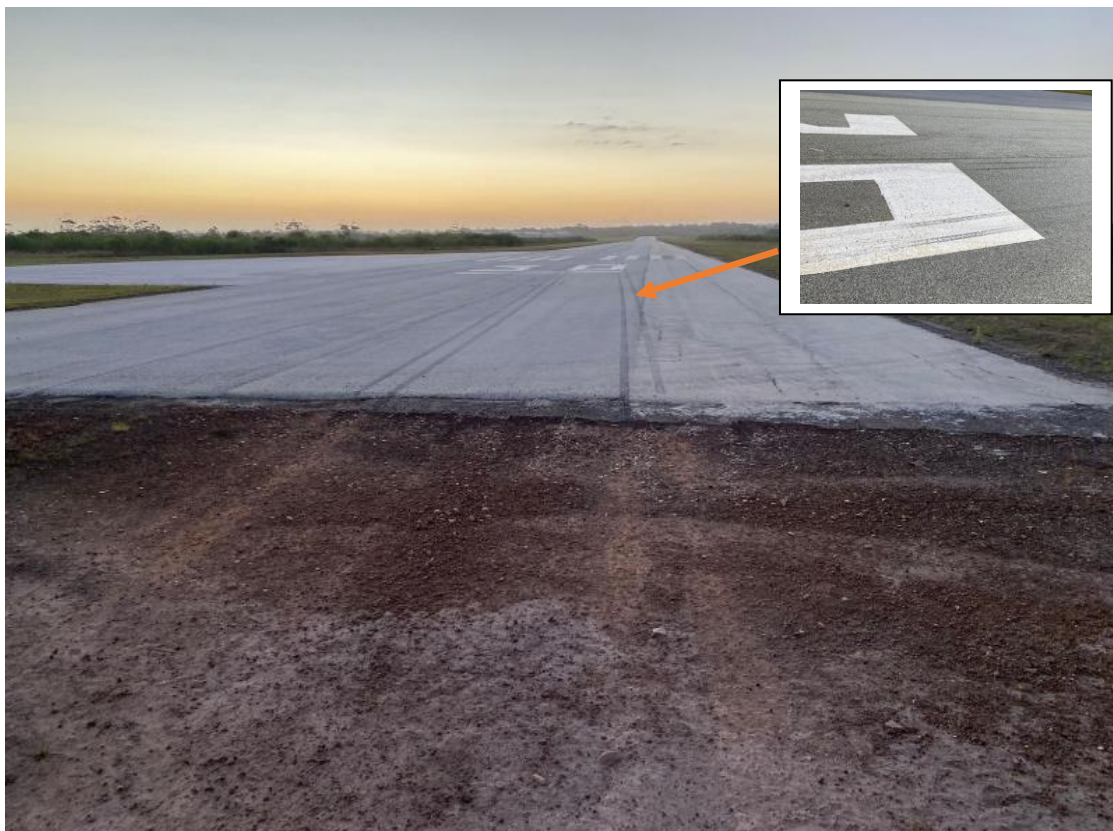
1.12.1 The aircraft approached Runway 12 with the wind being 200° at 1kts. Approximately halfway down the runway, the pilot applied brakes from the right-side seat, but the brakes were not effective (as per normal) and did not slow down the aircraft. The pilot then applied the brake pedals as hard as he possibly could. Because there is an embankment with a drop of several metres at the end of Runway 12, the pilot seated on the left-side seat steered the aircraft to the left to avoid crashing on the embankment; the pilots managed to bring the aircraft to a stop. The aircraft overran the runway and stopped 80 metres from the threshold of Runway 30. No major structural damages were visible on the aircraft. The nose wheel hub collected grass between the hub circumference and the tyre. The outboard tyre had an indication of excessive breaking on tread surfaces, evidenced by tyre trails toward the end of the runway

(see Figure 6). The tyre trails were observed approximately 180m from the last quarter of the runway towards the edge. The aircraft continued to roll on unprepared grass, evidenced by tyre width trails (similar to the aircraft tyre width) which spanned for approximately 80m from the end of the runway edge.

Figure 6: Tyre trail markings on the runway surface. (Source: AMO)

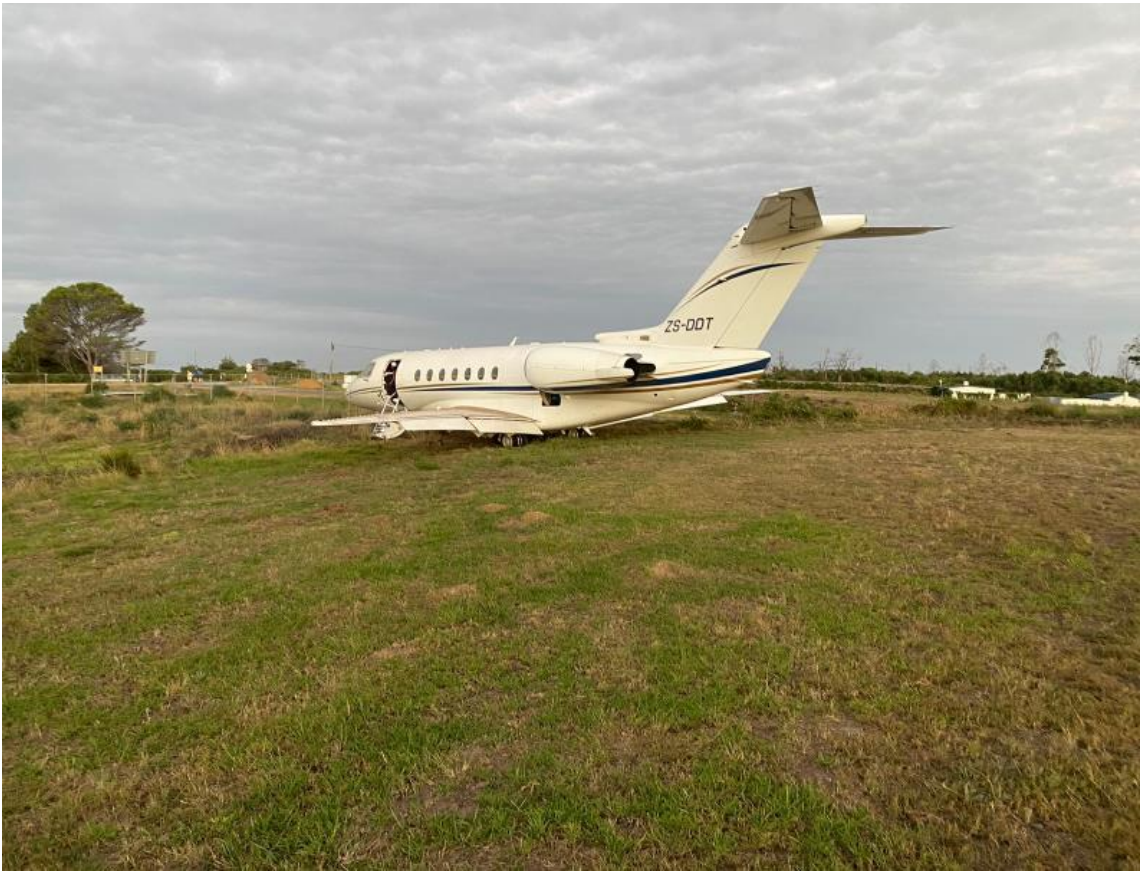
Figure 7: Final position of the aircraft after exiting the runway. (Source: AMO)

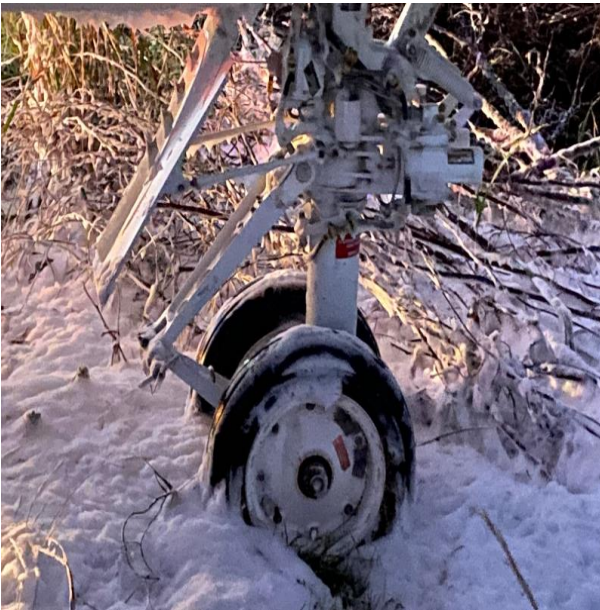
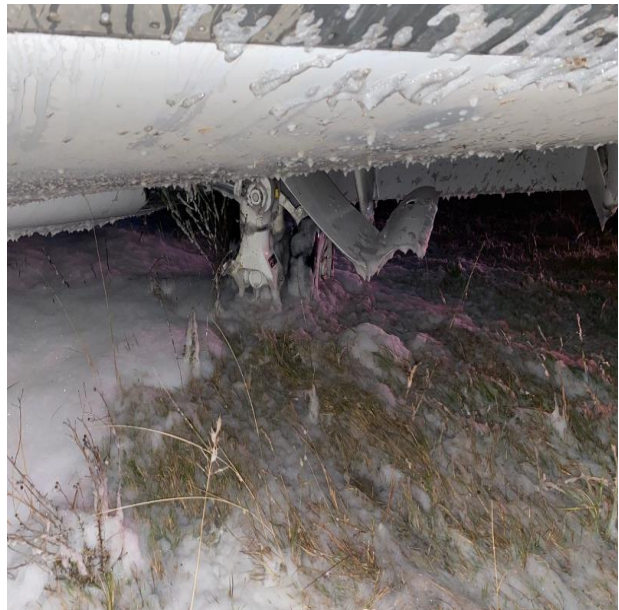
Figures 8 & 9: Foam spread on the undercarriage after the incident. (Source: AMO)

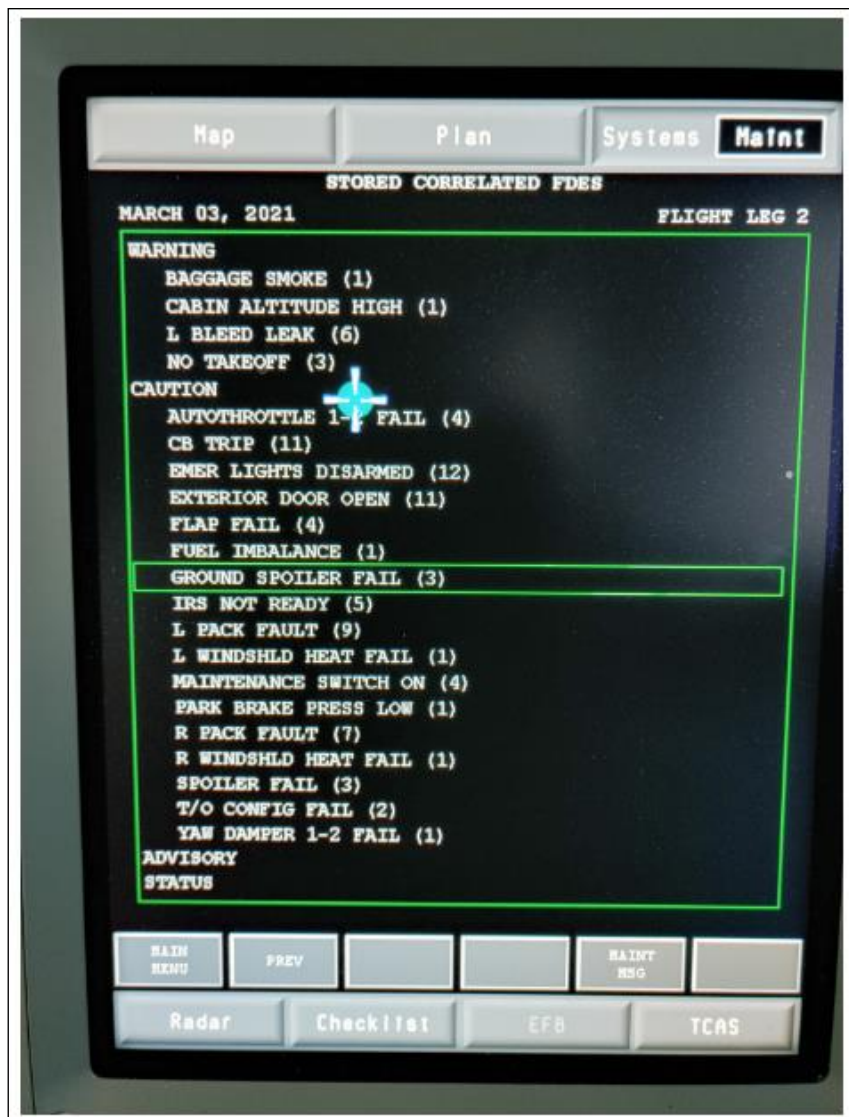
Figure 10: Stored correlated (flight data exchange [FDE]) indicating ground spoiler fail caution message on the multifunction control and display unit (MCDU). (Source: AMO)

1.12.2 The multifunction control and display unit (MCDU) was checked by the AMO. The MCDU records all the stored correlated flight data exchange (FDE) for any warning, caution and advisory messages during flight. The caution for ground spoiler failure registered as a message on the FDE.
