<b>AIRCRAFT SERIOUS INCIDENT REPORT AND EXECUTIVE SUMMARY</b>
---

<b>Reference:</b>		<b>CA18/3/2/1356</b>	
<b>Aircraft Registration</b>	<b>ZS-SPB</b>	<b>Date of Incident</b>	1 August 2021		<b>Time of Incident</b>	0956Z	
<b>Type of Aircraft</b>	Cessna 172N		<b>Type of Operation</b>		Training Flight (Part 141)		
<b>Pilot-in-command Licence Type</b>	Commercial Pilot Licence		<b>Age</b>	26	<b>Licence Valid</b>	Yes	
<b>Pilot-in-command Flying Experience</b>	<b>Total Flying Hours</b>		285		<b>Hours on Type</b>	265.6	
<b>Last Point of Departure</b>	Lanseria International Airport (FALA), Gauteng Province						
<b>Next Point of Intended Landing</b>	Lanseria International Airport (FALA), Gauteng Province						
<b>Damage to Aircraft</b>	None						
<b>Location of the incident site with reference to easily defined geographical points (GPS readings if possible)</b>							
On taxiway Charlie at Global Positioning System (GPS) co-ordinates determined to be S 25°56'50.62" E27°55'43.68" at an elevation of 4458 feet

**Reference Number** : CA18/3/2/1356  
**Occurrence Category** : Category 2  
**Type of Operation** : Training (Part 141)  
**Name of Operator** : Skyhawk  
**Aircraft Registration** :

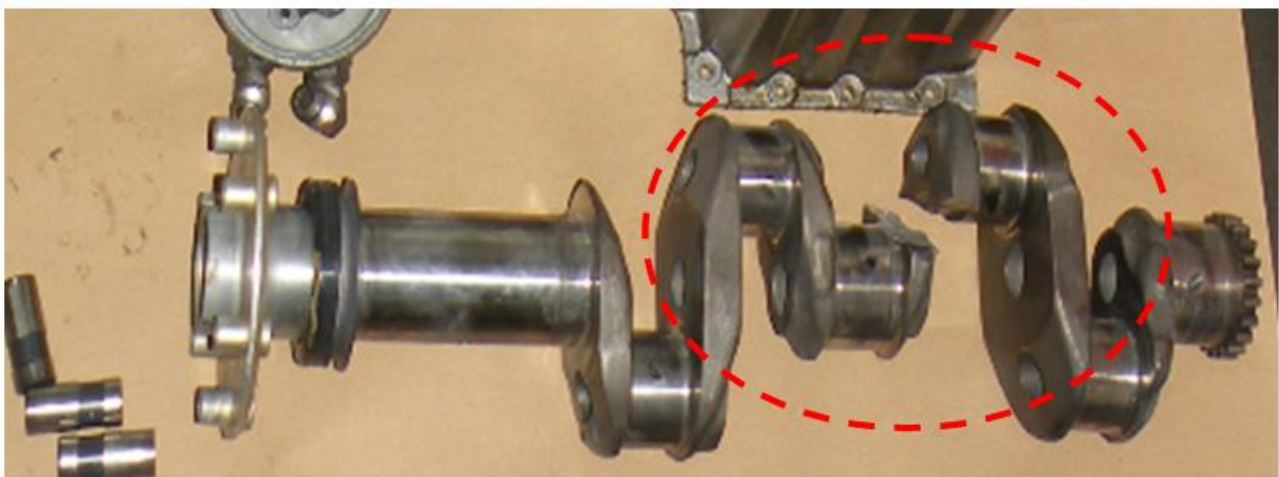
1.16.1.2 After the teardown inspection, the AMO reported that the crankshaft had broken into two halves at the Number 4 connecting rod journal. Evidence could not establish why the crankshaft broke.

**Figure 2:** The crankshaft showing the area where the failure occurred.

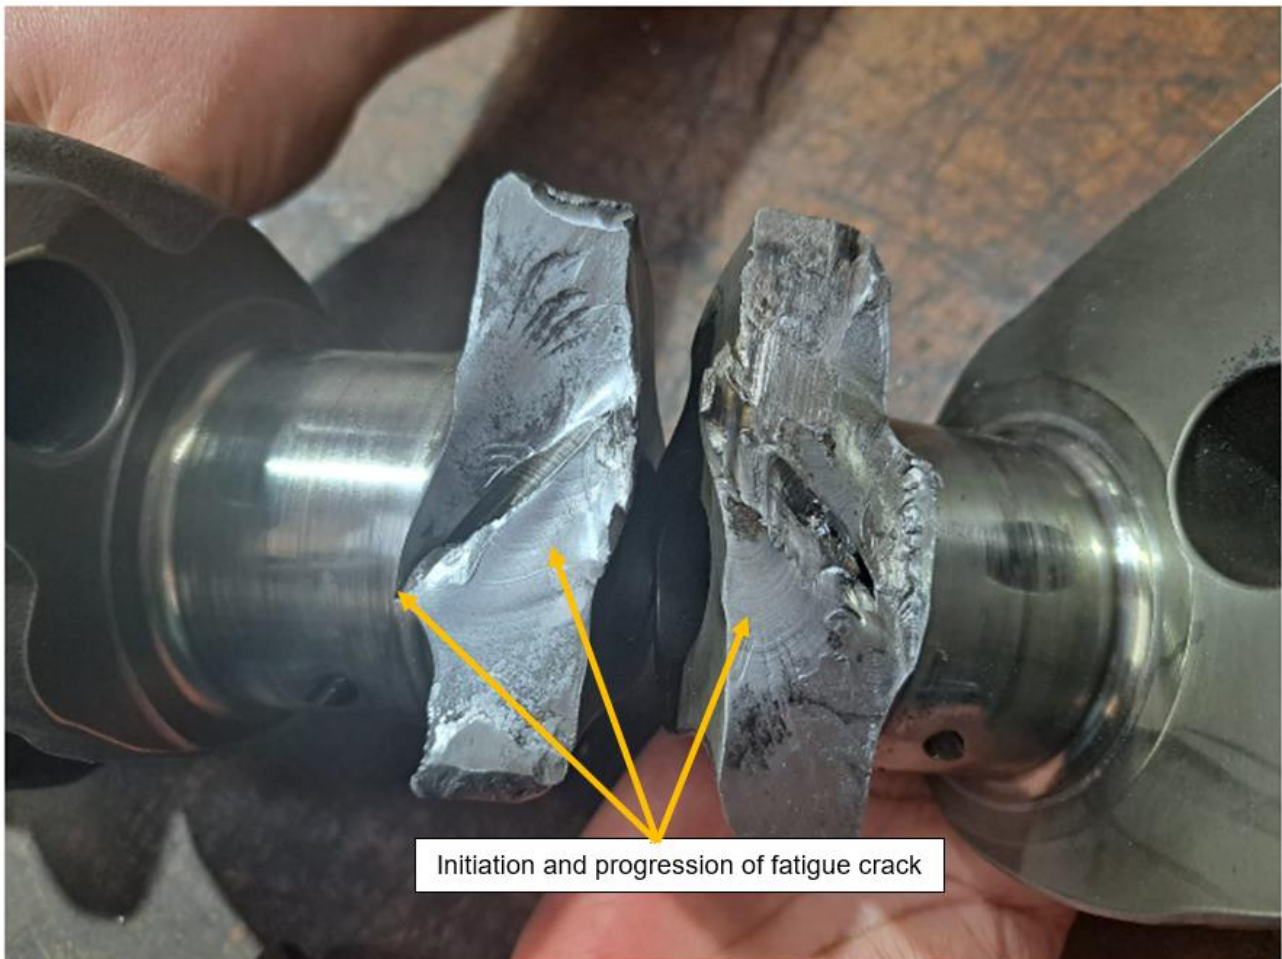
**Figure 3:** Front view of the crankshaft's fatigue crack initiation and progression.

1.16.1.3 Fatigue cracks initiated at the transition between the Number 4 connecting rod journal surface and the fillet of the crankarm, between the Number 3 and Number 4 connecting rod journals. The region where the fatigue fracture occurred was affected by localised deformations which are distinctive fatigue progression marks that are 'steplike' and extend from the site of initiation to the surface. These marks are created by major changes in the alternating loading spectrum. The magnetic particle inspection was conducted on 12 December 2019, and no cracks were detected during that inspection. According to the engine documentation, the aircraft was flown for approximately 1 047.1 hours since the last magnetic particle inspection. It was estimated that the fatigue crack had initiated and progressed over a period of at least 19 months.

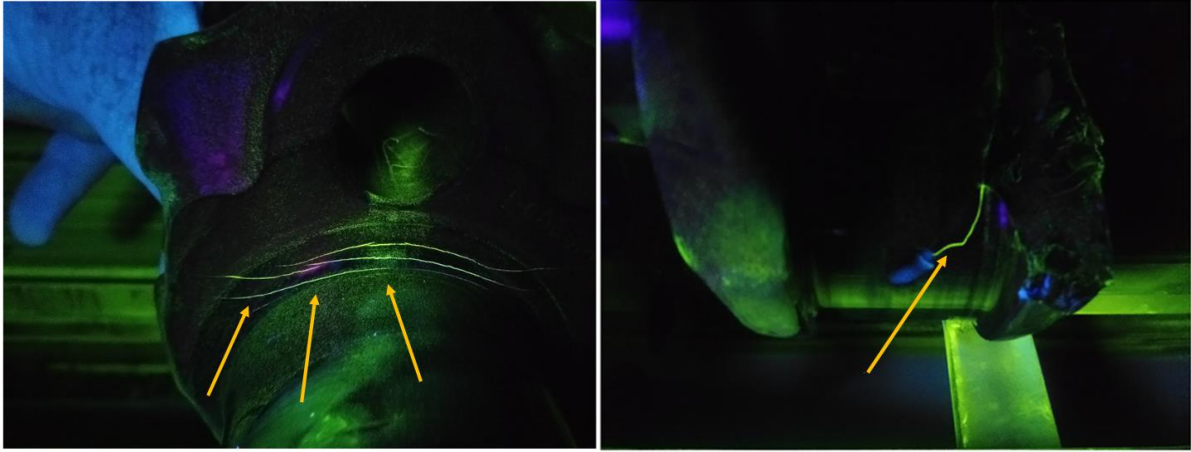
1.16.1.4 The AMO also reported that the crankshaft had also snapped, and when it was magnafluxed it was found that there were various cracks on the radius. *Magnaflux is a process in which a solution containing iron powder is sprayed over the area where the crack initiated, in this instance, the broken crankshaft. Iron powder would settle inside the cracks. The powder would then be visible when an ultraviolet black light is shined on the area to identify the cracks.*

**Figures 4 and 5:** Post-accident pictures showing the initiation site and marks of fatigue crack progression.

- 2.2.6 A comparison of the broken crankshaft between the ATSB Aviation Research and Analysis Report (Figures 8.93 and 8.94) and the incident aircraft crankshaft (Figures 4 and 5) show that both fatigue cracks initiated at the transition from the journal bearing surface to the crank web fillet, where it is most likely that a notch could have been introduced during the journal polishing process. Although the hours accumulated by the engines in example 7 and the incident aircraft engine are different, both the engine journals had undergone a type of material reduction process (polishing during their last overhaul).

- 3.2.12 It is possible that the polishing process carried out during the last overhaul introduced a notch at the transition from the journal bearing surface to the crank web fillet which was the initiation point of the fatigue crack that led to the failure of the crankshaft.

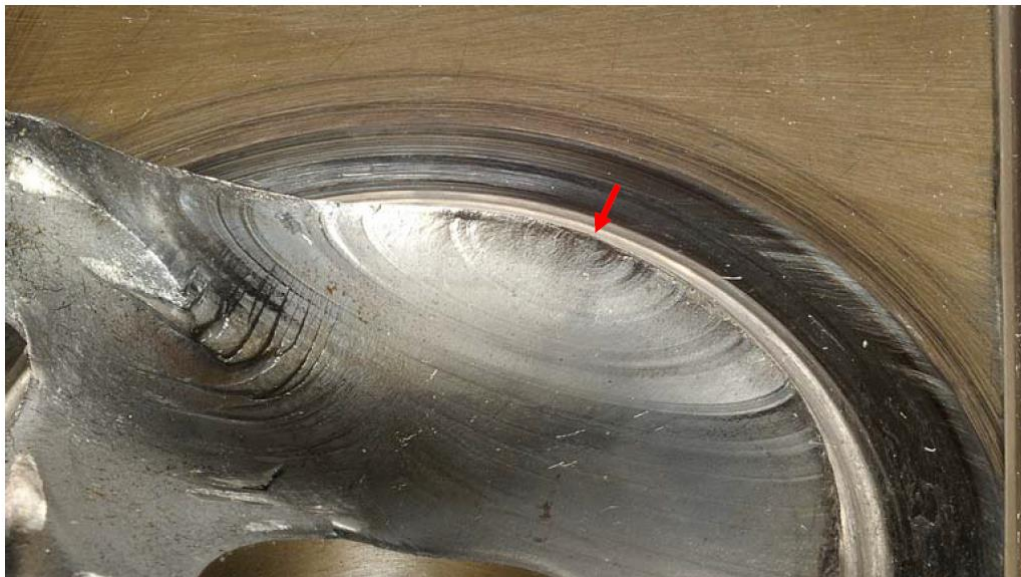
*The fillets of all connecting rod journals had been notched, at the transition from the journal bearing surface to the crank web fillet, during the journal polishing process. Fatigue cracking initiated at the surface of the No.6 journal where the fillet had been notched.*

Figure 8.93: Detailed view of the fatigue crack initiation site, crankweb side

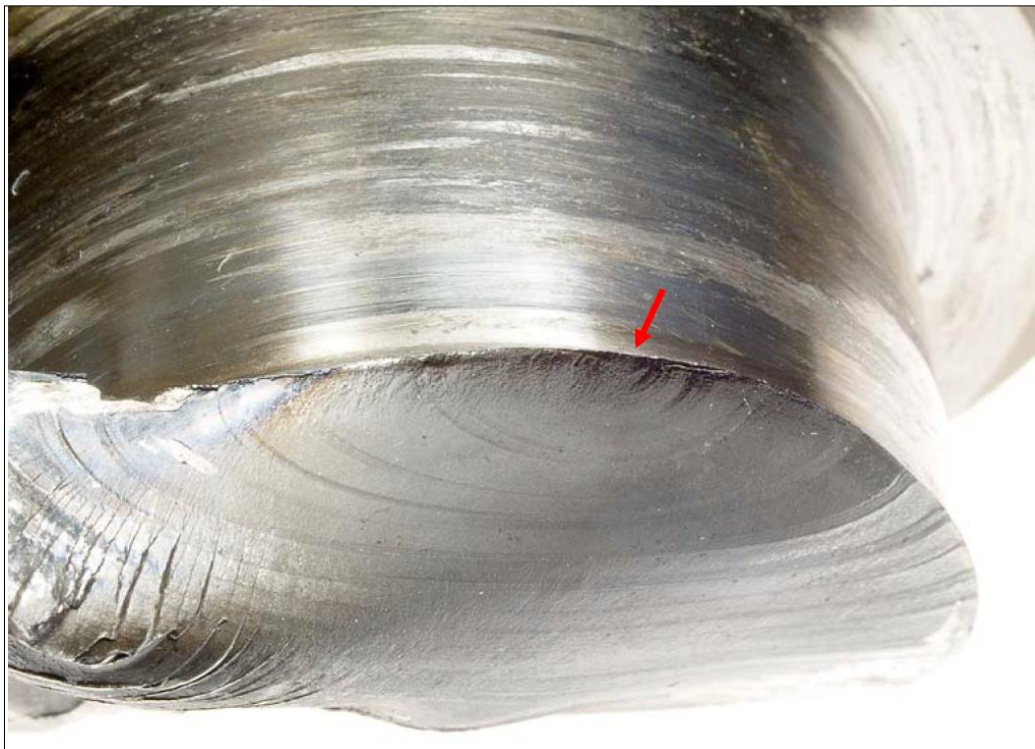
Figure 8.94: Detailed view of the fatigue crack initiation site, journal side

*It is apparent, in this example, that while the site of fatigue initiation coincided with the predicted circumferential position of highest crankweb bending stress, the severe stress-concentrating feature created at the journal-to-fillet transition, during journal polishing, influenced the radial location of the initiation site in the fillet. The change in the site of crack initiation, with respect to the fillet, affected the plane of fatigue crack growth.*
