**AIRCRAFT SERIOUS INCIDENT REPORT AND EXECUTIVE SUMMARY**

<b>Reference:</b>		CA18/3/2/1368				
<b>Aircraft Registration</b>		<b>ZS-PTV &amp; ZS-JRE</b>		<b>Date of Incident</b>		25 August 2021		<b>Time of Incident</b>		0725Z	
<b>Type of Aircraft</b>		ZS-PTV – Piper PA-28R-200 ZS-JRE – Boeing 737-400			<b>Type of Operation</b>			Training (Part 141) Commercial (Part 121)			
<b>Pilot-in-Command Licence Type</b>		SPL (A) (Integrated) ATPL (A)		<b>Age</b>		33 32		<b>Licence Valid</b>		Yes	
<b>Pilot-in-Command Flying Experience</b>			<b>Total Flying Hours</b>			104 6980.6		<b>Hours on Type</b>		27.8 2875.8	
<b>Last Point of Departure</b>		Port Alfred Aerodrome (FAPA), Eastern Cape Province Cape Town International Aerodrome (FACT), Western Cape Province									
<b>Next Point of Intended Landing</b>		East London Aerodrome (FAEL), Eastern Cape Province									
<b>Number of People On-board</b>		1 + 0 6 + 158	<b>Number of People Injured</b>		0	<b>Number of People Killed</b>		0	<b>Other (On Ground)</b>		0

<b>Probable Cause</b>											
Loss of minimum separation (AIRPROX) between the two aircraft on final approach after the SP deviated from executing the ATCO's instruction.											
<

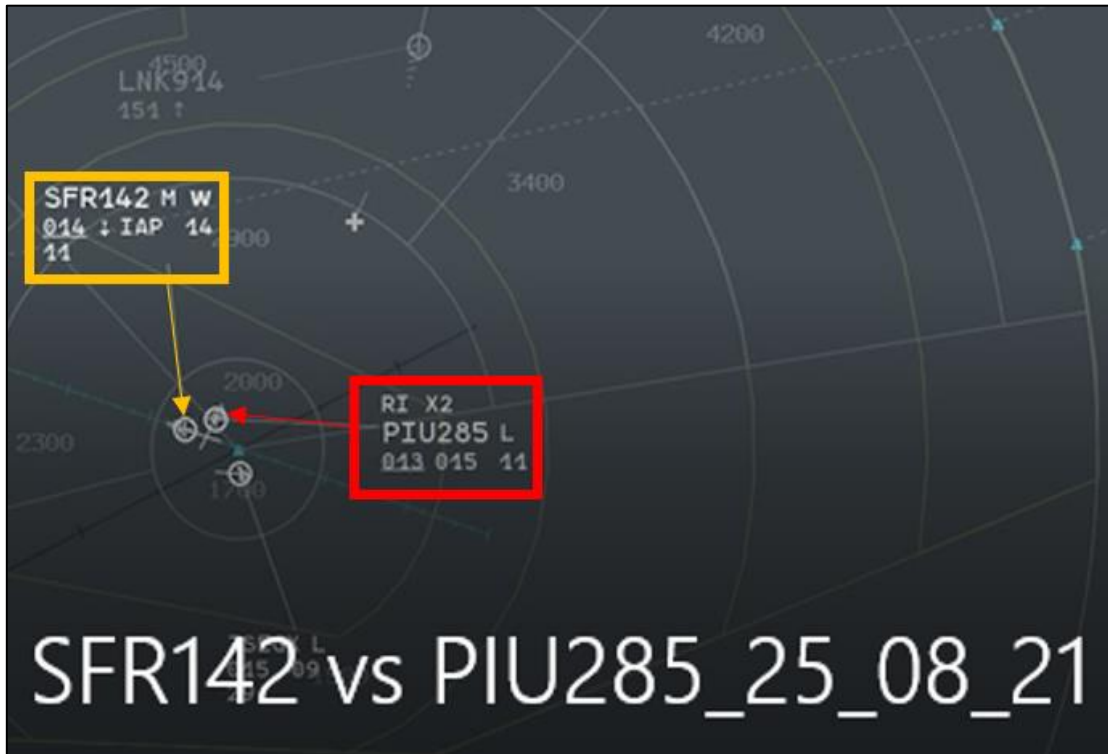
- 1.1.7. At 07:24:28Z, the ATCO cleared the ZS-JRE aircraft to land. At 07:25:12Z, the ZS-JRE crew asked the ATCO if he was aware of the traffic turning base leg for RWY 11 in front of them. As both aircraft converged, the ZS-JRE flight crew received a Traffic Collision Avoidance System (TCAS) Traffic Advisory (TA) alert from their aircraft's Airborne Collision Avoidance System (ACAS). The crew did not carry out any avoidance manoeuvres. The separation between the aircraft was approximately 500 feet (ft) (152 metres (m)) vertically and approximately 4 nautical miles (NM) (7 408 m) horizontally.

**Figure 1:** SFR142 (ZS-JRE) and PIU285 (ZS-PTV) at 07:25:08Z, at which time the vertical separation was around 106 ft with the horizontal separation of around 2.3 NM.

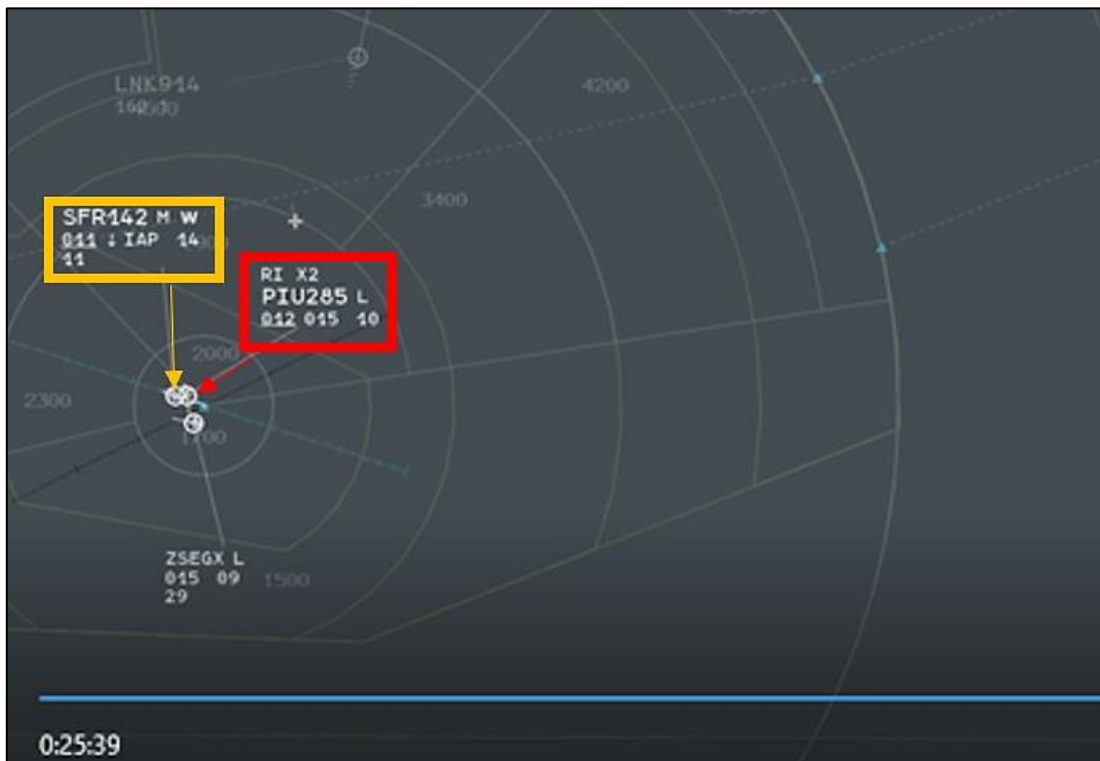
- 1.1.8. At 07:25:27Z, the ATCO instructed the SP to turn right and report final approach for RWY 11. At 07:25:35Z, the ATCO again instructed the SP to turn right immediately, this time with a much more forceful tone. However, the SP continued with the left turn. This reduced the separation between the aircraft to approximately 4ft (1.2 m) vertically and approximately 1.5 NM (2 778 m) horizontally.

**Figure 2:** At 07:25:39Z, the vertical separation was approximately 100 ft with a horizontal separation of 1.0 NM.

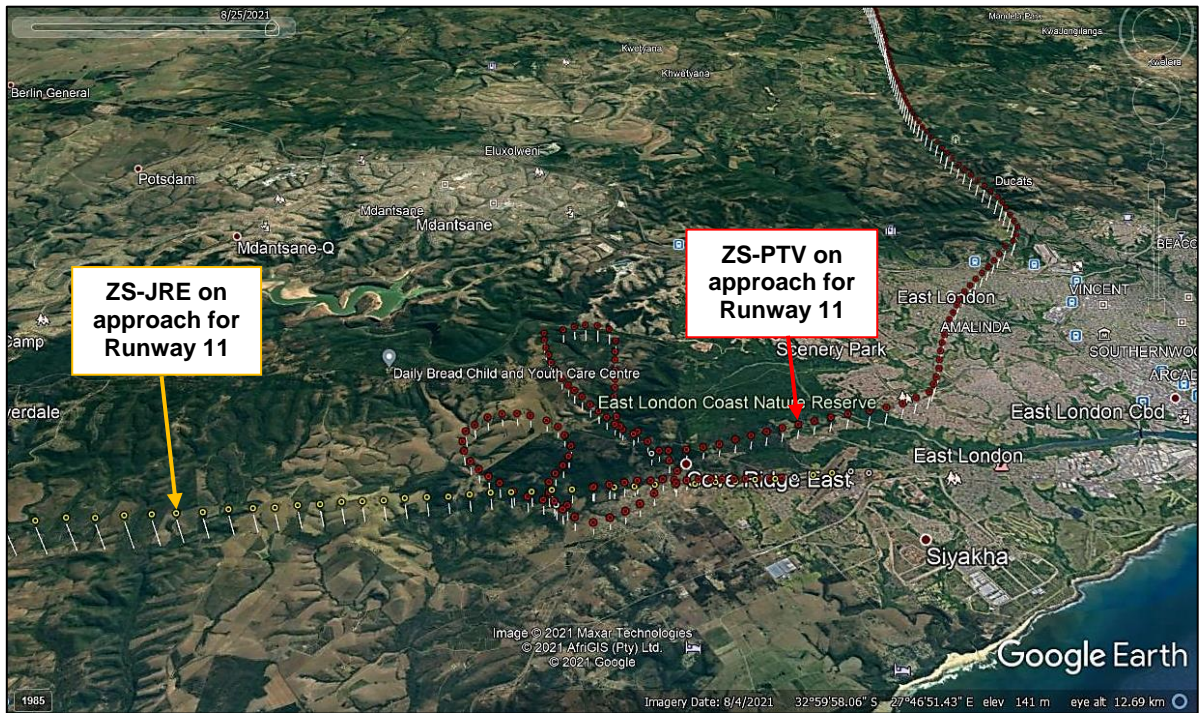
1.1.9. The ZS-JRE crew was advised of the instructions issued to the ZS-PTV SP and to continue to land as both aircraft were being monitored by the ATCO on the radar system, the ZS-PTV aircraft was observed to be above ZS-JRE. The ZS-PTV aircraft crossed overhead the ZS-JRE aircraft path, and the pilot was instructed to orbit and then to report established on final approach for RWY 11. At this time, the ZS-JRE had landed and vacated the runway.

**Figure 3:** The radar tracks flown by the ZS-PTV and ZS-JRE aircraft, respectively. (Source: Google Earth)

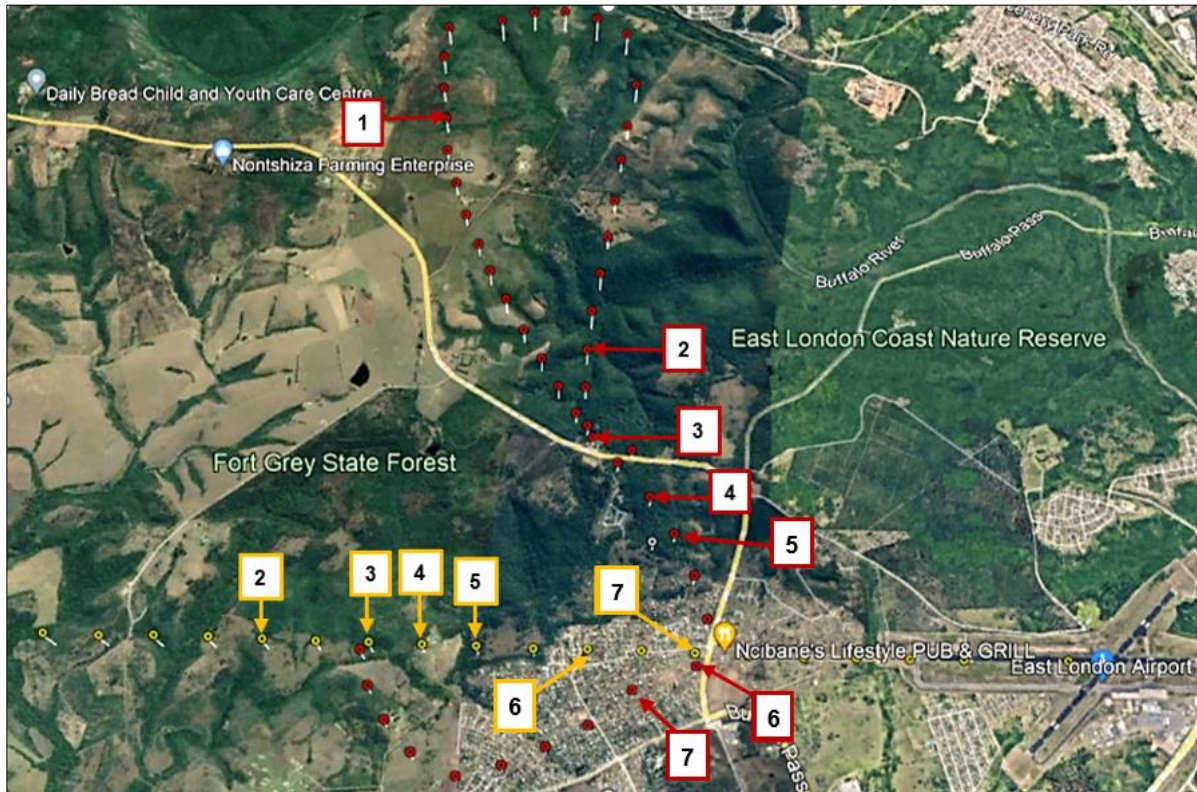
1.8.3. Figure 6 shows the radar tracks flown by the ZS-PTV (red pins) and the ZS-JRE (yellow pins) aircraft, respectively. The vertical and horizontal distances of the aircraft in relation to their location at different times is given in Table 1. At 07:25:27Z, the aircraft were at the same flight level of 1 100ft AGL, where it was estimated that they were at least 4ft (1.2m) vertically and

1.5NM (2 778m) horizontally.

**Figure 6:** The flight path of the two aircraft showing significant events that led to the serious incident. (Source: Google Earth Map)
