AIRCRAFT SERIOUS INCIDENT REPORT AND EXECUTIVE SUMMARY

| | | | | Reference: | | CA18/3/2/1383 | |
| Aircraft Registration | ET-AYB | Date of Incident | 6 November 2021 | | Time of Incident | 1055Z | |
| Type of Aircraft | Airbus A350-900 | | Type of Operation | | Air Transport Operations (Part 121) | | |

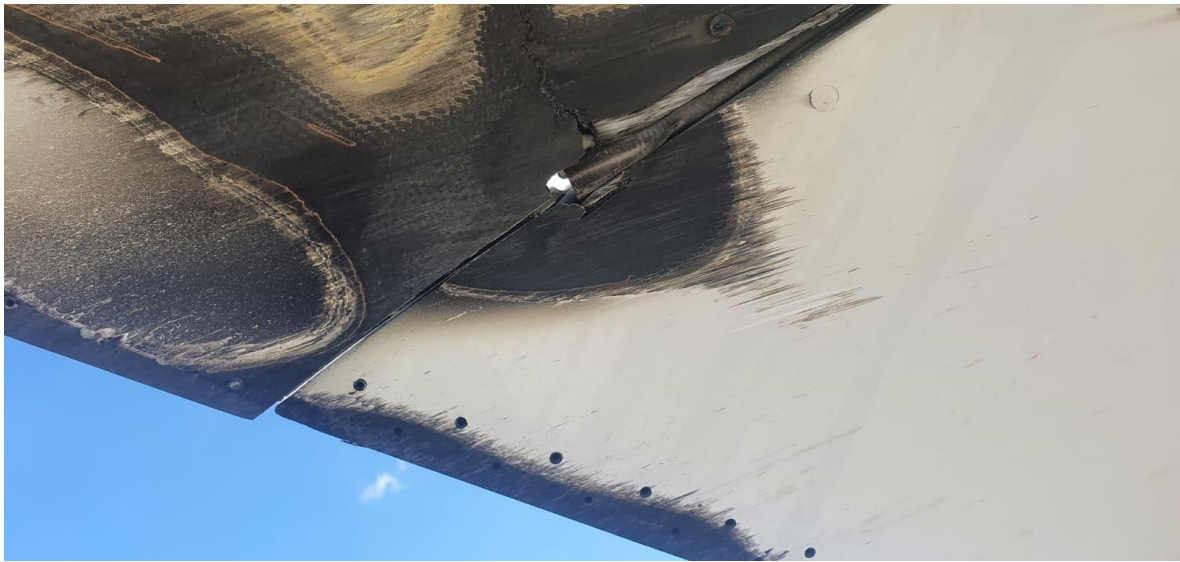
1.3.1 The right-winglet, right-wing tip and outer aileron sustained minor damage during the serious incident sequence.

Figure 2: Underside damage on the right-wing tip.

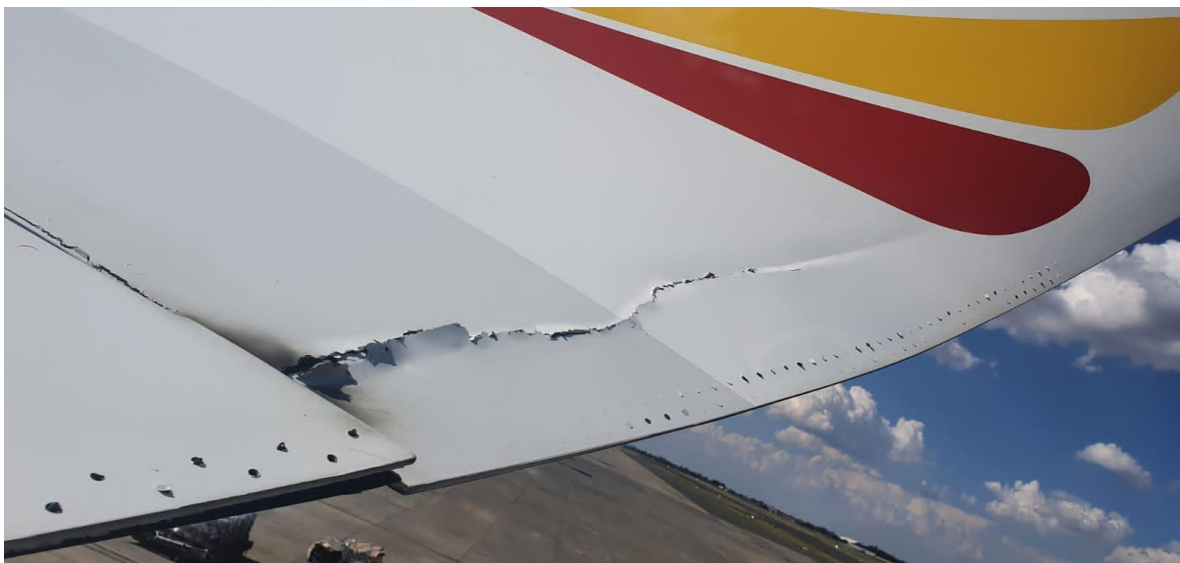
Figure 3: Upper side damage on the right-wing tip and winglet.

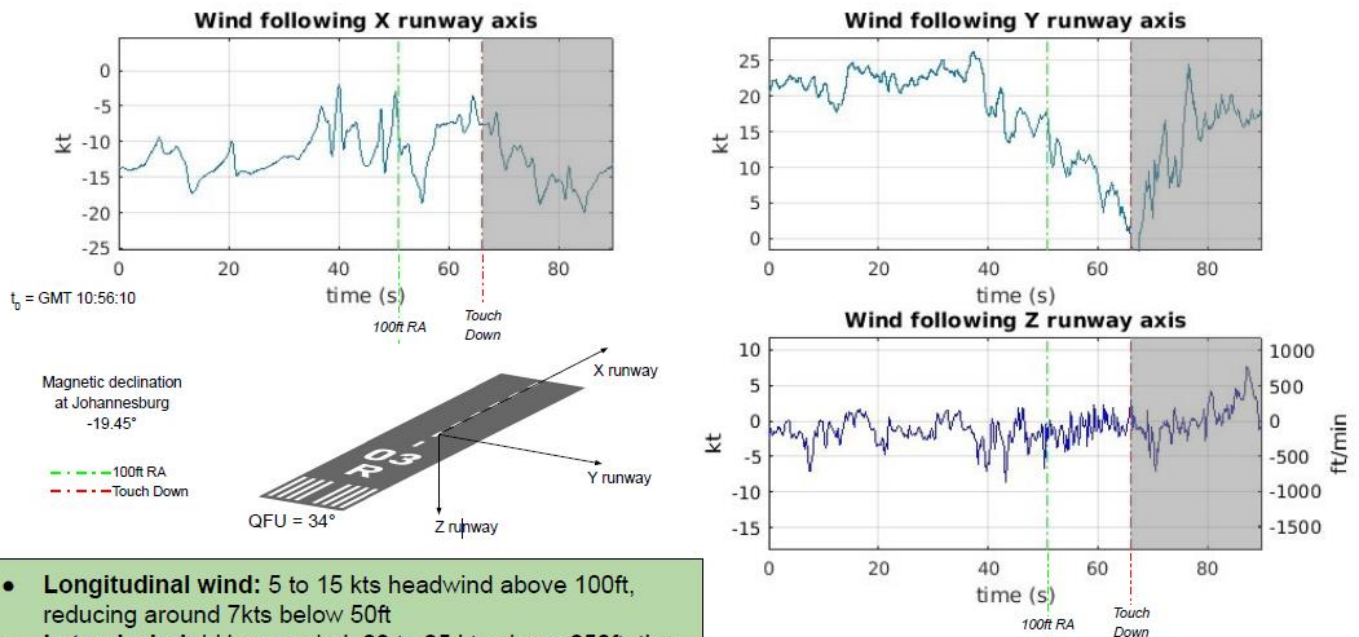
1.7.3. Wind Speed and Direction recorded by the flight data recorder (Source: Airbus)

No evidence of windshear presence as there was no recorded triggering from Predictive & Reactive Windshear Systems and no evidence from recomputed wind components.

- **Longitudinal wind:** 5 to 15 kts headwind above 100ft, reducing around 7kts below 50ft
- **Lateral wind:** LH crosswind, 20 to 25 kts above 250ft, then progressive reduction. Limited component <5kts at TD
- **Vertical wind:** not significant

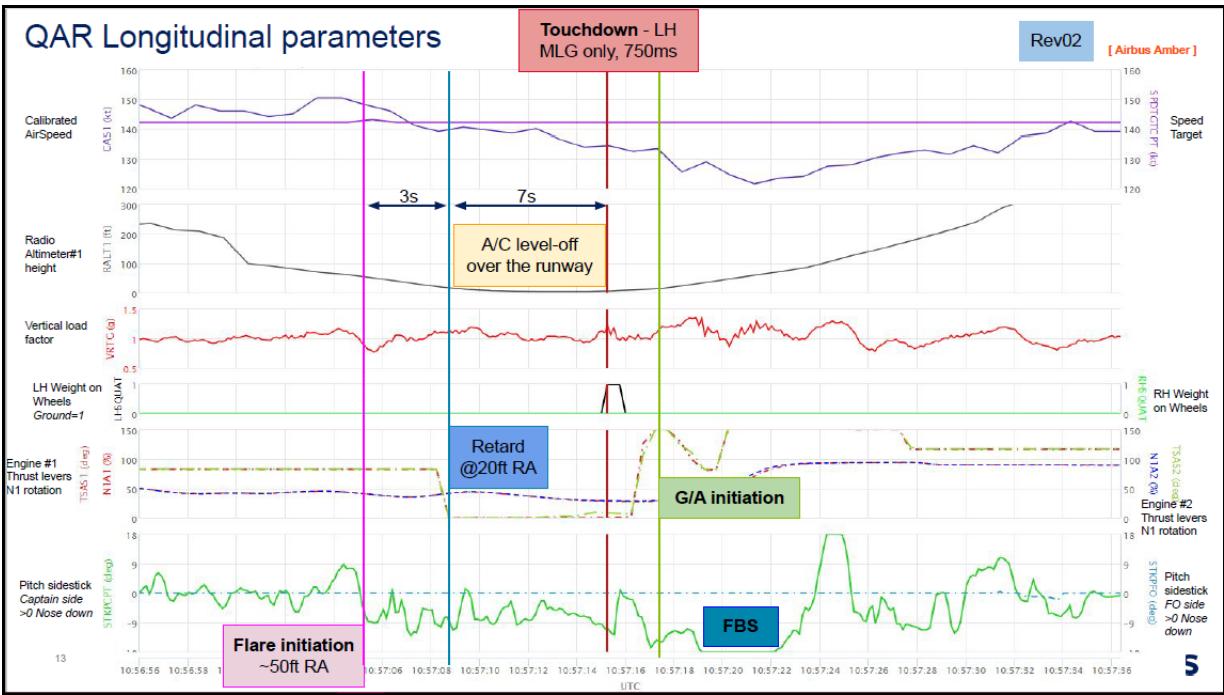
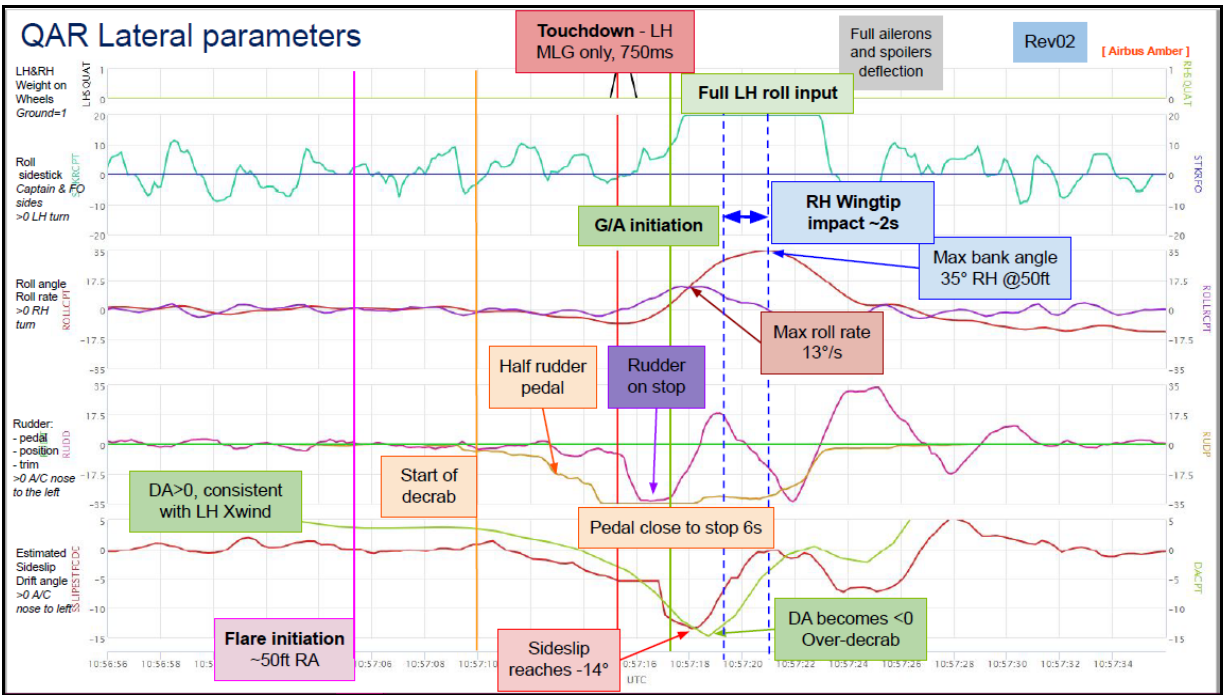
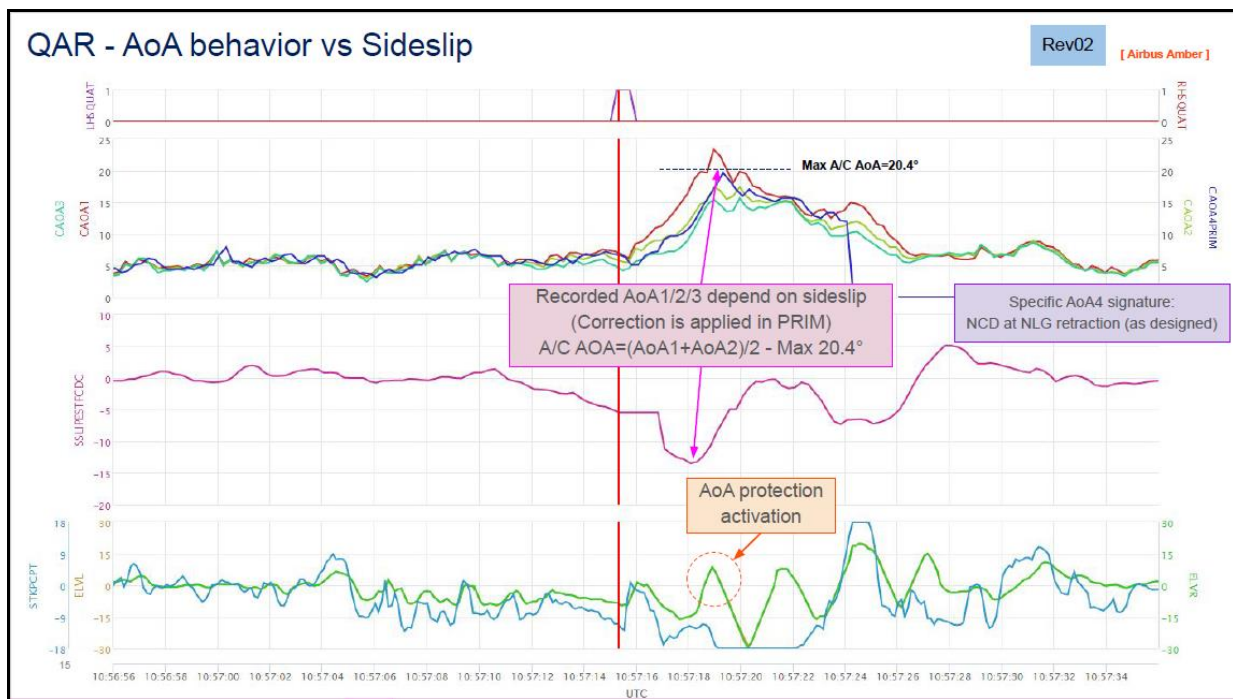
- *Progressive increase of drift angle & sideslip until ~15° ⇒ significant induced roll due sideslip*
- *RH roll rate build-up ~13°/s max, countered by full LH roll input - ailerons & spoilers deflected accordingly*

- *Max bank angle reached 35° RH at ~50ft - probable time of RH wingtip contact with runway*
- *Rudder pedal input released*
- *Second uneventful approach with auto land*

- *Environmental conditions:*
 - Crosswind component, but reducing close to ground
 - No evidence of windshear
- *Full rudder pedal input before touchdown and maintained during the go-around*
 - Significant sideslip build-up resulting in induced roll, bank angle excursion and wingtip contact
- *Engineering simulations showed that:*
 - The amplitude of the rudder input was the primary contributor to the observed behaviour. When landing is compressed, the lateral law changes from AIR to GROUND (PRIM computer) at touch down which allows more rudder deflection authority.
 - The increased transition time (AIR to GROUND) introduced in PRIM P13 (certified end of 2021) would have reduced the rudder deflection dynamic, reduce the rudder maximum deflection, reduce the left sideslip and thus limited the bank angle excursion in such scenario

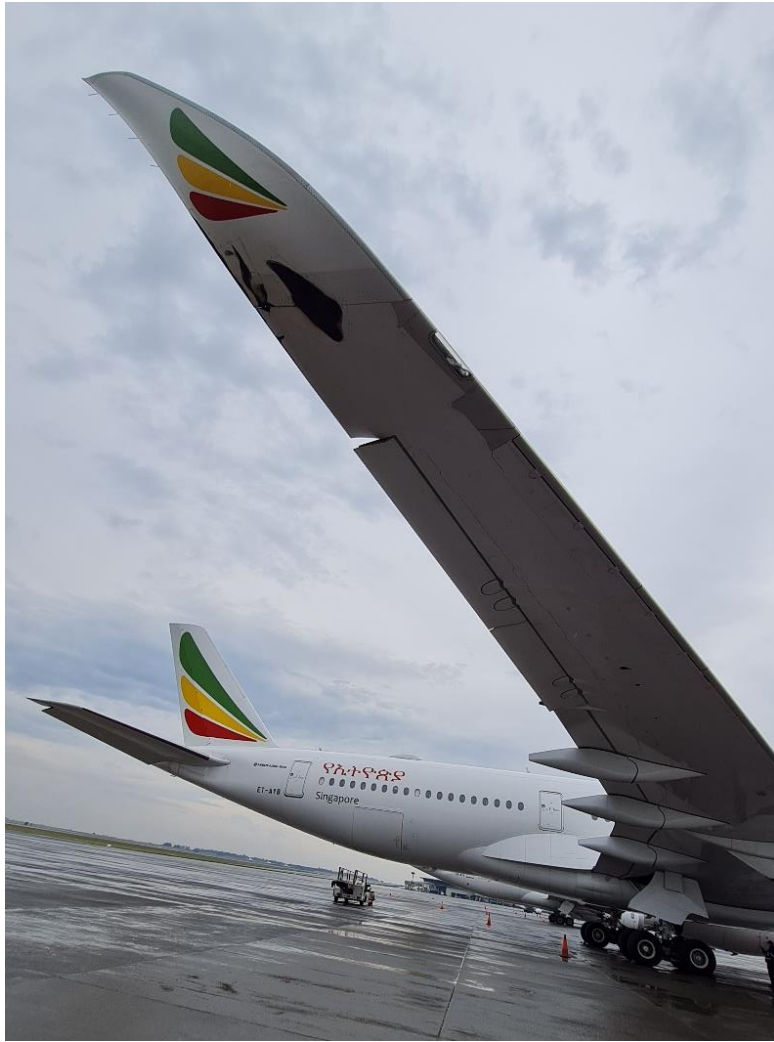
Figure 5: The aircraft post-incident.

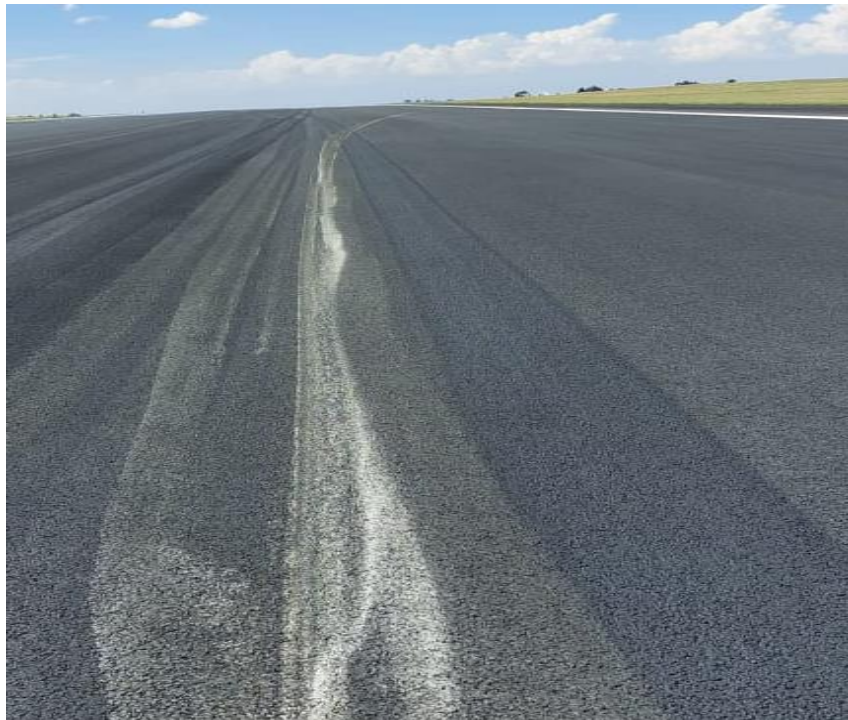
1.12.1 The aircraft was programmed for OKPIT 4A standard instrument landing system (ILS) approach for Runway 03R. The pilot attempted to touch down on the touchdown zone when the aircraft banked sharply to the right and, subsequently, caused the right-wing tip to skid on the runway surface for approximately 110m.

Figure 6: Runway scar mark left by the wing tip as it contacted the runway surface.
