**AIRCRAFT SERIOUS INCIDENT REPORT AND EXECUTIVE SUMMARY**

<b>Reference:</b>		<b>CA18/3/2/1385</b>	
<b>Aircraft Registration</b>	<b>A2-ABK</b>	<b>Date of Incident</b>	30 December 2021		<b>Time of Incident</b>	1027Z	
<b>Type of Aircraft</b>	ATR 72-600		<b>Type of Operation</b>		Air Transport Operation (Part 121)		
<b>Pilot-in-command Licence Type</b>	Airline Transport Pilot Licence (ATPL) Aeroplane		<b>Age</b>	57	<b>Licence Valid</b>	Yes	
<b>Pilot-in-command Flying Experience</b>	<b>Total Flying Hours</b>		17 510		<b>Hours on Type</b>	14 155	
<b>First Officer Licence Type</b>	Airline Transport Pilot Licence (ATPL) Aeroplane		<b>Age</b>	32	<b>Licence Valid</b>	Yes	
<b>First Officer Flying Experience</b>	<b>Total Flying Hours</b>		3 972		<b>Hours on Type</b>	3 466	
<b>Last Point of Departure</b>	O.R. Tambo International Airport (FAOR), South Africa						
<b>Next Point of Intended Landing</b>	Sir Seretse Khama International Airport (FBSK), Botswana

**Probable Cause/s and/or Contributory Factors**

During the climb phase, three PT2 blades of the hot section were fractured on the chromium-coated section; this led to the failure of all three blades in-flight which subsequently caused ot

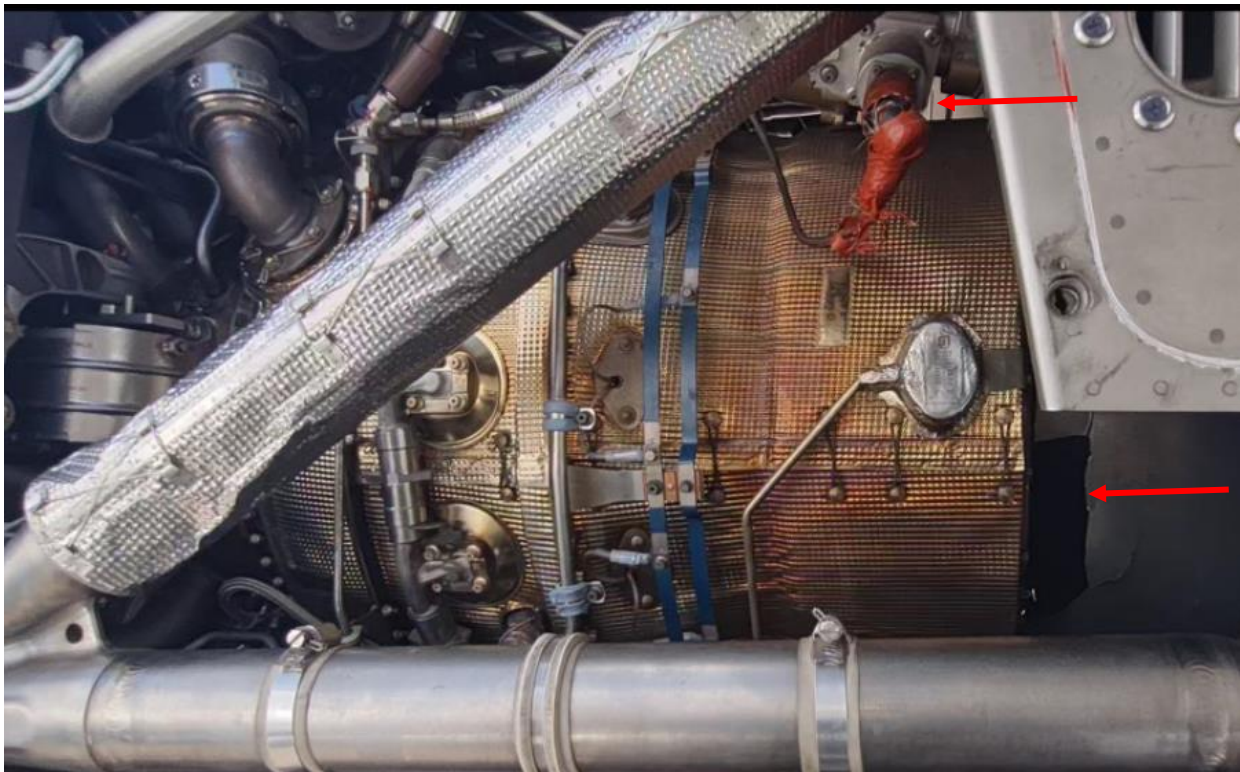
**Figure 2:** Exhaust pipe and P10 connector sustained damage due to the sheared exit guide vanes.

Post-incident inspection of the ENG 2 revealed that the exhaust pipe, turbine blades, exit vanes and handling bleed valve (HBV) electrical connector were damaged. The inspection also revealed that there were exhaust pipe metal pieces on the bottom cowling. All engine damage was contained in the engine cowlings.

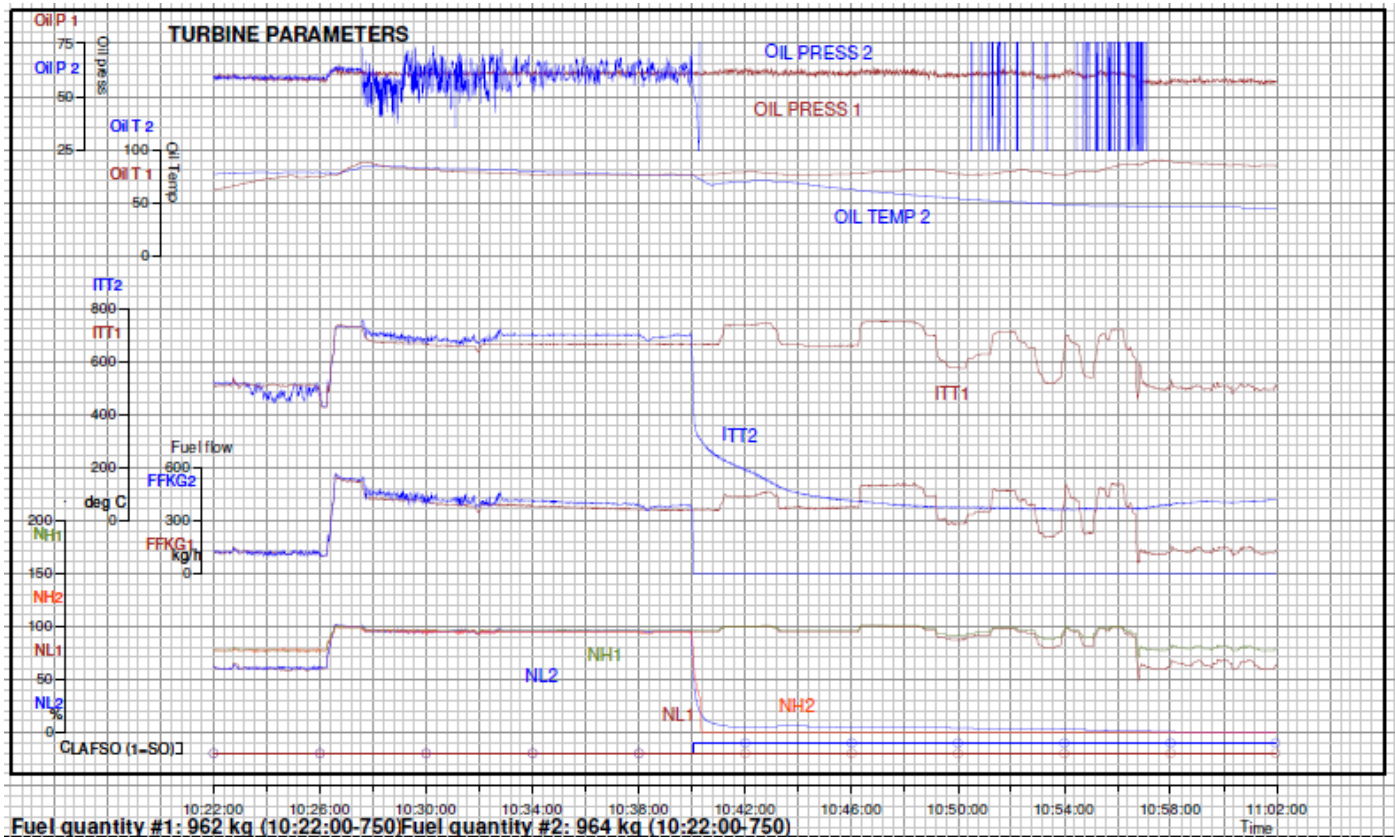
Fluctuations were no more visible on most of the engine 2 parameters, only OIL pressure 2 remained fluctuating. ITT2 remained around 35°C above ITT1.

Figure 4: Engine parameters (Oil, ITT, Fuel flow, NH and NL) from take-off until FL 93. (Source: QAR)

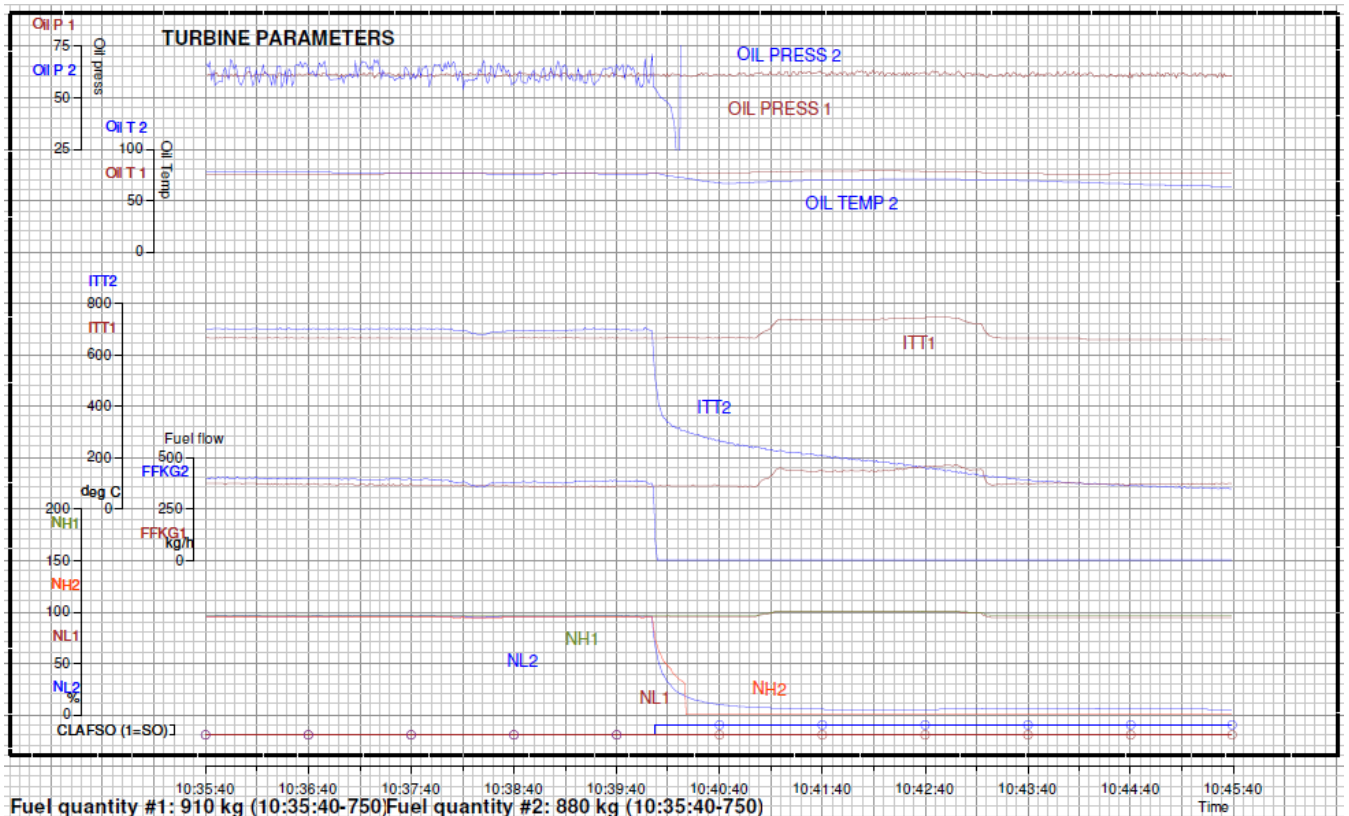
Condition Lever 2 was set on fuel shut off position. PL2 remained in the notch.  
Engine 2 parameters (NL2, NH2, NP2, FF2, ITT2, OILP2, OIL temperature 2) decreased.  
Engine 2 bleed valve and pack 2 control valve closed.

**Figure 5:** Engine parameters (Oil, ITT, Fuel flow, NH and NL) from engine fire warning until ENG 2 shut down. (Source: QAR)

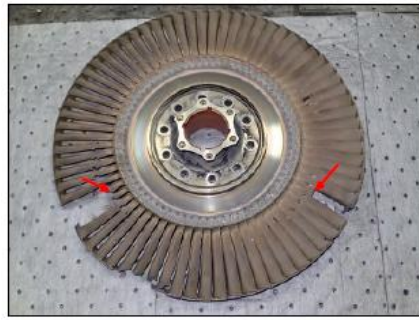
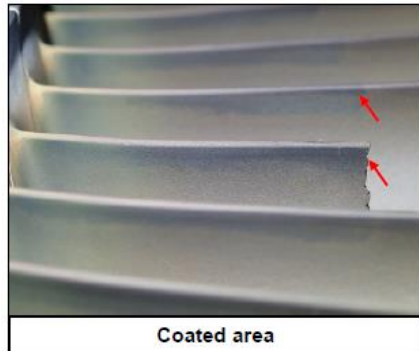
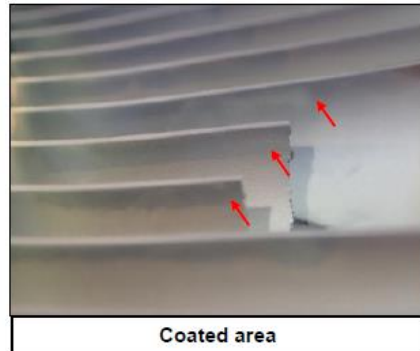
- *Performed modular teardown of the Hot Section module in accordance with (i.a.w) PW127N Maintenance Manual and approved DAA data for LLP access.*
- *Performed modular teardown of the Cold Section module i.a.w. PW127N Overhaul Manual and approved DAA data for LLP access.*
- *Performed borescope inspection on reduction gearbox (RGB) module in accordance with PW127N Maintenance Manual (MM), condition found satisfactory.*
- *Inspect hot section components i.a.w MM/HSI limits.*
  1. *Three 2nd stage PT blades were found to have fractured off at the aerofoil coated*

area about one third above the platform. Two off fractured blades and one full blade with ECI indication was sent for lab analysis on the fractured surface.

Coated area

- Scanning electron microscopy (SEM) analysis on the fractured PT2 blades found traces of chromium sulphide (CrS) in the coated area which suggest sulphidation on the coated area. It is highly likely that the crack initiated from the chromium coating sulphidation area and led to the eventual blade failure.

- All observed defects will be rectified at this shop visit and the engine may be released for continued service following a successful test cell run.

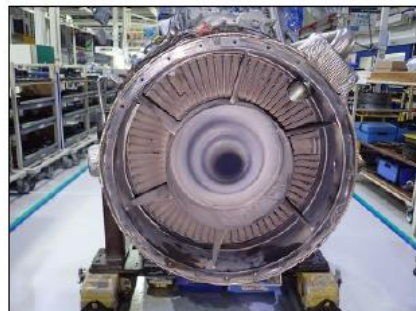
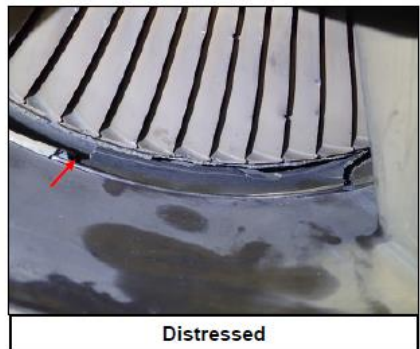
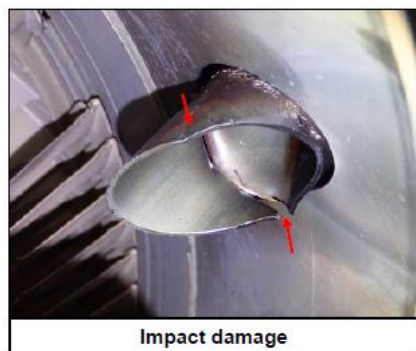
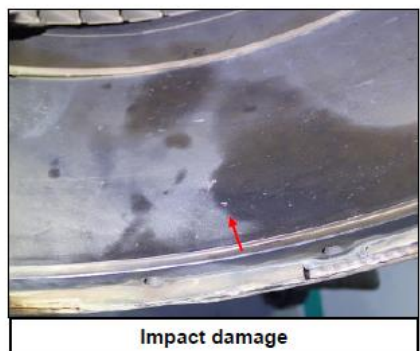
2. Exhaust duct and the accessory gearbox (AGB) breather tube was found with impact damage.

Distressed

Impact damage

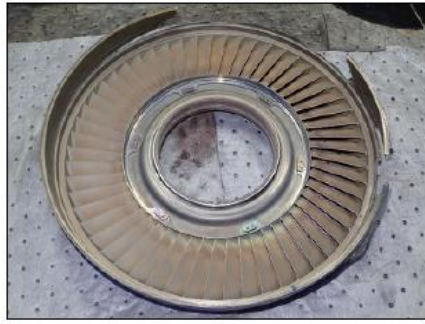
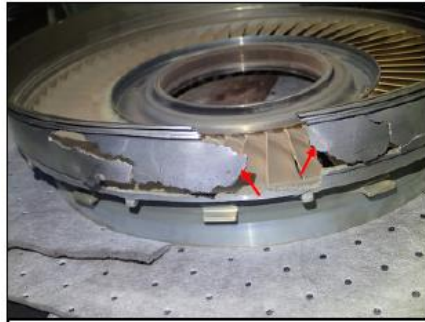
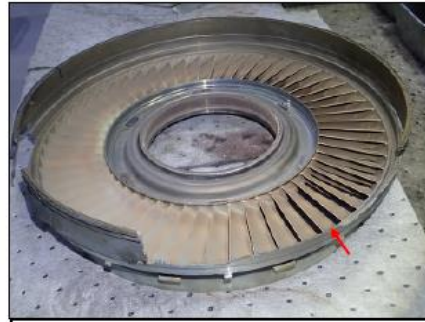
3. PT2 stator was found with missing material on the outer shroud area.

Distressed

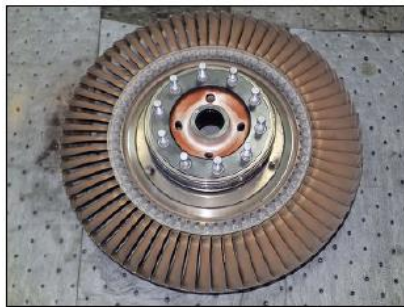
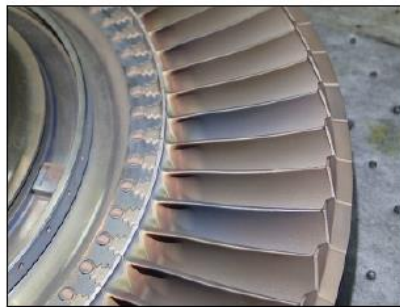
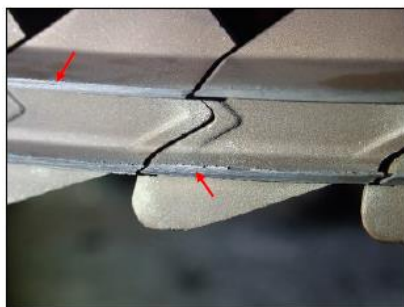
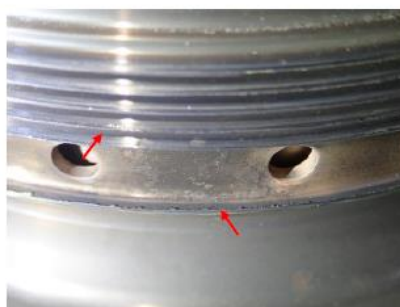
4. PT1 blades were found intact, severe rubbing was noticed on the outer platform shroud seal.

Nil abnormality

Rubbing

- The blades distress probably led to unbalance in the PT rotor and induced high vibration in the engine. This could be observed from the severe rubbing noted on various parts upstream, especially on LP impeller, LP shroud segments, HP impeller, GGC diffuser pipes fracture, turbine interstage case interstage seal and 1st stage PT blades.
