Section/division Accident and Incident Investigations Division

LIMITED OCCURRENCE INVESTIGATION REPORT - FINAL

Reference Number	CA18/3/2/1386													
Classification S		Serious In	Serious Incident			e 11 M	11 May 2022				Time	1015Z		
Type of Operation	•	Private Flight (Part 91)				•								
Location														
Place of Departure			ata Game Farm, eng Province			Place of Intended Landing				Kwalata Game Farm, Gauteng Province				
Place of Occurrence	Kwalata Game Farm													
GPS Co- ordinates		Latitude	25° 23' 1	S	S Longitude		28° 19' 06.42" E		Е	Elevation		3 602 feet		
Aircraft Information														
Registration	Registration ZS-RKK													
Make; Model; S/N Robinson Helicopter; R44 Raven II (Serial Number: 11338)														
Damage to Aircraft							Total Aircraft Hours				1 802.8			
Pilot-in-com	maı	nd												
Licence Type	Private Pilot L (Helicopter)		icence			Gender		Male				Age 46		6
Licence Valid	Υe	es	Total	Total Hours		3 051			Total Hours		on Type 3		3	051
Total Hours 90 Days		70			Total Flying on Type Page 90 Days			pe Past		70

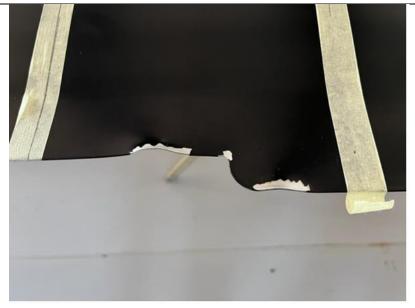
Figure 1: Damage on the main rotor blade. (Source: Pilot)

- vii. The Certificate of Airworthiness (CoA) was renewed on 31 August 2021 with an expiry date of 31 August 2022.
- viii. The pilot banked the helicopter to the right to track closer and the gunner fired the net gun towards the blesbok; however, one of the net weights struck one of the main rotor blades.

The net gun weight struck one of the main rotor blades' trailing edge and the pilot decided to conduct a successful precautionary landing.

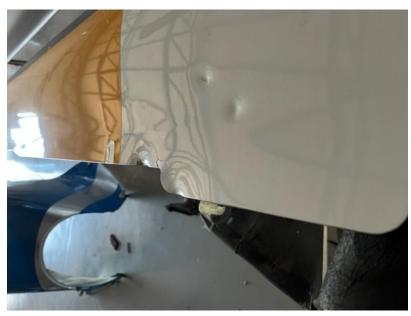
Figure 2: Top view of the damage on the trailing edge and the dents caused by the net weights. (Source: Pilot)
