AIRCRAFT SERIOUS INCIDENT REPORT AND EXECUTIVE SUMMARY

Reference:		CA18/3/2/1391	
Aircraft Registration		ZS-ASN (DC3) and ZS-ZWF (B738)		Date of Incident		8 February 2022	
				Time of Incident		0834Z	
Type of Aircraft		Douglas DC3-TP67 and Boeing 737-800		Type of Operation		Part 135 and Part 121	
Pilot-in-Command Licence Type (ZS-ASN)		Airline Transport Pilot Licence		Age		52	
				Licence Valid		yes	
Pilot-in-Command Flying Experience		Total Flying Hours		7 856.1		Hours on Type	
				3473.1			
Pilot-in-Command Licence Type		Airline Transport Pilot Licence		Age		49	
				Licence Valid		Yes	
Pilot-in-Command Flying Experience		Total Flying Hours		19 123		Hours on Type	
				15 983			
Last Point of Departure (ZS-ASN)		Lanseria International Aerodrome (FALA), Gauteng Province					
Last Point of Departure (ZS-ZWF)		King Shaka International Aerodrome (FALE), KwaZulu-Natal Province					
Next Point of Intended Landing (ZS-ASN and ZS-ZWF)		Lanseria International Aerodrome (FALA), Gauteng Province

Reference Number : CA18/3/2/1391
Occurrence Category : Serious Incident
Type of Operation : Part 135 (Air Transport Operation)
: Part 121 (Commercial Transport Operations)
Name of Operator : Fly Jet

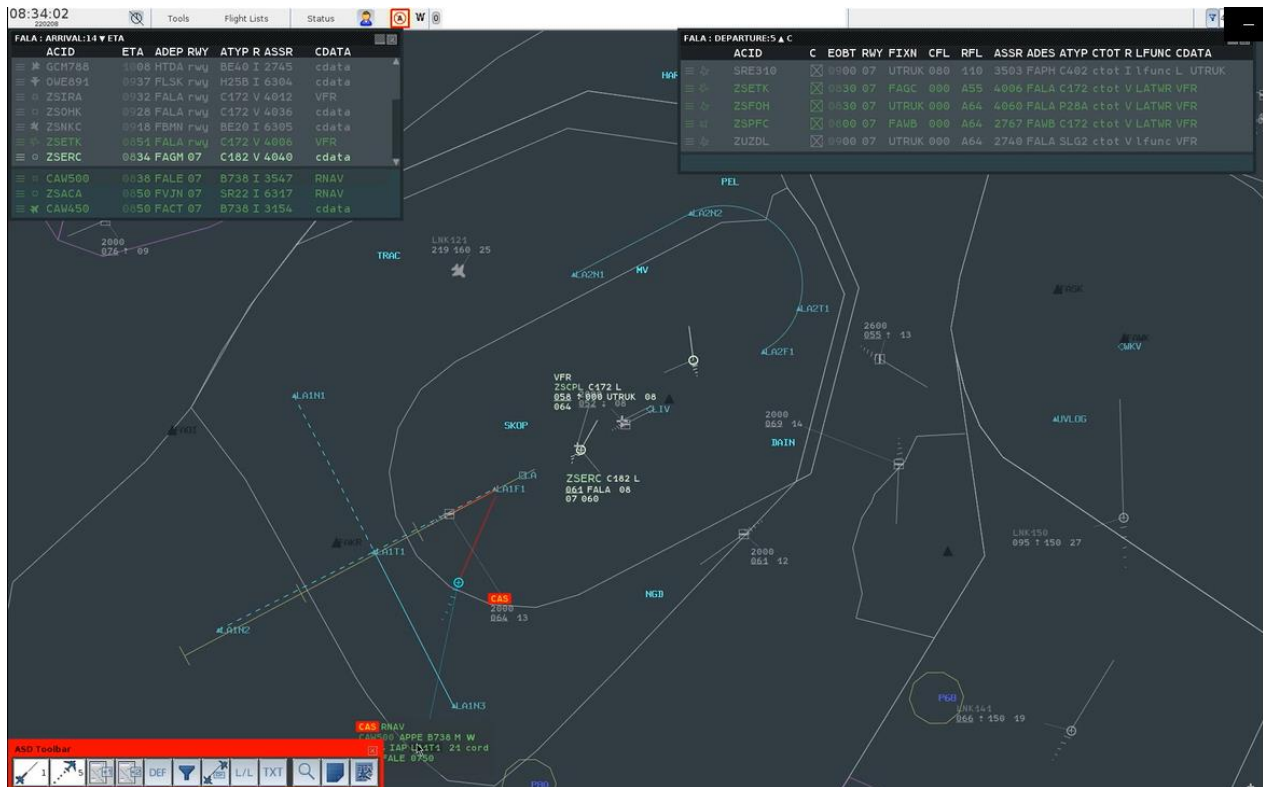
Figure 2: The still picture of the Air Situation Display used for monitoring at FALA. Both aircraft are in red. (source: ANSP)

- 1.1.4 The air situation display turned red (see Figure 2) which made the ATCO aware of the reduced separation. The ATCO called the ZS-ASN aircraft to break off the approach, orbit to the left and re-join the late left downwind RWY 07. The ZS-ASN reported that they were 8nm for final approach. They found this confusing as they were getting ready to call at 6nm final approach as previously requested. They asked for confirmation on the north bound turn, and downwind reporting. The ATCO affirmed “turn left now, continue routing north”. The ATCO then told ZS-ZWF to continue approach and also made the crew aware of the ZS-ASN aircraft that was breaking off to the left, routing north. The pilot of ZS-ZWF told the ATCO that he had the other traffic in sight.

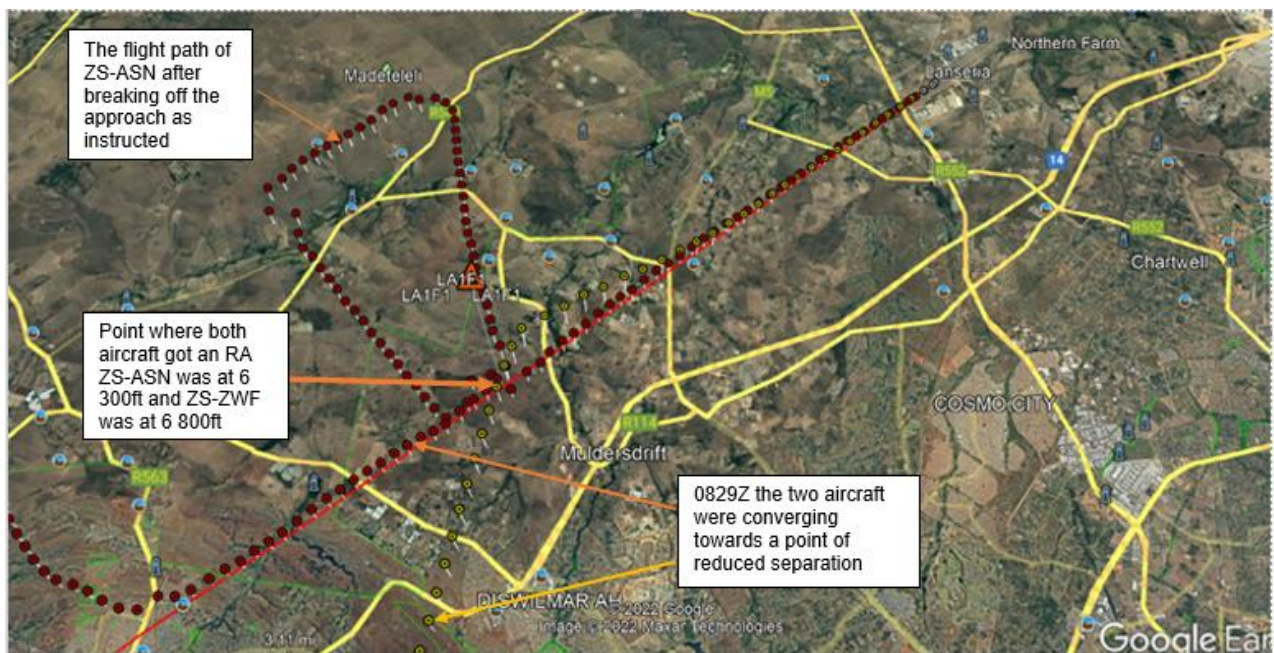
- 1.1.8 The serious incident occurred during day light, approximately 7.17nm on final approach for landing RWY 07 at FALA and at Global Positioning System (GPS) co-ordinates determined to be 26°01'14.58" South 27°49'28.27" East, at an elevation of 4796ft.

Figure 2: Serious incident location, approximately 7.17nm from RWY 07 at FALA. The red dots show the flight path of ZS-ASN and the yellow dots show ZS-ZWF. (Source: Google Earth)
