**AIRCRAFT SERIOUS INCIDENT REPORT AND EXECUTIVE SUMMARY**

<b>Reference:</b>		<b>CA18/3/2/1392</b>	
<b>Aircraft Registration</b>	ZS-ZWD	<b>Date of Incident</b>	10 February 2022		<b>Time of Incident</b>	0417Z	
<b>Type of Aircraft</b>	Boeing 737-800		<b>Type of Operation</b>		Commercial (Part 121)		
<b>Pilot-in-command Licence Type</b>	ATPL		<b>Age</b>	43	<b>Licence Valid</b>	Yes	
<b>Pilot-in-command Flying Experience</b>	<b>Total Flying Hours</b>		12117		<b>Hours on Type</b>	7928	
<b>Last Point of Departure</b>	Lanseria International Airport (FALA), Gauteng Province						
<b>Next Point of Intended Landing</b>	Cape Town International Airport (FACT), Western Cape Province						
<b>Damage to Aircraft</b>	Substantial to engine 1						
<b>Location of the incident site with reference to easily defined geographical points (GPS readings if possible)</b>							
At Global Positioning System (GPS) co-ordinates determined to be 26°41'46.06" S 27° 3'51.52" E during climb between FL260 and FL270

**Reference Number** : CA18/3/21329  
**Occurrence Category** : Serious incident  
**Type of Operation** : Scheduled (Part 121)  
**Name of Operator** : Comair  
**Aircraft Registration** : ZS-ZWD  
**A

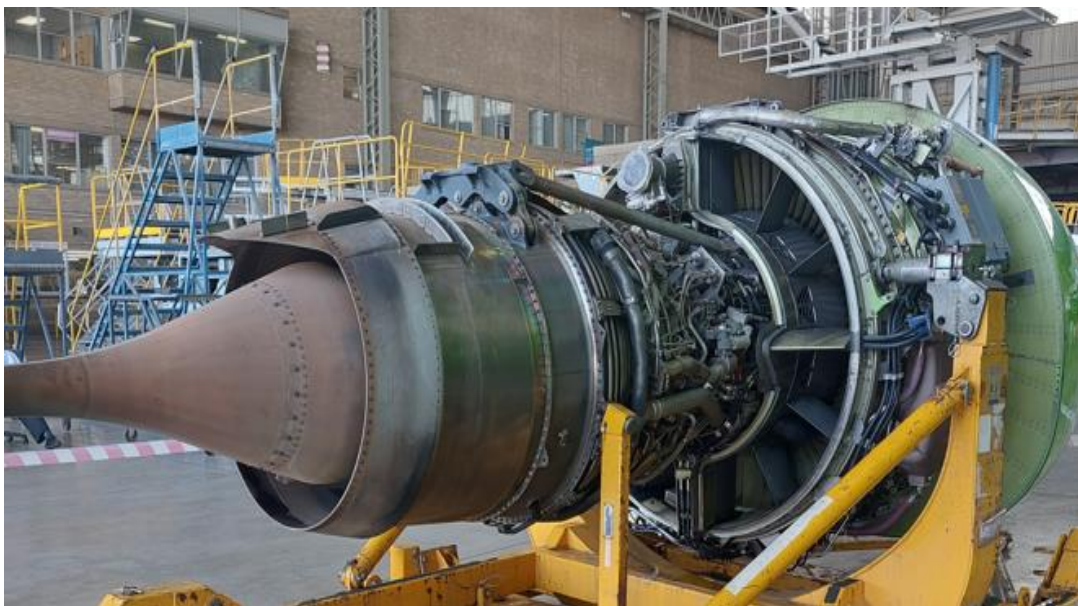
1.3.1. The No.1 engine and left-side leading edge of the horizontal stabiliser were damaged.

Figure 2: The damaged engine after it was removed from the aircraft.

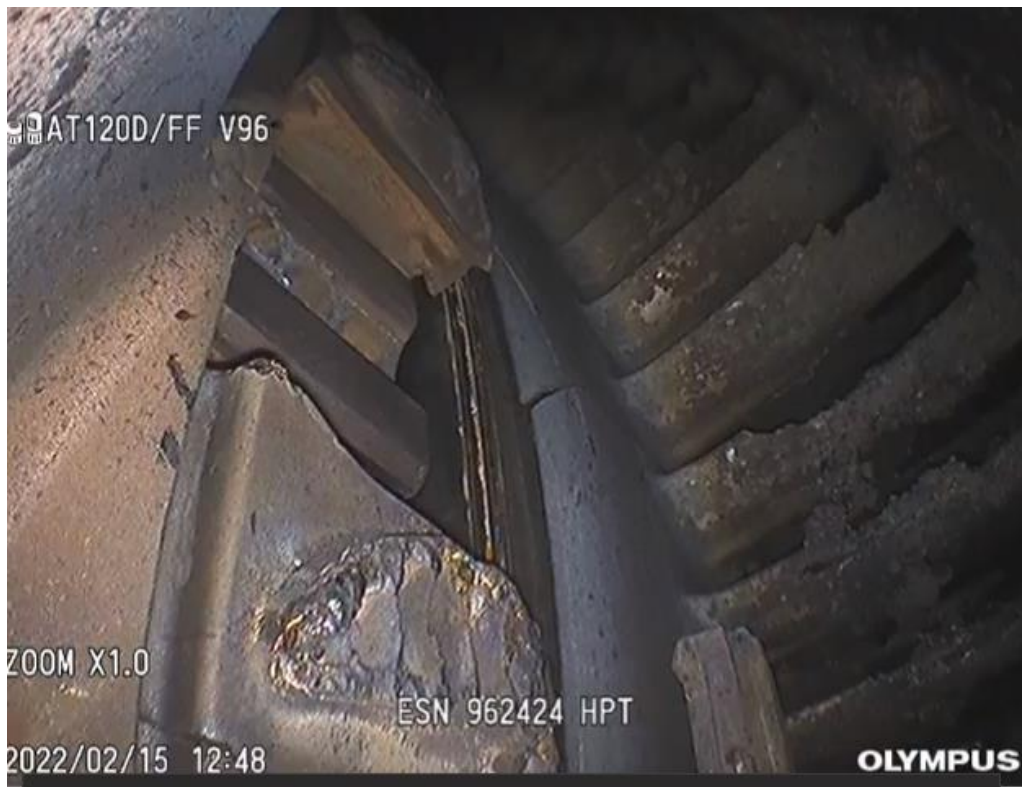
**Figure 3:** All blades sheared off. Two blades broke out of disk. (Source SAAT)

- Two blades broke out of disk.

borescope inspection of the engine revealed internal discolouration and failure of the hot section and shearing of high-pressure turbine blades. The cause of the engine failure could not be determined due to the operator being liquidated. The investigation will be reopened once the new owner takes over the operation.

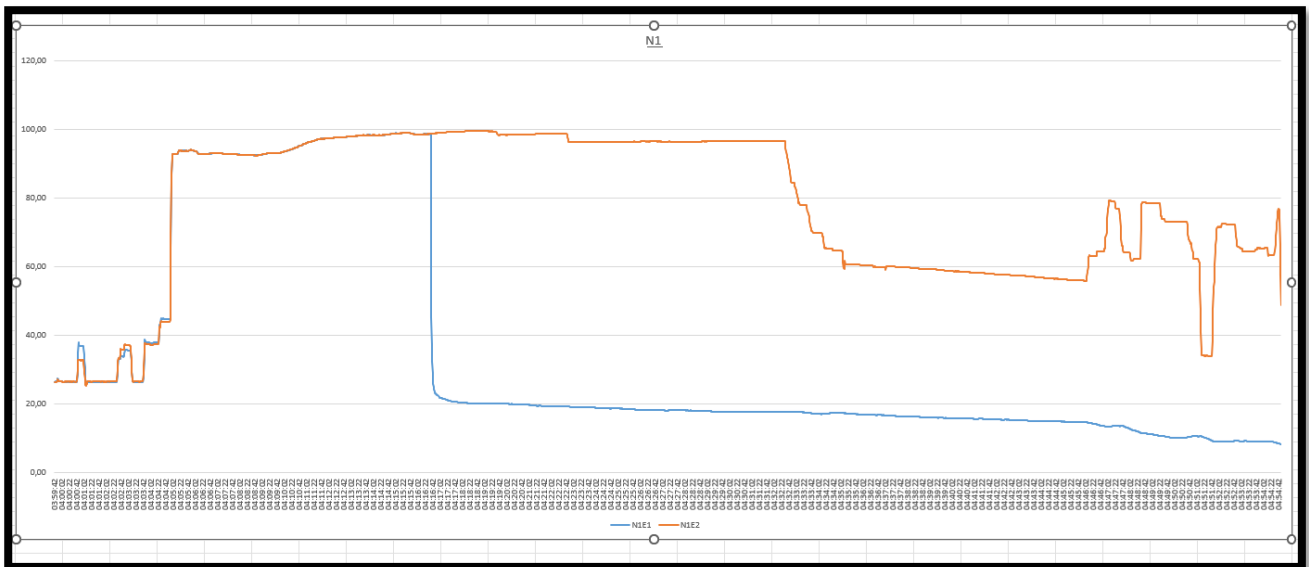
**Graph1:** Blue line shows the left engine's VN1T and yellow line, the right engine's VN1T. (Source: SAAT)

1.11.2 The FDR data Graphs 1, 2 and 3 show that the left engine failed at 04:17:30Z at an altitude of 26034 feet (ft) and that the exhaust gas temperature shot up from 800°C to approximately 1000°C briefly before dropping sharply to zero.

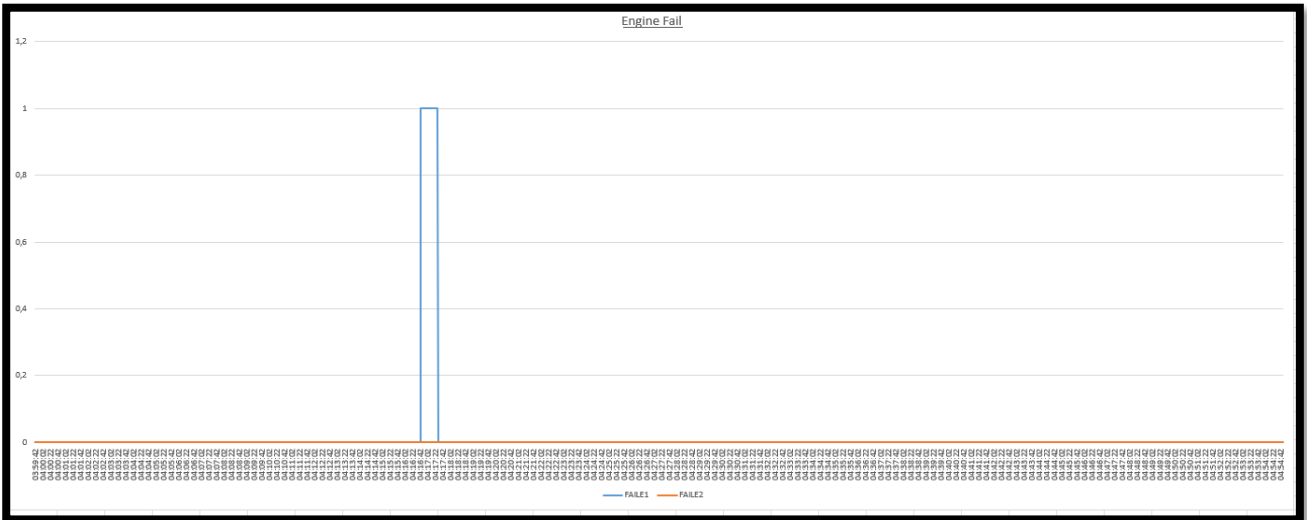
**Graph 2:** Engine failure. (Source: SAAT)

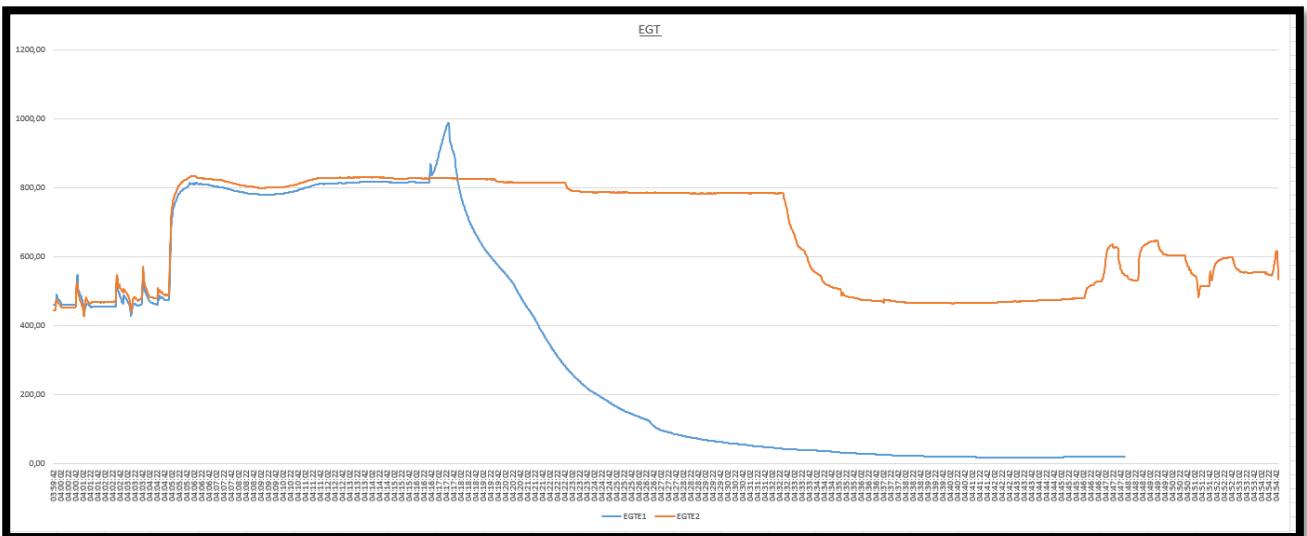
**Graph 3:** Rise in temperature on engine 1, followed by a sudden drop. (Source: SAAT)

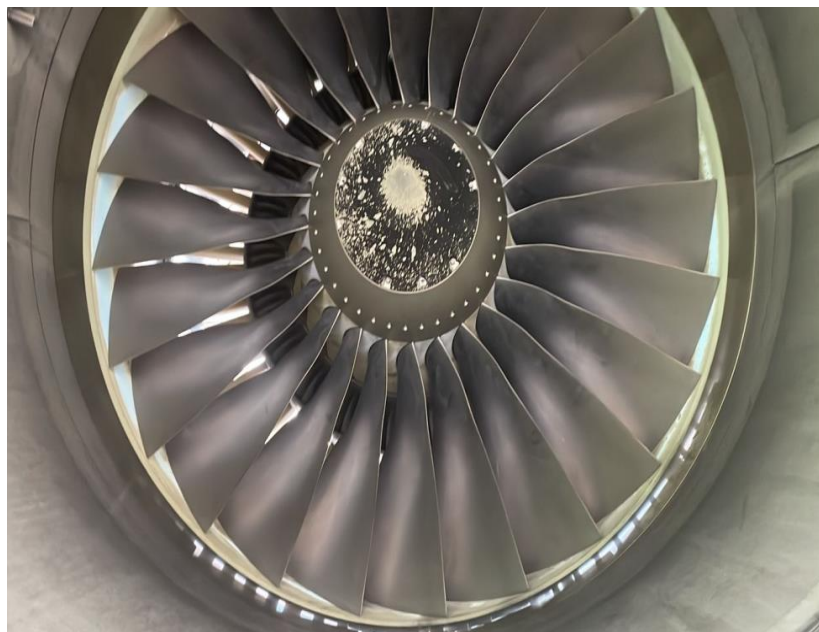
- 1.12.1 During the climb phase, there was a loud bang with subsequent vibration on the aircraft. Relevant checklists were referenced, and the No.1 engine was shut down and secured as per the Boeing 737-800 Quick Reference Handbook (QRH), after which a MAYDAY was declared. A decision was made to divert to FAOR. The aircraft landed safely with one engine in operation on Runway 03R. The No.1 engine was severely damaged.
- 1.12.2 On-site investigation revealed the following: the fan blades were undamaged and still intact in their respective positions with no evidence of foreign object debris (FOD) ingestion. The compressor and the stator blades were still intact in their respective positions.

**Figure 4:** No damage to the compressor fan blades.

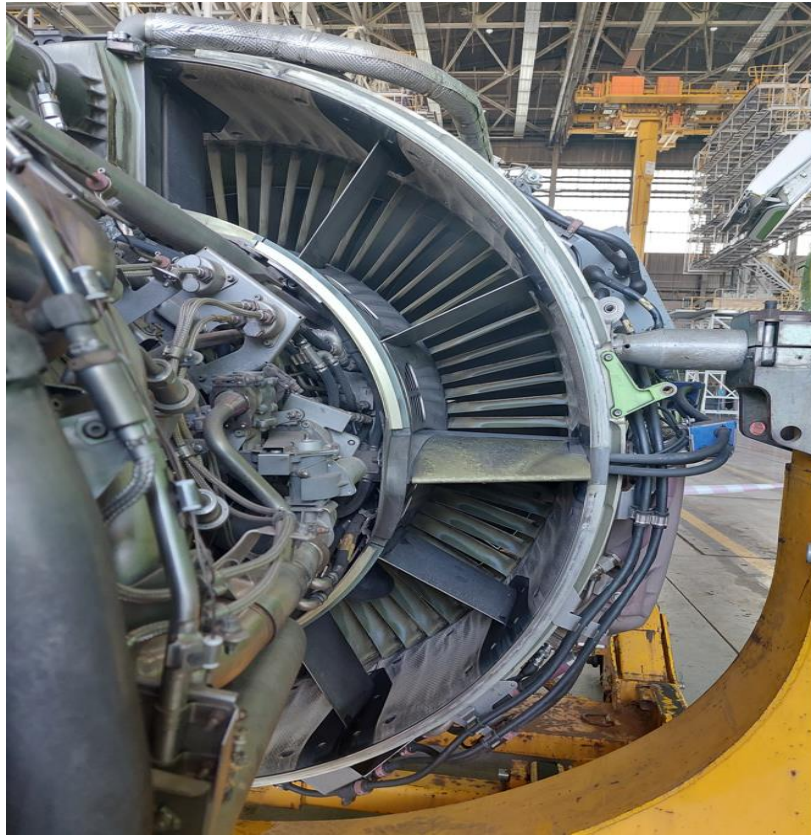
**Figure 5:** The compressor and the stator blades.

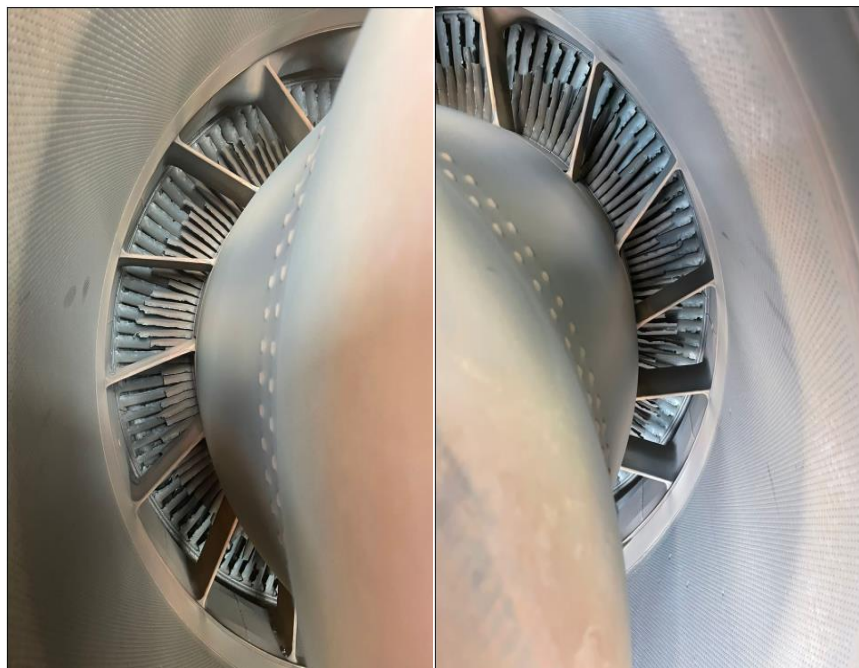
1.12.3 The turbine rotor blades were found damaged with cuts almost at the same height all round.

**Figure 6:** Damaged turbine rotor blades.

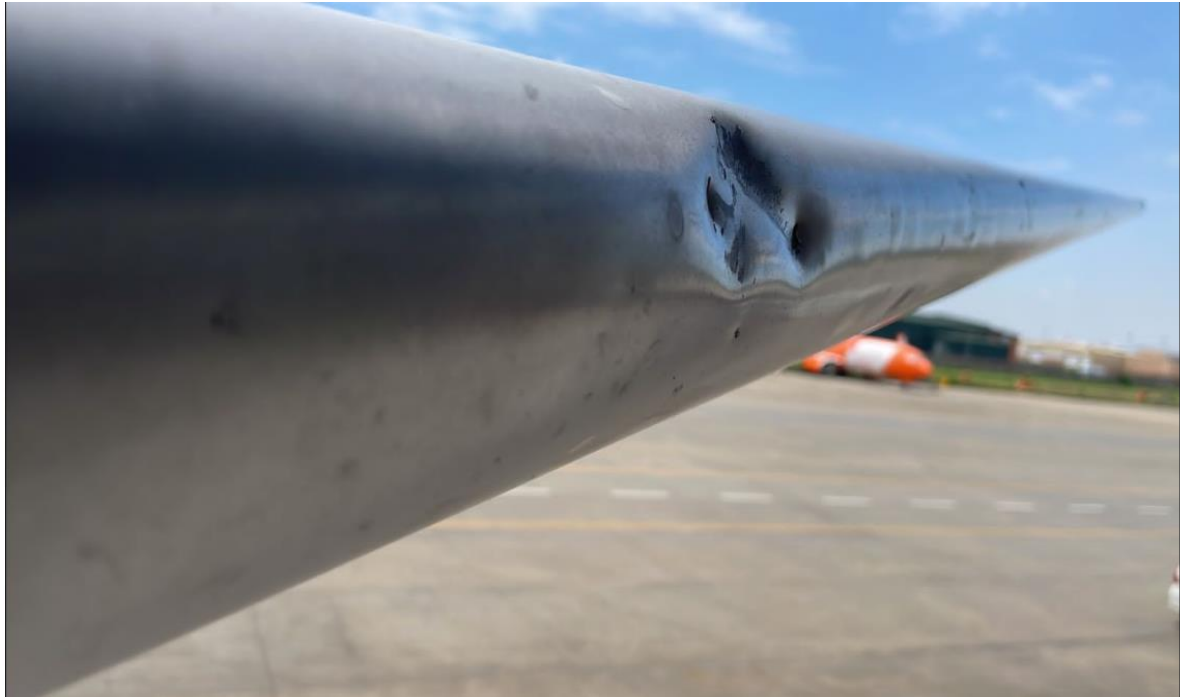
1.12.4 The left-side leading edge of the horizontal stabiliser was pierced by debris from the engine.

**Figure 7:** Left side horizontal stabiliser.
