**AIRCRAFT SERIOUS INCIDENT REPORT AND EXECUTIVE SUMMARY**

<b>Reference:</b>		CA18/3/2/1394	
<b>Aircraft Registration</b>	ZT-RZS	<b>Date of Incident</b>		19 February 2022		<b>Time of Incident</b>	0100Z
<b>Type of Aircraft</b>	Agusta Westland AW119			<b>Type of Operation</b>		Air Ambulance Service (Part 138)	
<b>Pilot-in-command Licence Type</b>		Airline Transport Pilot Licence (Helicopter)		<b>Age</b>	37	<b>Licence Valid</b>	Yes
<b>Pilot-in-command Flying Experience</b>		<b>Total Flying Hours</b>		4972.5		<b>Hours on Type</b>	868.2
<b>Last Point of Departure</b>		Paarl Provincial Hospital Helistop, Western Cape Province					
<b>Next Point of Intended Landing</b>		Cape Town International Airport (FACT), Western Cape Province					
<b>Damage to Aircraft</b>		None					
<b>Location of the incident site with reference to easily defined geographical points (GPS readings if possible)</b>							
Paarl Provincial Hospital rooftop (helistop), Western Cape province, at Global Positioning System (GPS) co-ordinates determined to be 33°43'33.06" South 018°58'14.07" East at an elevation of 439.54 feet (ft)

<b>Reference Number</b>	: CA18/3/2/1394
<b>Occurrence Category</b>	: Serious Incident
<b>T

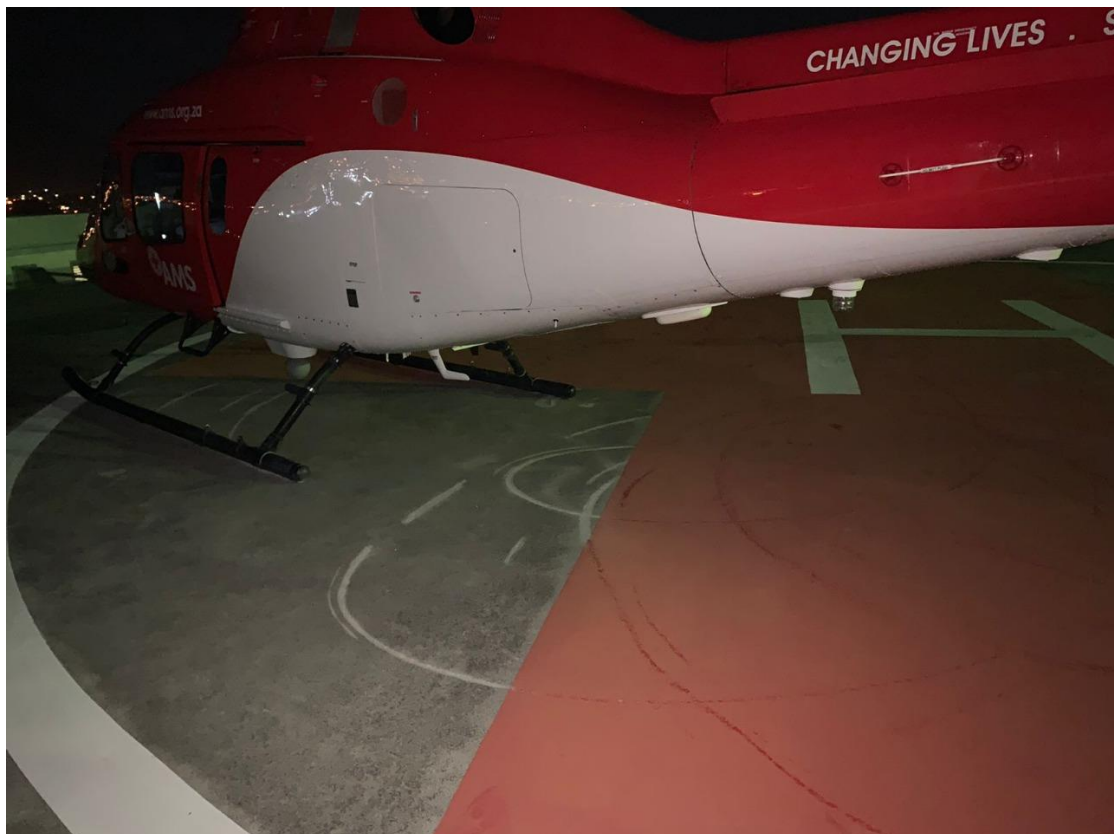
1.12.1. The helicopter was not damaged, however, scrape marks were evident on the surface of the helistop.

1.12.2. According to the pilot, the helicopter was positioned on the helistop facing north. During the start-up whilst the engine was passing 100% NR to get to 102% NR, the helicopter experienced a series of abrupt violent left-side yaw movements which could not be arrested by applying the right rudder pedal.

**Figure 2:** The scrape marks on the helistop made by the skids of the helicopter.  
(Source: Operator)
