AIRCRAFT SERIOUS INCIDENT REPORT AND EXECUTIVE SUMMARY

Reference:	CA18/3/2/1395		
Aircraft Registration	ZS-ZWB	Date of Incident	7 March 2022		Time of Incident	0412Z	
Type of Aircraft	Boeing 737-800		Type of Operation		Commercial (Part 121)		
Pilot-in-command Licence Type	Airline Transport Pilot Licence (ATPL)		Age	59	Licence Valid	Yes	
Pilot-in-command Flying Experience	Total Flying Hours		12 865	Hours on Type	3 318		
Last Point of Departure	Lanseria International Airport (FALA), Gauteng Province						
Next Point of Intended Landing	Cape Town International Airport (FACT), Western Cape Province						
Damage to Aircraft	Substantial to number 1 engine						
Location of the incident site with reference to easily defined geographical points (GPS readings if possible)							
At Global Positioning System (GPS) co-ordinates determined to be 26° 41.10' South 027°33.10' East during the climb phase whilst passing FL210 to reach FL217							
Meteorological Information	Wind direction: 94.9°; Wind speed: 05kts; Temperature: 15.9°C; Dew Point: 14°C; Cloud Cover: Nil; Cloud Base: Nil; Visibility: 9 999m; QNH: 849.5hPa

Reference Number	: CA18/3/2/1395
Occurrence Category	: Category 1
Type of Oper

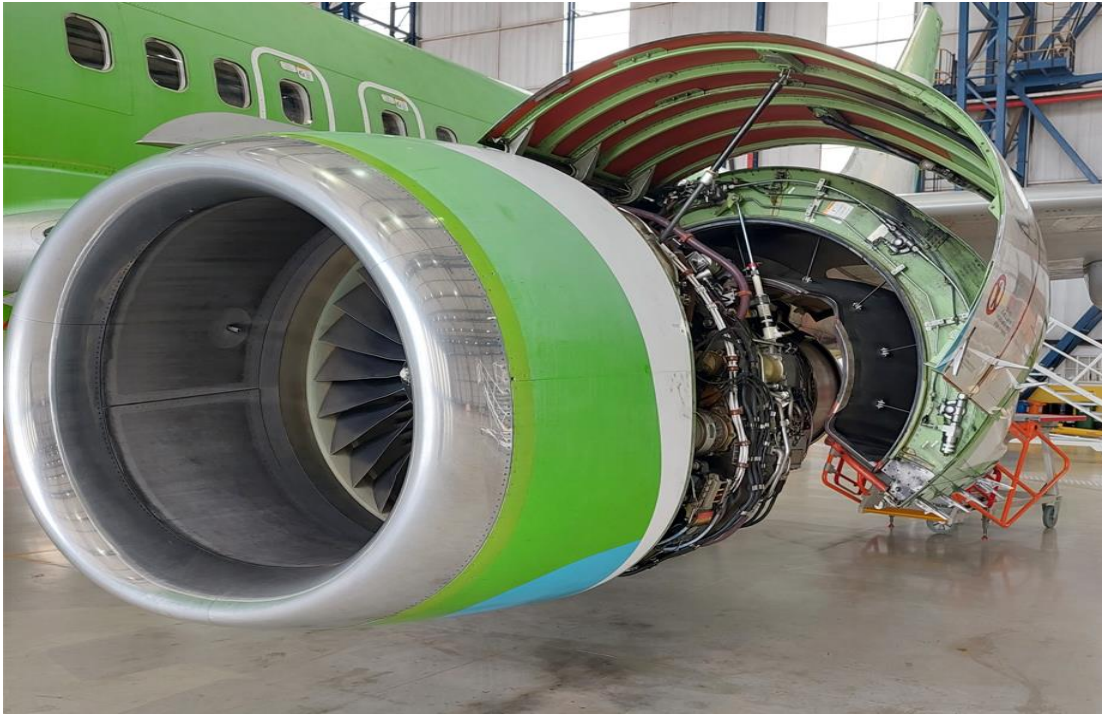
Figure 2: The affected engine.

- 1.3.1. The No.1 engine, the left side of the fuselage skin and the left leading edge of the horizontal stabiliser were damaged.

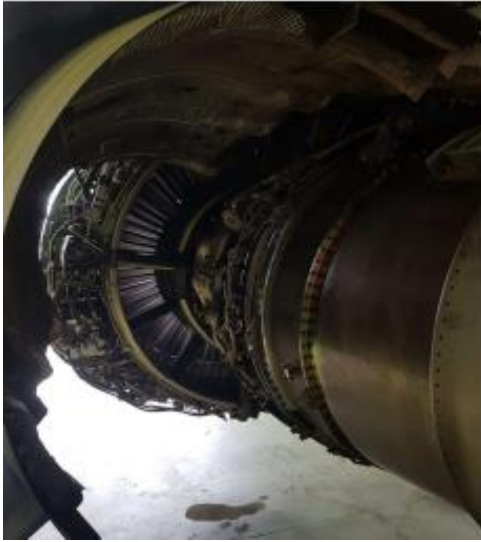
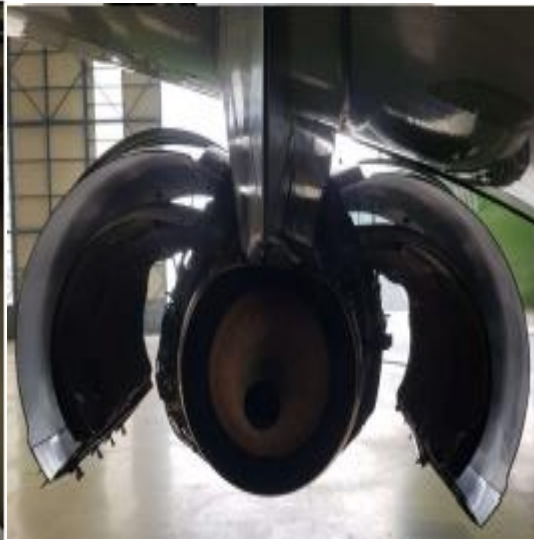
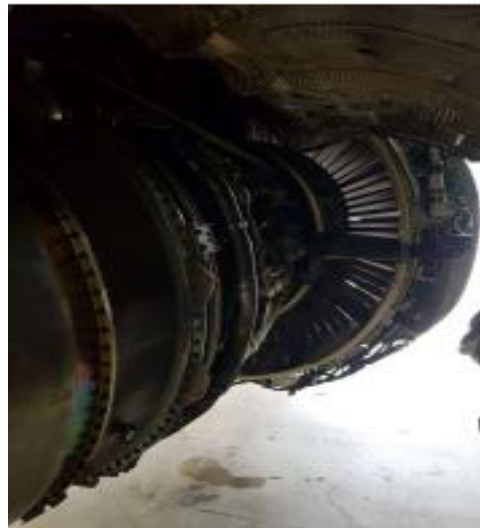
No discrepancies noted at this time. Suggested Action: None. (See Figure 3,4 and 5)

No discrepancies noted at this time.

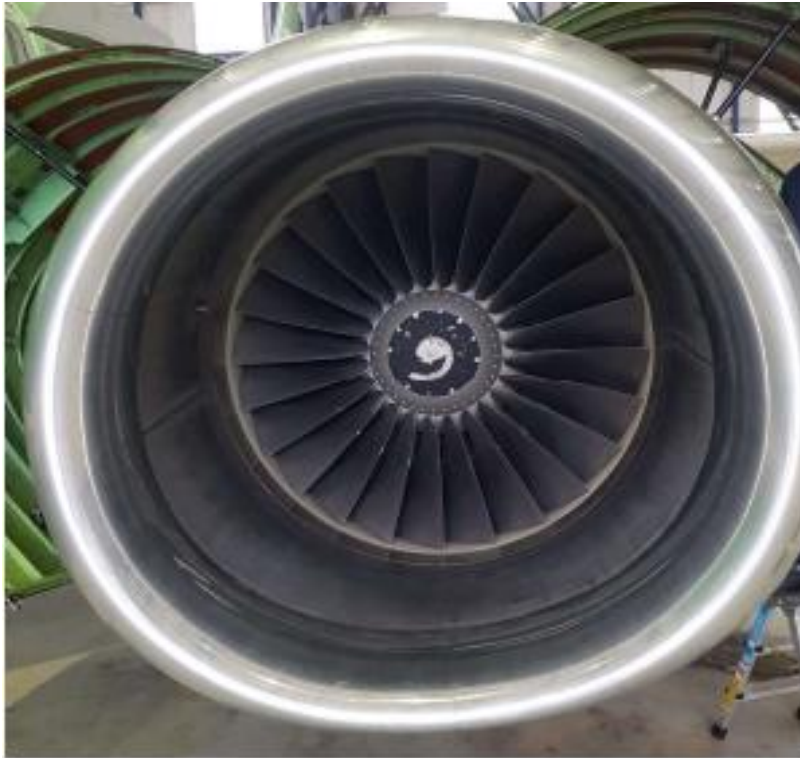
Figure 6

LPC 1 Fan blades were smooth to the touch with no recent foreign object debris (FOD). Running seal has no heavy rubs or missing material. (See figure 6)

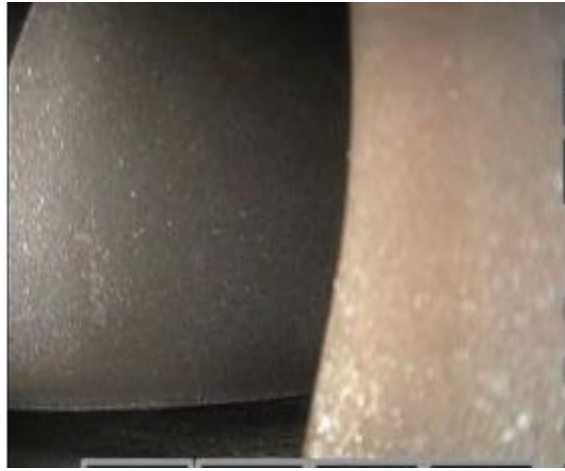
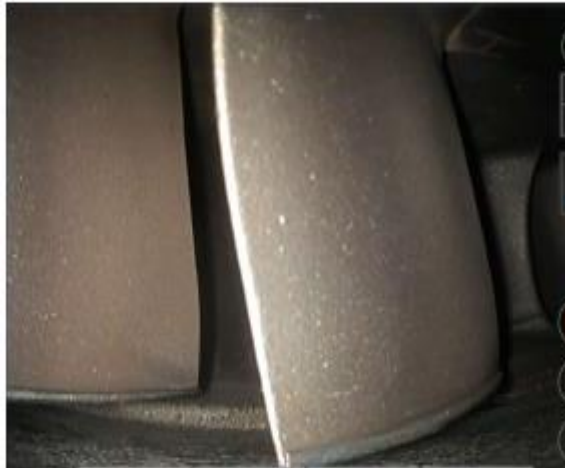
Figure 7 (top) and Figure 8 (bottom)

The engine was unable to be turned.

Suggested Action: None. LE dents

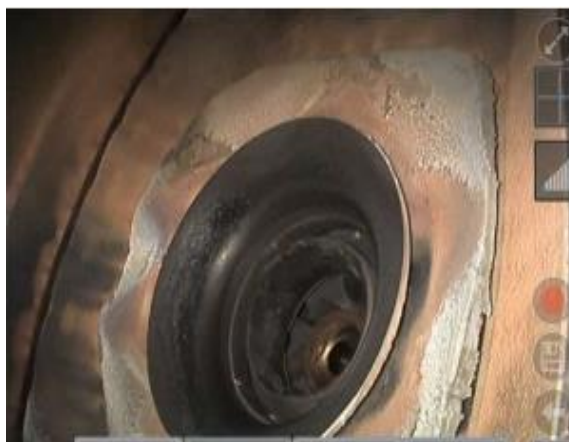
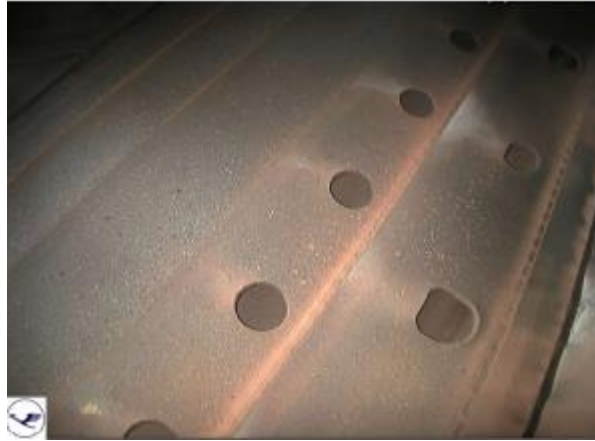
Figure 9 (top) and Figure 10 (bottom)

Inner & Outer Liners First liner normal, other liner colour difference visible. (Figures 9 and 10)

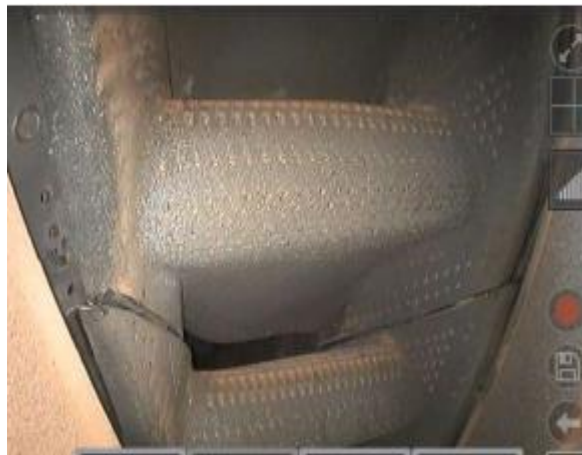
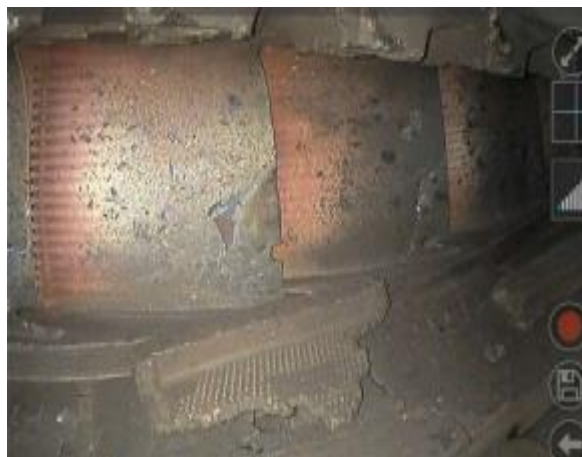
HPT NGVs LE Discolouration

The engine was unable to be turned. (Figures 11 and 12)

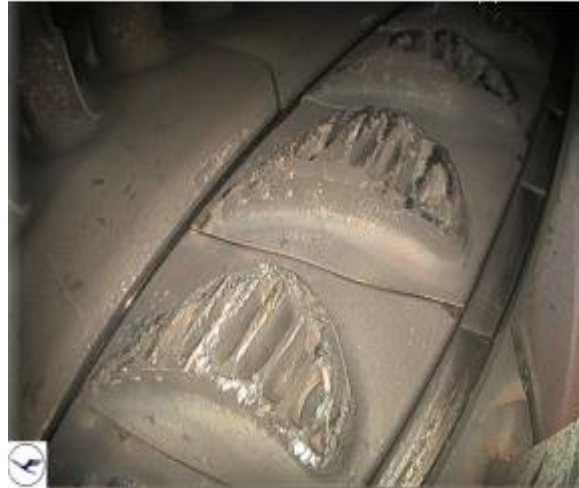
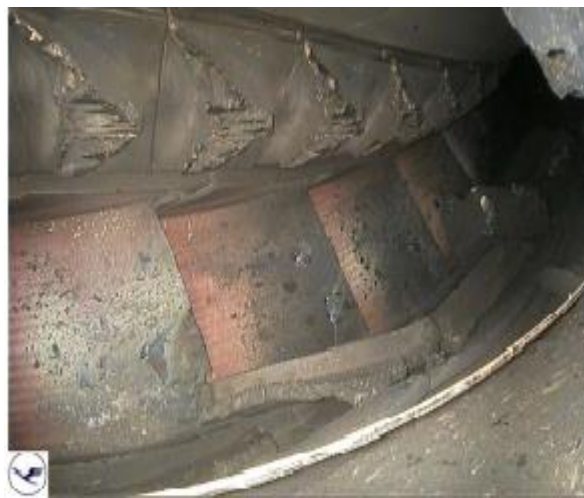
Figure 13 and Figure 14

HPT Blades LE Blades broken off completely.

HPT Blades TE Blades broken off completely. (Figures 13 and 14)

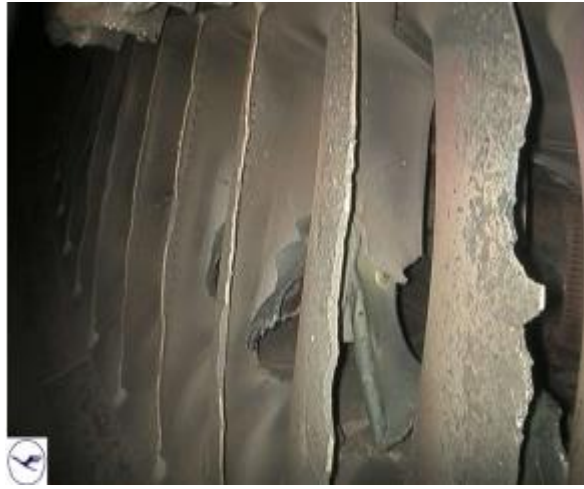
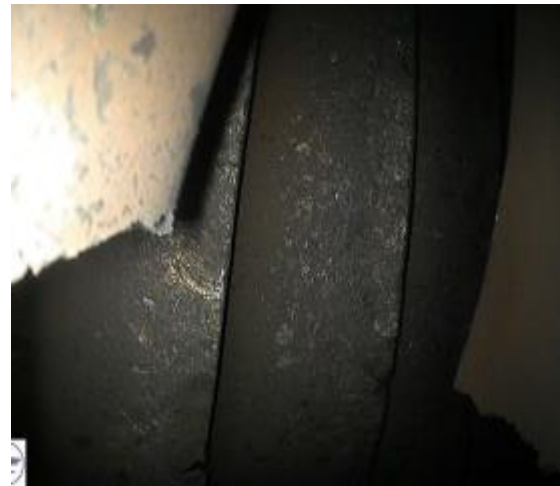
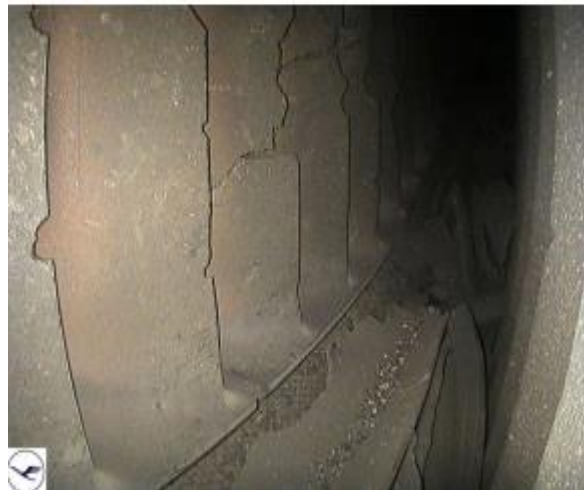
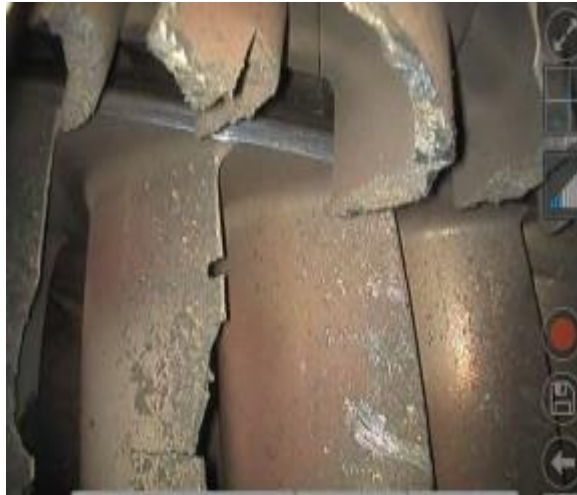
LPT 2 Blades - Several blades broken.

LPT 3 Blades - Several blades broken.

LPT 4 Blades - Several blades broken. (Figures 15,16, 17 and 18)

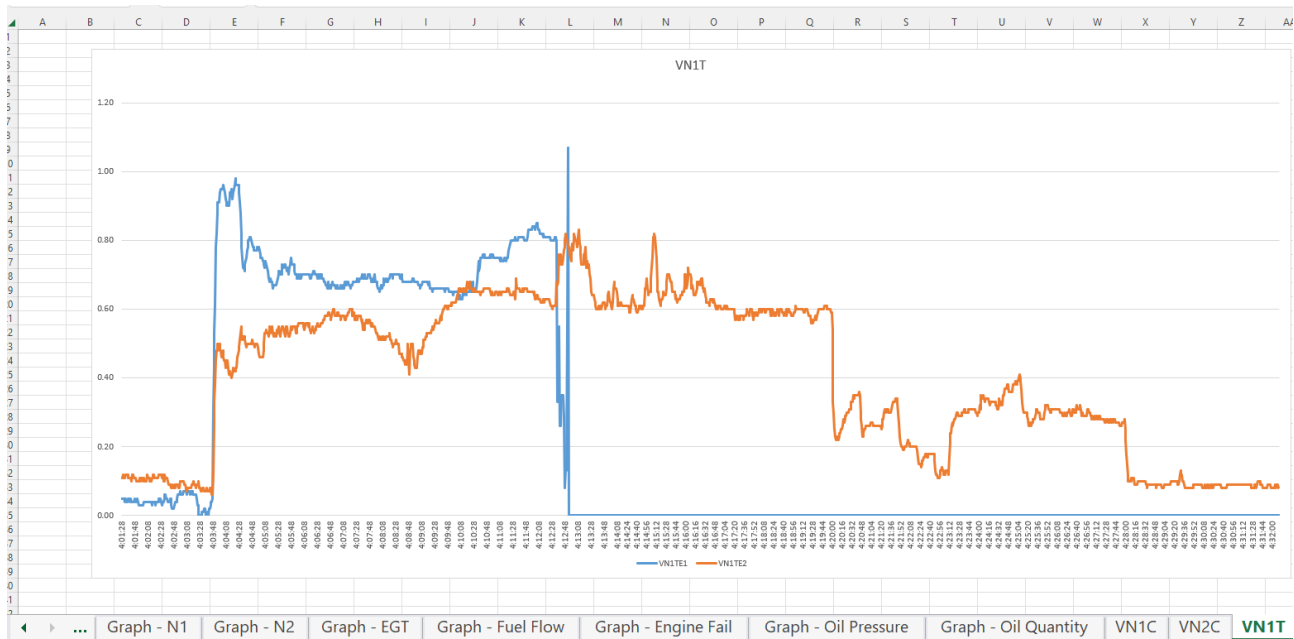
Graph 1: Blue line shows left engine VN1T and yellow line depicts right engine VN1T.

1.11.2 The FDR data graphs 1 and 2 show that the left engine failed at 0432:36Z at an altitude of 20 573 feet (ft), and at the same time, the fan engine started vibrating between 0.03 and 1.83%. Under normal operation, engine fan vibrations should be approximately 0.40%. The low pressure turbine (LPT) also vibrated from 0.08 to 1.07%, the vibration limits should be approximately 0.40%.

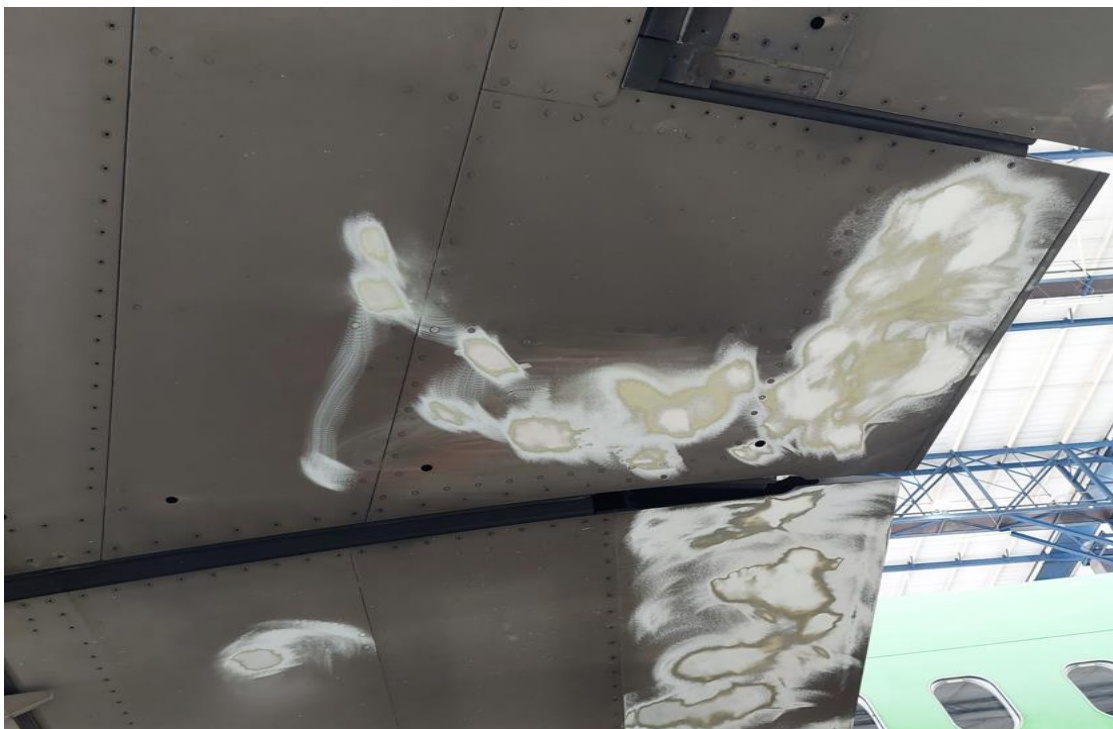
1.12.1. Post serious incident examination of the aircraft at FAOR showed that the left fuselage, the left-wing inboard flaps lower surfaces, and the left horizontal stabiliser had evidence of impact damage (surface scratching and skin gouging, tears and penetrations).

Figure 19: Inboard flaps during repairs.

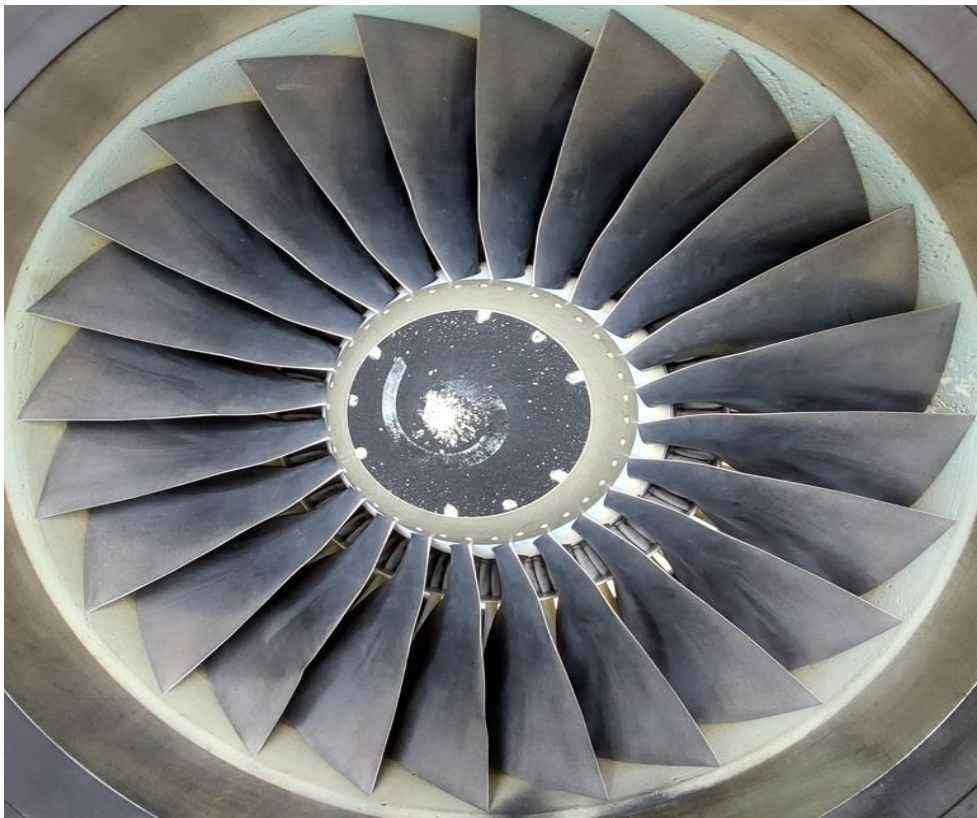
1.12.3. Post-incident investigation revealed the following: the fan blades were undamaged but still intact in their respective positions with no evidence of foreign object debris (FOD). The compressor and the stator blades were still intact in their respective positions.

Figure 20: No damage to the fan blades.

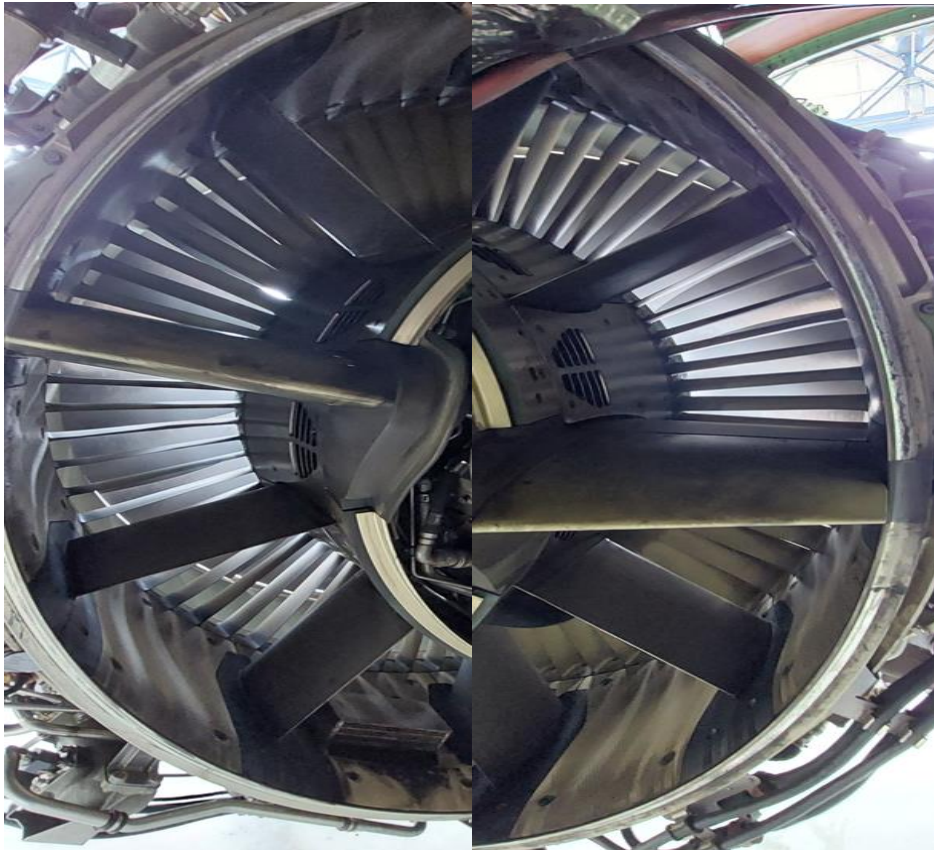
Figures 21 and 22: The compressor and the stator blades.

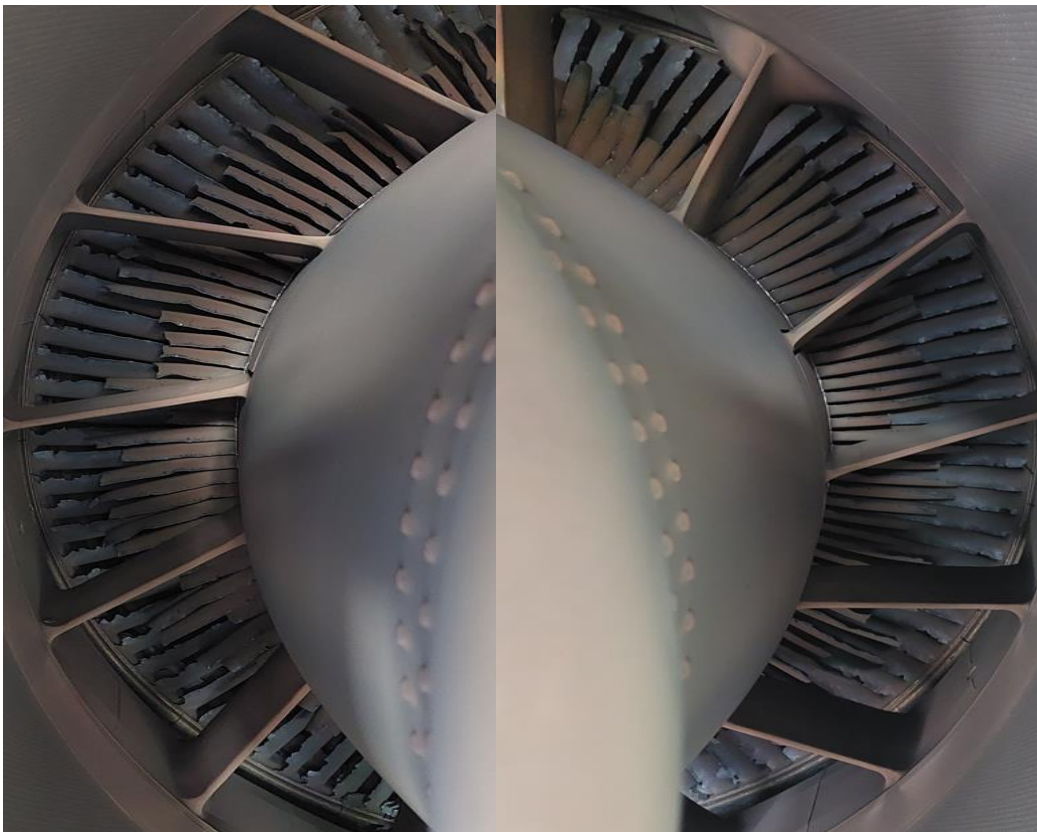
1.12.4. The low pressure turbine (LPT) blades were damaged with cuts almost at the same height all around.

Figure 23: Damaged turbine rotor blades.

- 3.2.6 During visual inspection on 10 March 2022 after the serious incident, the last stage blades of the left engine low pressure turbine were found damaged.

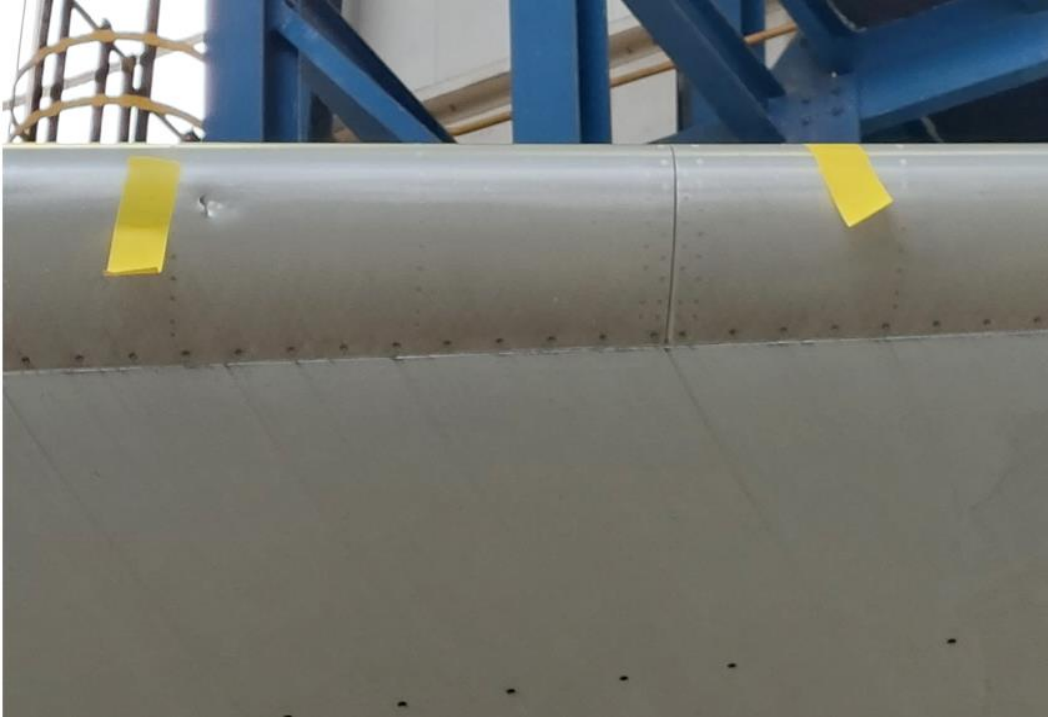
1.12.5 The left-side leading edge of the horizontal stabiliser was pierced by debris from the engine.

Figure 24: Damage to the leading edge of the left horizontal stabiliser.

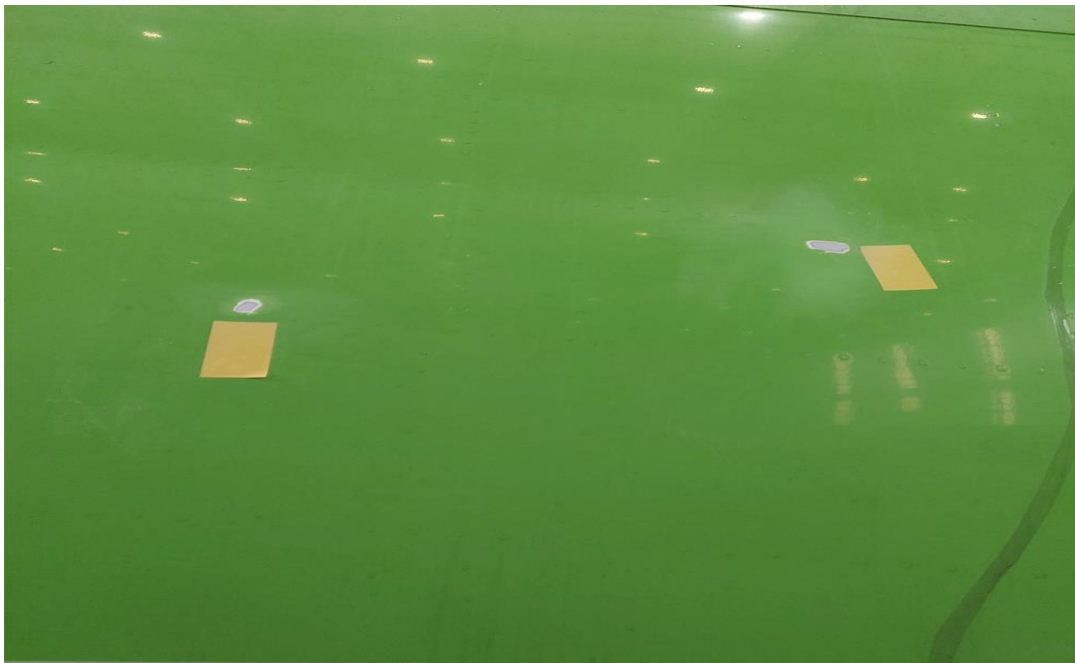
1.12.6 Debris from the engine abraded the left side of the fuselage.

Figure 25: Damage to the skin of the left-side fuselage.

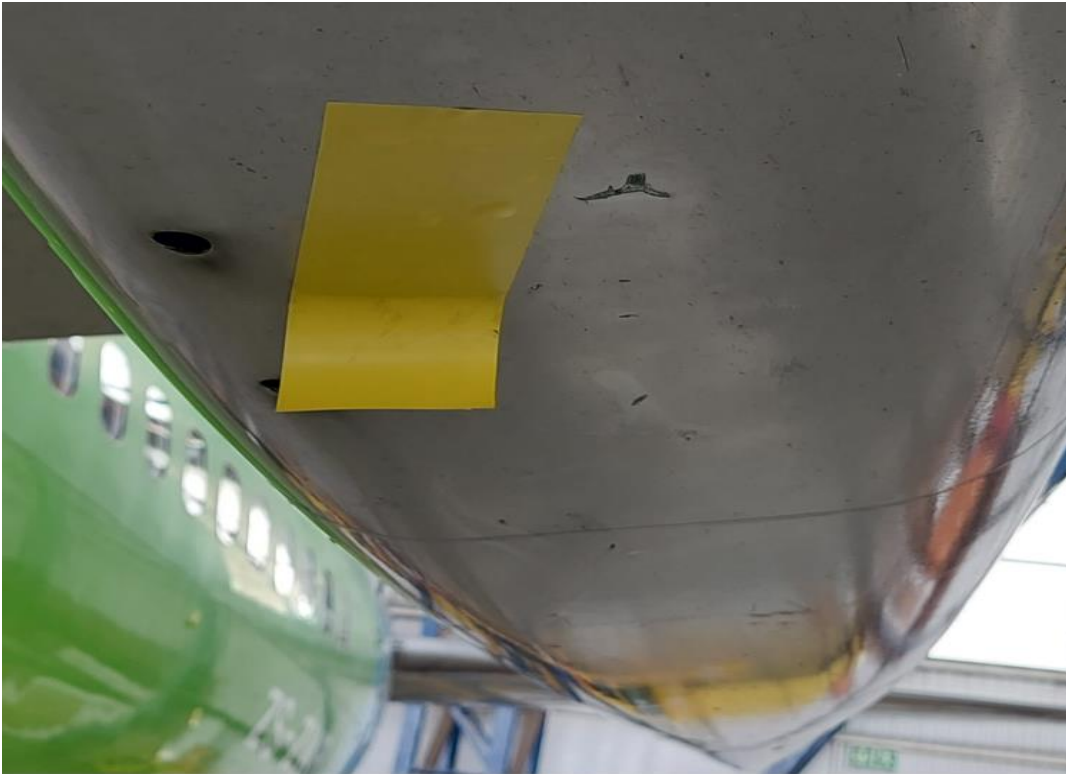
1.12.7 The left-side in-board flap fairing was abraded by debris from the engine.

Figure 26: Damage to the underside of the fuselage aft section.
