AIRCRAFT SERIOUS INCIDENT REPORT AND EXECUTIVE SUMMARY

Reference:		CA18/3/2/1398	
Aircraft Registration	ZU-FWM	Date of Incident	4 July 2022		Time of Incident	1645Z	
Type of Aircraft	Windlass Aquila 912		Type of Operation		Training (Part 141)		
Pilot-in-command Licence Type		National Pilot Licence	Age	63	Licence Valid	Yes	
Pilot-in-command Flying Experience		Total Flying Hours		7850	Hours on Type	3000	
Last Point of Departure		Oudtshoorn Aerodrome, Western Cape Province					
Next Point of Intended Landing		Oudtshoorn Aerodrome, Western Cape Province					
Damage to Aircraft		Minor					
Location of the incident site with reference to easily defined geographical points (GPS readings if possible)							
Oudtshoorn Aerodrome in the Western Cape Province, at Global Positioning System (GPS) co-ordinates determined to be 33°36'05.97" South 022°11'10.94" East, at an elevation of 1063 feet (ft)							
Meteorological Information		Wind direction: 120; Wind speed: 8kts; Visibility: CAVOK; Temperature: 20°C; Cloud cover: 0 OCTAS; Cloud base: Clear; Dew point: 11°C; QNH: 1021hPa

Reference Number	: CA18/3/2/1398
Occurrence Category	: Serious Incident
Type of Operation	: Training (Part 141)
Name o

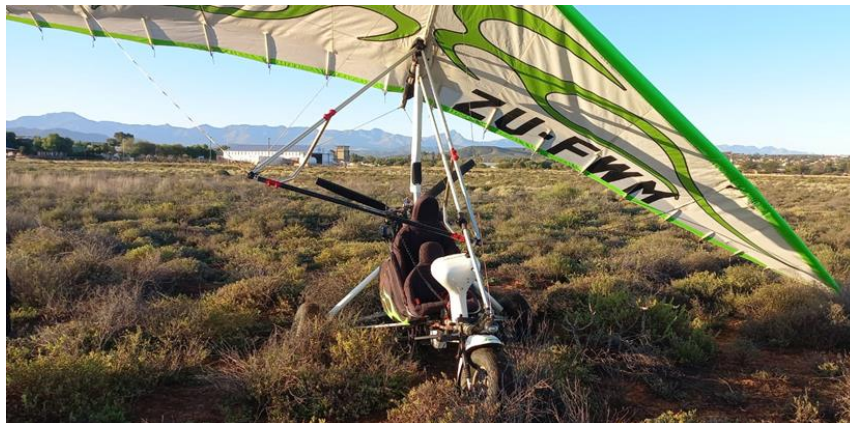
1.12.1. The aircraft landed on RWY 22 and, after exiting the active RWY whilst being taxied back to the apron on taxiway Alpha, the engine mount that supports the engine and the seats frame broke off, which caused the seats to drop down a margin. This led to the throttle cable being pulled down before it got stuck in the open position (80% power). As a result, the trike got into a high-speed taxi. The FI was unable to close the throttle because it was stuck in the open position. The FI then opted to steer the trike away from possible hazards and obstacles. Whilst the trike was careering through the rugged terrain, both carburettors fell off which caused the engine to stop operating. The trike came to a halt approximately 300 metres (m) to the right of Runway 22 at FAOH. The engine mount (Pylon) failed, and the rear axle and the radiator bracket bent during the taxi.

Figure 2: The trike on an open field post-incident. (Source: Operator)

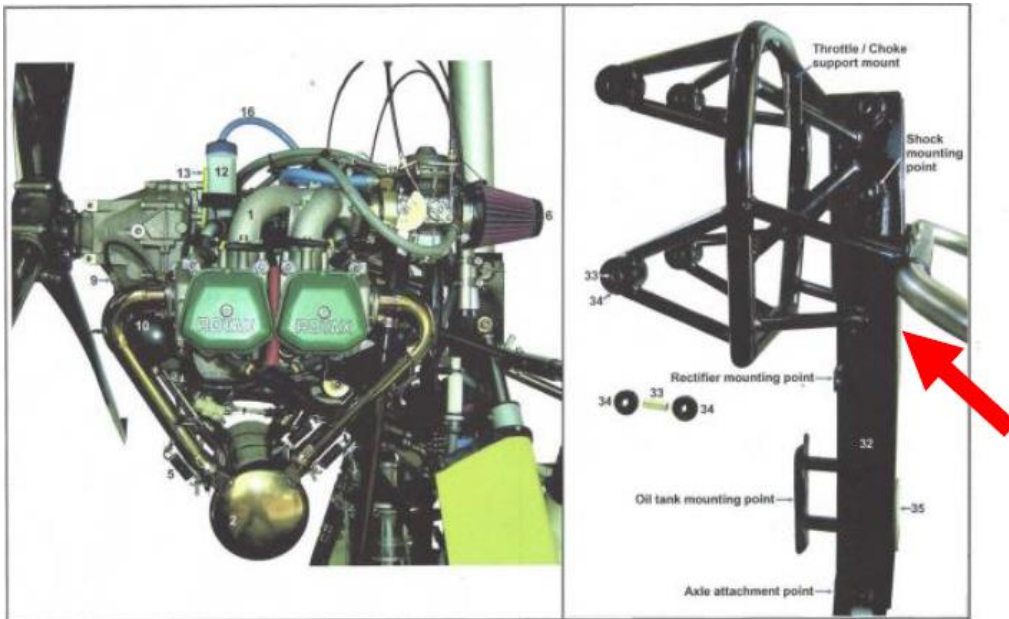
The visual inspection revealed a fracture within the vertically orientated square tube section of the engine mount (Figure 6, red arrow; Figure 7, red circles). The fracture initiated adjacent to the square tube/cross-member welded joint.

Figure 6: Engine mount assembly. (Source: University of Pretoria Report)

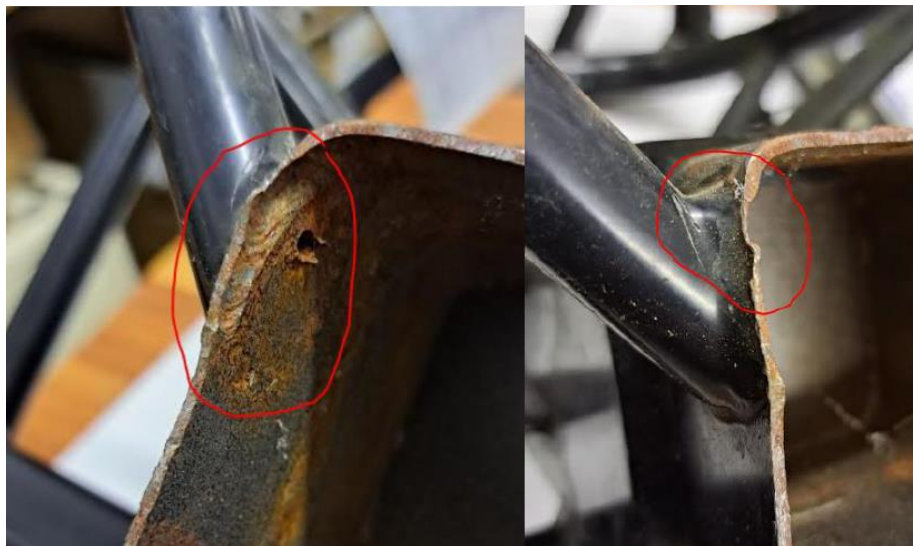
Figure 7: Engine mount fracture location. (Source: University of Pretoria Report)

The visual inspection revealed a fracture adjacent to the engine mount vertical square tube/cross-member **welded joint**.

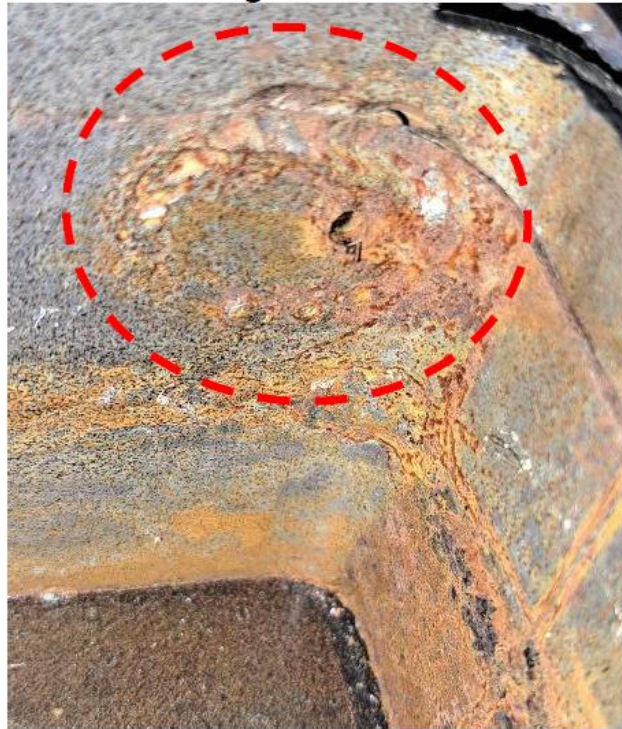
The inner area of the tube revealed clear signs of material loss (Figures 8 and 9, red dashed circles) consistent with a 'burn through' type of welding defect.

Figure 8: Inner tube area at fracture initiation point. (Source: University of Pretoria Report)

4.2.1 The manufacturer issued an Alert Service Bulletin 0001 for the inspection of the 912 series, engine bracket mounts advising owners and operators to conduct a thorough inspection for any cracks on the engine bracket and specifically along all welding joints. Owners are to pay careful attention for fatigue corrosion, and any form of burn-through

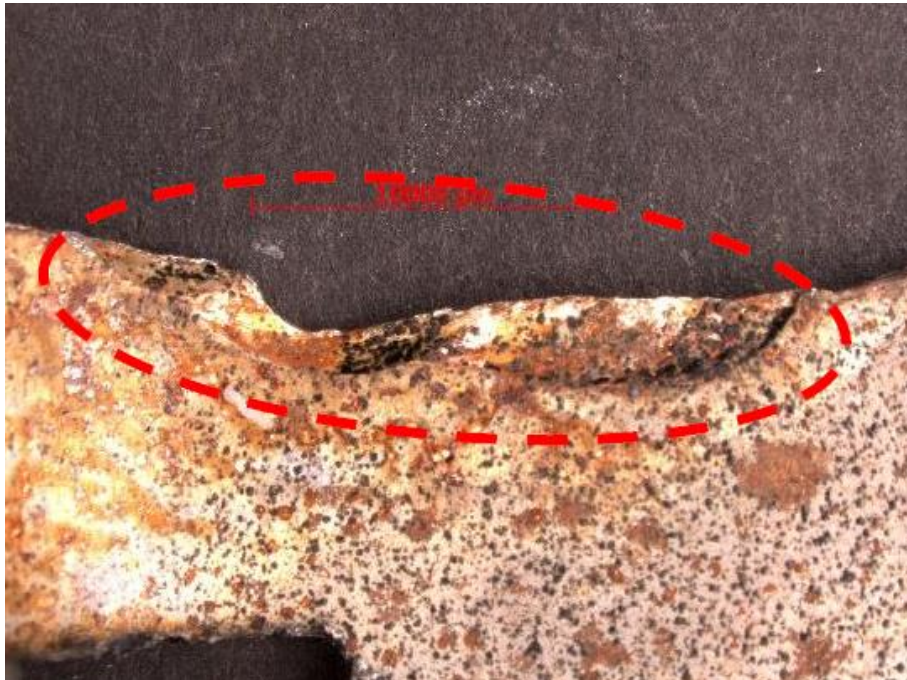
Figure 9: Inner tube area showing signs of burn-through. (Source: University of Pretoria Report)

3.4.2 Burn-through welding as a result of excessive heat during welding which blew holes through the centre of the metal and, consequently, reduced the thickness of the metal.

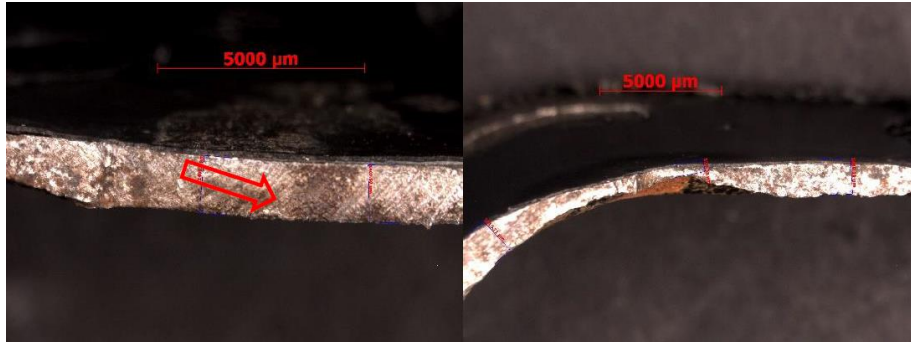
This defect resulted in a significant loss of wall thickness to the square tube (Figure 10) of $\pm 78\%$.

Figure 10: Dimensions, loss of wall thickness. (Source: University of Pretoria Report)

A welding defect closely corresponding to ‘burn-through’ resulted in a localized **loss of wall thickness to a maximum of $\pm 78\%$** . This resulted in an increase in the **localized stress** (Stress = Load/Area) during operation which in turn resulted in the initiation of a fracture. On reaching **critical-crack-size**, the fracture progressed under a predominantly **fatigue mode** over an undetermined period till final fracture.

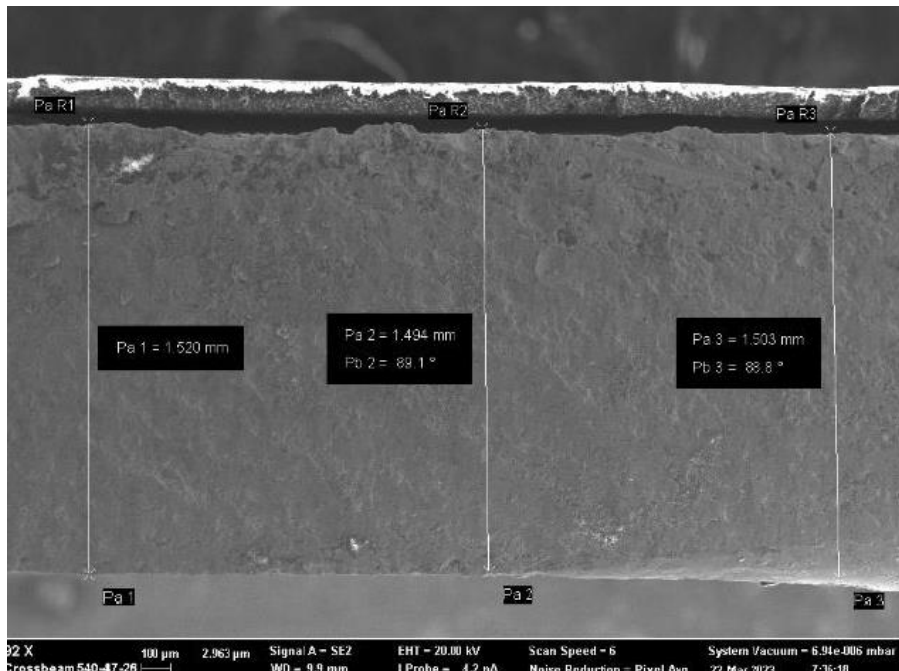
The higher magnification inspection confirmed the extensive loss of wall thickness.

Figure 11: Original wall thickness (92X,20kV, SE, FEGSEM).
(Source: University of Pretoria Report)

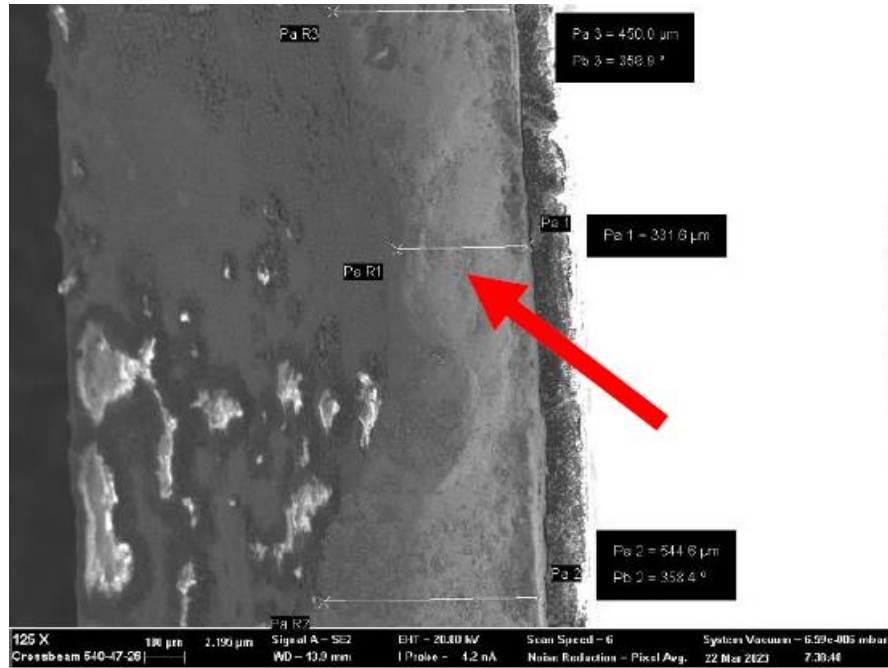
Figure 12: Loss of wall thickness (125X, 20kV, SE, FEGSEM).
(Source: University of Pretoria Report)

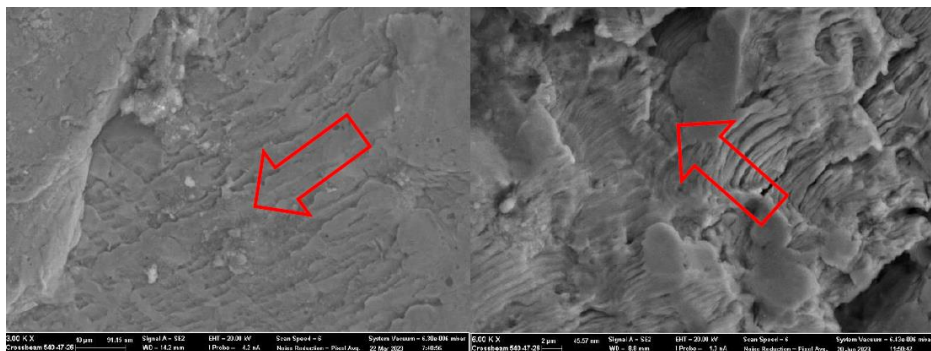
*The presence of fatigue induced striations supports the conception of a predominant **fatigue** failure mode.*

Figure 13: Fatigue induced striations (3000-6000X, 20kV, SE, FEGSEM).
(Source: University of Pretoria Report)

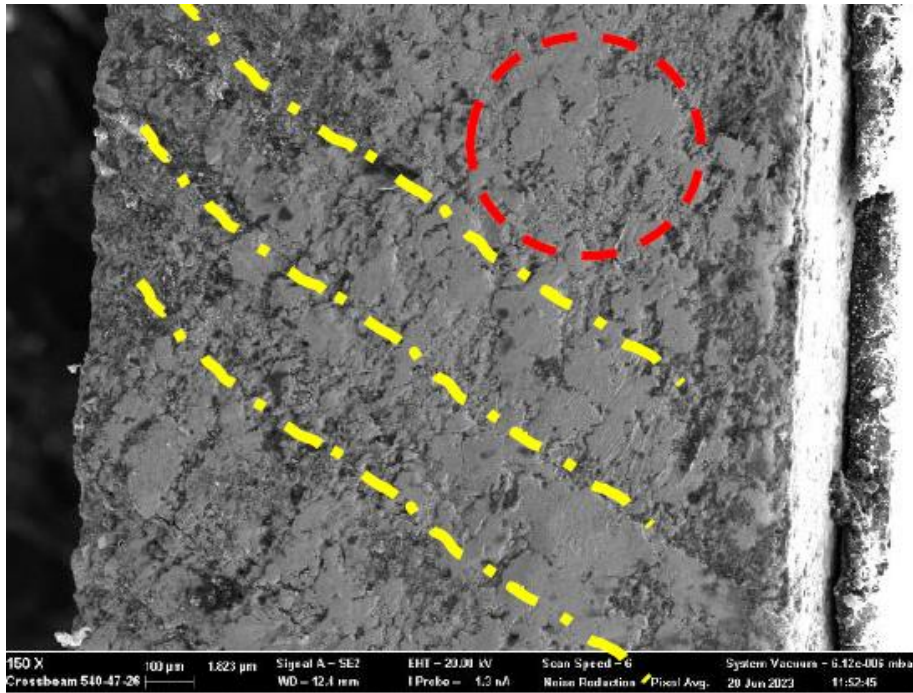
*At low magnifications clear indications 'beach-marks' were noted with a progression direction expanding from the weld defect. This is indicative of a **fatigue** failure mode.*

The EDS MAP result revealed extensive fracture surface contamination consistent with environmental exposure. This, combined with the noted mechanical damages to

the fracture surface, support the notion that the fracture progressed over an undetermined period till final fracture.

Figure 14: Surface beach marks and mechanical damage (150X, 20kV, SE, FEGSEM).
(Source: University of Pretoria Report)
