LIMITED OCCURRENCE INVESTIGATION REPORT – FINAL

Reference Number	CA18/3/2/1400						
Classification	Serious Incident	Date	11 July 2022	Time	0815Z		
Type of Operation	Training Flight (Part 141)						
Location							
Place of Departure	Wonderboom Aerodrome (FAWB), Gauteng Province		Place of Intended Landing	Wonderboom Aerodrome (FAWB), Gauteng Province			
Place of Occurrence	On Runway 11 at Wonderboom Aerodrome (FAWB)						
GPS Co-ordinates	Latitude	S 25°39'12.54"	Longitude	E 028°13'15.05"	Elevation	4 058 feet (ft)	
Aircraft Information							
Registration	ZS-JBO						
Make; Model; S/N	Cessna; 172M (Serial Number: 172-63614)						
Damage to Aircraft	Minor		Total Aircraft Hours (Tacho)	6 644.9			
Pilot-in-command							
Licence Type	Student Pilot Licence (SPL)		Gender	Female		Age	20
Licence Valid	Yes	Total Hours	53.4		Total Hours on Type	32	
Total Hours 90 Days	29.4		Total Flying on Type Past 90 Days	6.7			
People On-board	1 + 0	Injuries	0	Fatalities	0	Other (on ground)	0

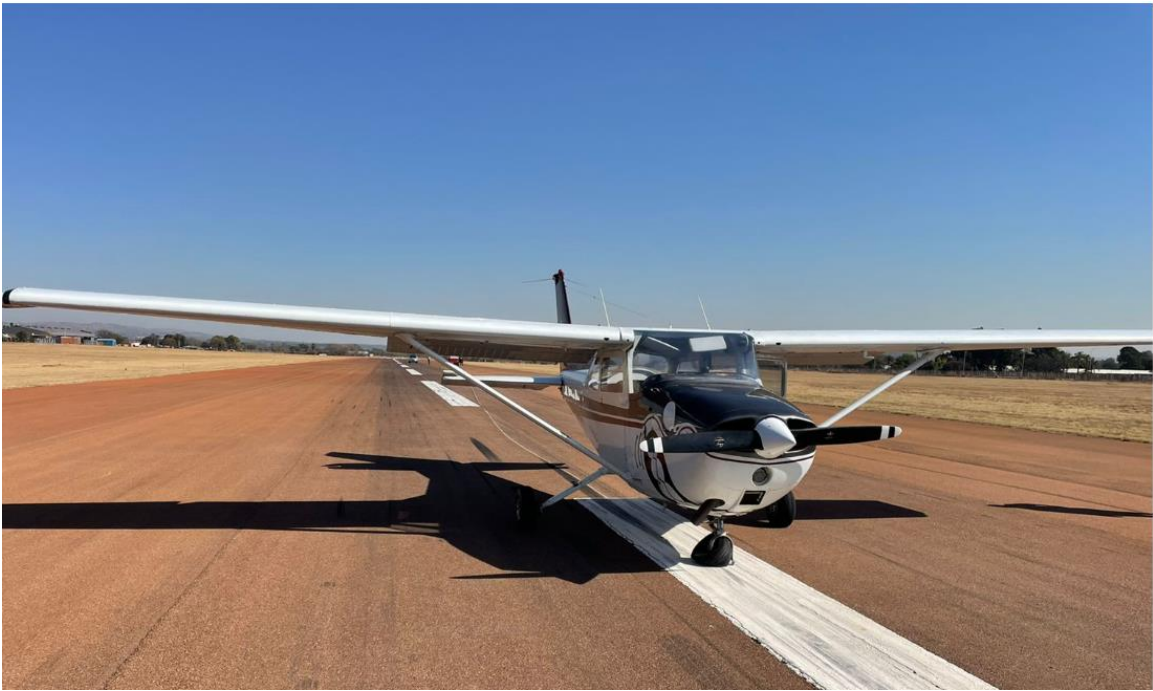
Figure 1: The aircraft after the serious incident. (Source: Operator)

The aircraft was too high on final approach, which resulted in a deep and hard landing before it bounced and touched down with its nose landing gear wheel first. This resulted in damages to the nose wheel hubs and the tyre assembly.

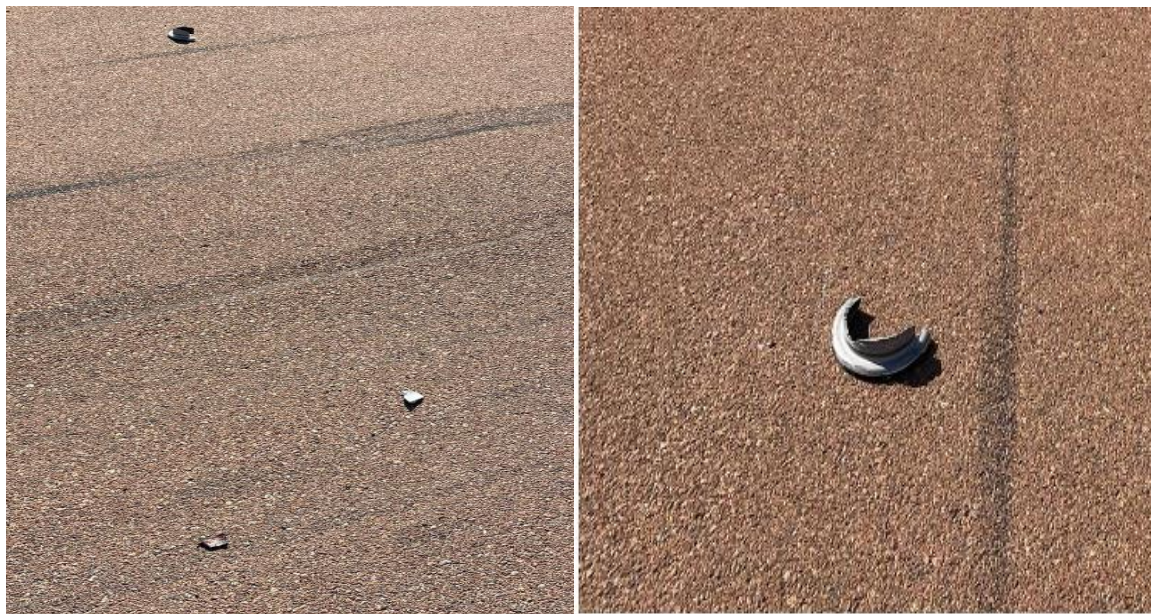
Figures 2 and 3: Left and right nose wheel hub debris. (Source: Operator)
