LIMITED OCCURRENCE INVESTIGATION REPORT – FINAL

Reference Number	CA18/3/2/1403						
Classification	Serious Incident	Date	19 July 2022		Time	0800Z	
Type of Operation	Training (Part 141)						
Location							
Place of Departure	Wonderboom Aerodrome (FAWB), Gauteng Province		Place of Intended Landing	Wonderboom Aerodrome (FAWB), Gauteng Province			
Place of Occurrence	On Runway 11 at Wonderboom Aerodrome (FAWB), Gauteng Province						
GPS Co-ordinates	Latitude	25°39'11"South	Longitude	28°13'05"East	Elevation	4 048ft	
Aircraft Information							
Registration	ZS-SDA						
Make; Model; S/N	Cessna C172P (Serial Number: 172-76251)						
Damage to Aircraft	Minor		Total Aircraft Hours	4662.3			
Pilot-in-command							
Licence Type	Student Pilot Licence (SPL)		Gender	Female		Age	20
Licence Valid	Yes	Total Hours	55		Total Hours on Type	55	
Total Hours 30 Days	31.9		Total Flying on Type Past 90 Days	31.9			
People On-board	1 + 0	Injuries	0	Fatalities	0	Other (on ground)	0

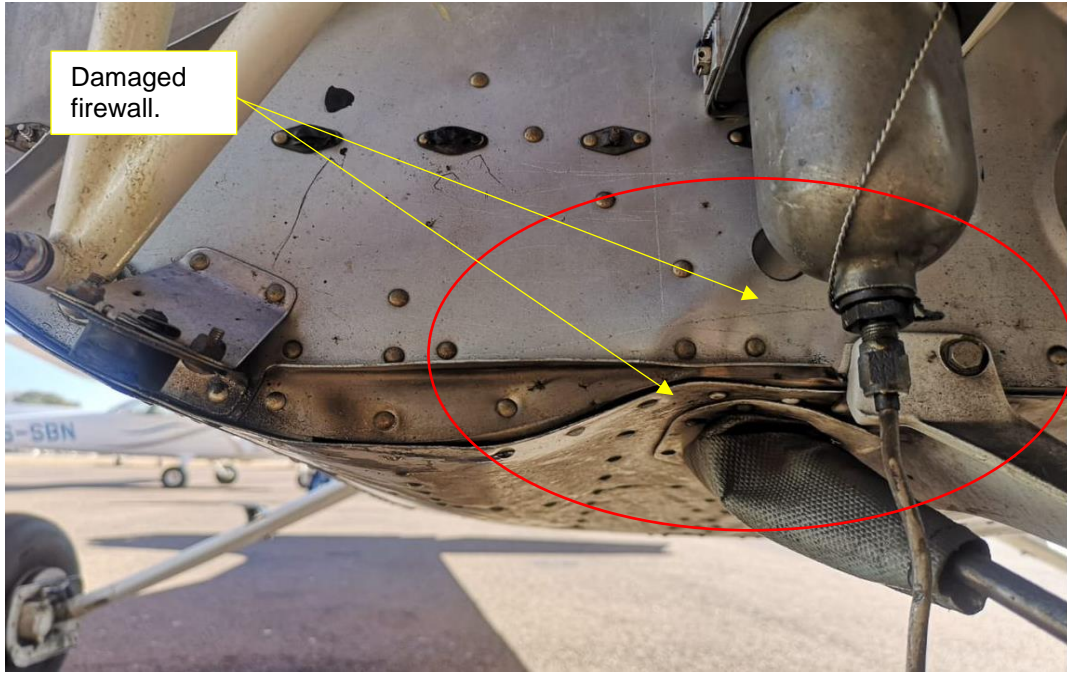
Figure 1: The bent firewall. (Source: Operator)

- (v) The aircraft's bottom left-side firewall was substantially damaged; however, the occupant did not sustain any injuries during the serious incident.

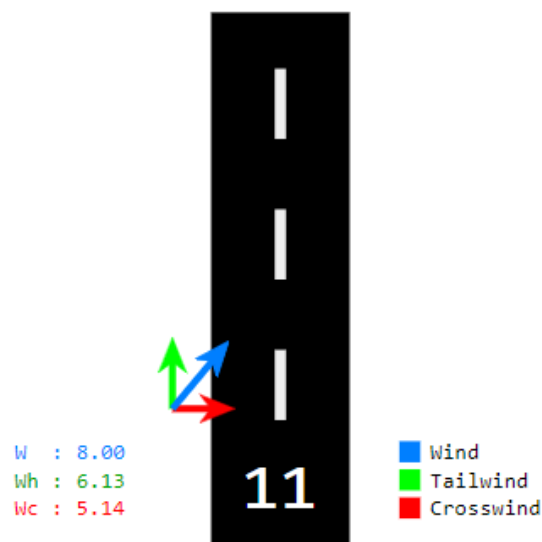
- (vi) The wind on the runway in use at the time was not favourable for the pilot to land. The official weather report from the South African Weather Service (SAWS) was as follows:
METAR: FAWB 190800Z 33008KT CAVOK 16/07 Q1027.
There was a 5kt left crosswind component and a 6kt tailwind component when the student pilot landed on Runway 11.

Figure 3: The crosswind component as per the weather report. (Source: <https://e6bx.com>)
