**LIMITED OCCURRENCE INVESTIGATION REPORT – FINAL**

| <b>Reference Number</b> | CA18/3/2/1404 | | | | | | |
| Registration | ZU-FUS | | | | | | |
| Make; Model; S/N | Sling Aircraft, Sling 2 (Serial Number: 080) | | | | | | |

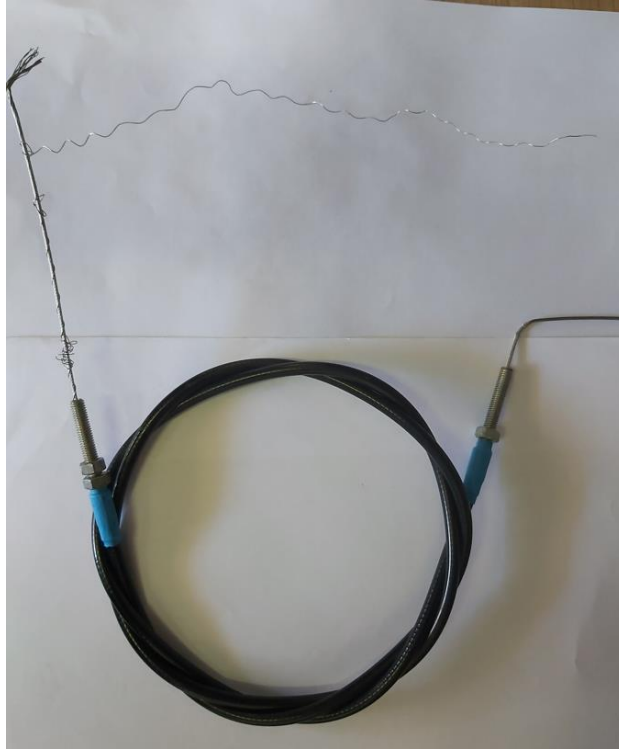
An approved person (AP) who came to inspect the aircraft following the forced landing reported that one of the cable strands of the throttle cable snapped, preventing the cable from travelling fully as commanded, therefore, this resulted in the throttle cable being stuck on partial power (not advancing to full power). The throttle cable was replaced with a serviceable cable at the incident site. Thereafter, the engine ground run was conducted and indicated no anomalies with the RPM at different power settings. The aircraft was later flown back to FAPE without further anomalies.

**Figure 1:** Throttle cable with broken/lose strands.

9. Post-examination of the throttle cable revealed that some of the cable strands snapped from where they attach to the quadrant. The cable exhibited compression loads caused by the washer (Figure 2) and guillotined at both ends of the compression loads. The cable strand snapped on the weak points, unwound, and coiled around the cable inside the sleeve, thus, restricting movement when the throttle lever was advanced (increased) during the exercise. It is likely that during the throttle cable installation, the attaching hardware (AN3 low profile nut) was overly tightened/torqued. The torque value required to tighten the nut is 4 Newton-meters (Nm) according to the BRP Rotax Manual (connections for Bowden cable throttle actuation and permissible load). The throttle cable is an on-condition item inspected every 100-hour as per the Sling 2 Maintenance Manual, Revision 2.9 dated 10 November 2021.

In-flight failure of the throttle cable led to limited engine power because of the strand that had lodged into the cable insulation, limiting throttle movement.

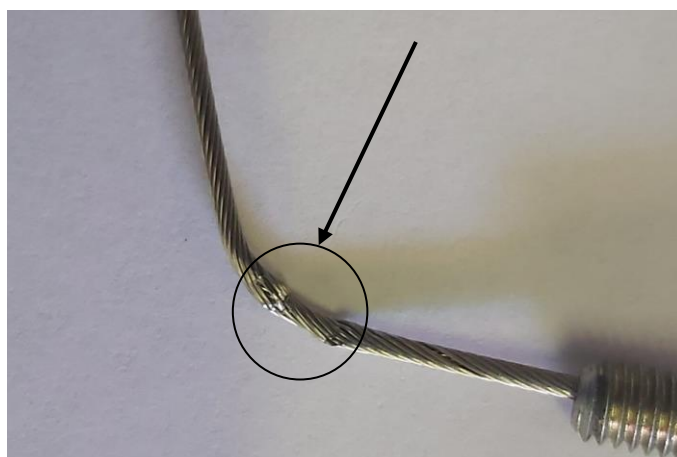
**Figure 2:** The indentation imprint caused by the washer.

- Improper maintenance inspection of the throttle cable led to limited engine power due to the failed cable strand that was lodged into the protective insulation of the cable.
- Incorrect torque of the cable securing the nut and bolt, resulting in the failure of the cable strand.

Safety Recommendation: It is recommended that the manufacturer update the SB and include torque values and tools to be used during the installation of the cable to eliminate any ambiguity and misinterpretation of instructions by the end user.

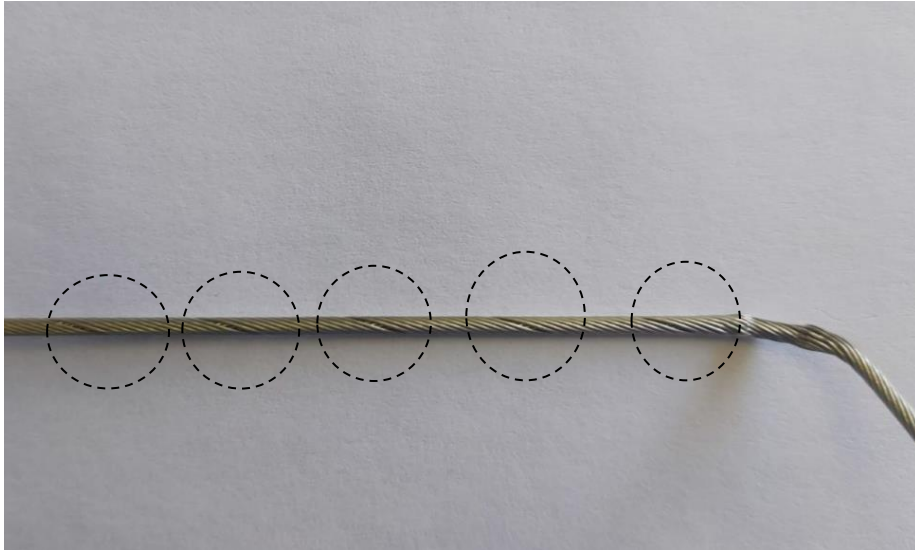
**Figure 3:** Circles showing the gap left by the missing cable strand.

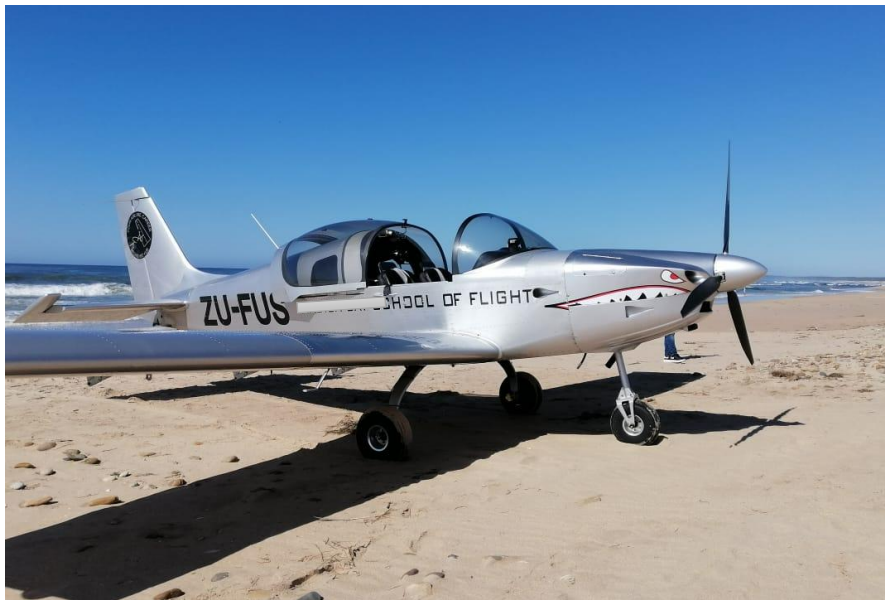
The instructor elected to execute a forced landing at the beach on the river mouth of Sunday River. The aircraft landed safely without further incidents. The aircraft was not damaged, and both occupants were not injured.

**Figure 4:** The aircraft as it came to a stop on the river mouth. (Source: Operator)
