LIMITED OCCURRENCE INVESTIGATION REPORT – FINAL

Reference Number	CA18/3/2/1405						
Classification	Serious Incident	Date	13 February 2023	Time	0838Z		
Type of Operation	Private (Part 91)						
Location							
Place of Departure	Delta 200 Airfield (FADX), Western Cape Province		Place of Intended Landing	Delta 200 Airfield (FADX), Western Cape Province			
Place of Occurrence	On a private road, approximately 2 nautical miles (nm) north of FADX, Western Cape Province.						
GPS Co-ordinates	Latitude	33°36' 46.91" S	Longitude	018°27' 33.33" E	Elevation	220 ft	
Aircraft Information							
Registration	ZS-ZGZ						
Make; Model; S/N	Cessna U206C Super Skywagon (Serial Number: U206-1003)						
Damage to Aircraft	None		Total Aircraft Hours	11 342.8			
Pilot-in-command							
Licence Type	Commercial Pilot Licence (CPL)		Gender	Male		Age	21
Licence Valid	Yes	Total Hours	266.9		Total Hours on Type	130.9	
Total Hours Past 30 Days	17		Total Flying Hours on Type Past 90 Days	124.5

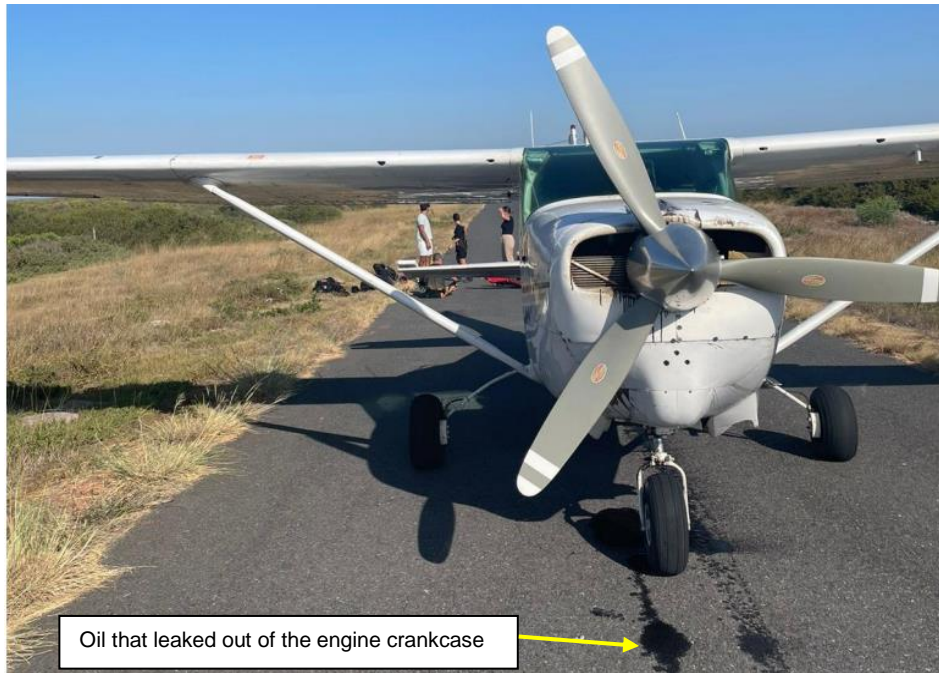
Approximately after exiting the TMA at 3 000 AGL, the pilot heard a loud bang coming from the engine. This was followed by oil splashing on the windscreen. The pilot followed the engine failure procedure as outlined in the Pilot's Operating Handbook (POH) and switched off the engine. He then broadcasted a Mayday call on the TIBA (uncontrolled airspace traffic information broadcasts by aircraft) on frequency 124.80 MHz whilst preparing for a forced landing. Through the limited visual on the left side of the windscreen, the pilot spotted a road passing through the industrial area. He then glided the aircraft towards the road and performed a successful forced landing approximately 2 nautical miles (nm) north of FADX. The pilot and the passengers were uninjured; they exited the aircraft without assistance.

Figure 2: The aircraft on the public road after the forced landing. (Source: Operator)

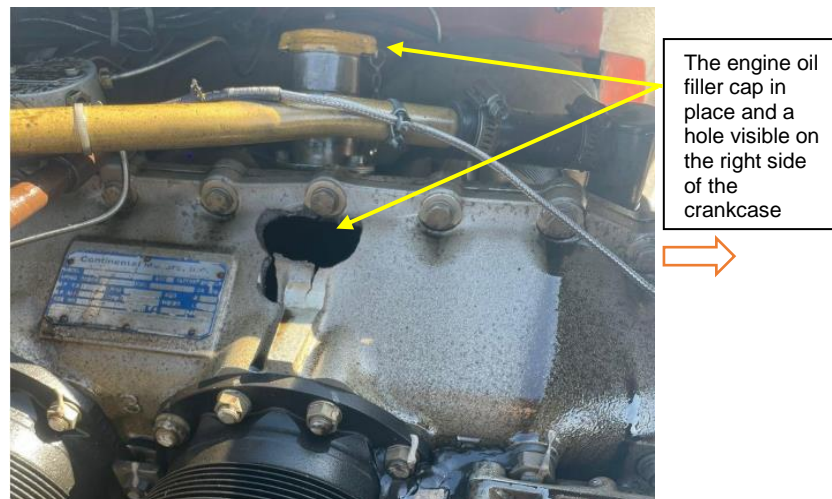
The engine was inspected before the aircraft was recovered to Stellenbosch Aerodrome (FASH) in the Western Cape province. The engine oil filler cap remained in place. The engine-driven oil pump and oil supply lines were intact. The crankcase had a hole at the top-right side in line with the No.5 piston area (right front). It was evident from the outside view that the hole at the top-right side of the crankcase was caused by the No.5 connecting rod inside the crankcase. The connecting rod shaft was 'spotted' inside the engine, adjacent to the hole. Oil was forced out of the crankcase and it escaped through the gaps in the engine cowling and contaminated the aircraft's windscreen. Some fragments of the connecting rod were ejected through the hole and were strewn on the cooling baffles between the cylinders. There was a significant amount of oil remaining in the sump; a sample of the oil was taken for analysis.

Figure 3: A hole on the right crankcase and the oil filler cap. (Source: AMO)

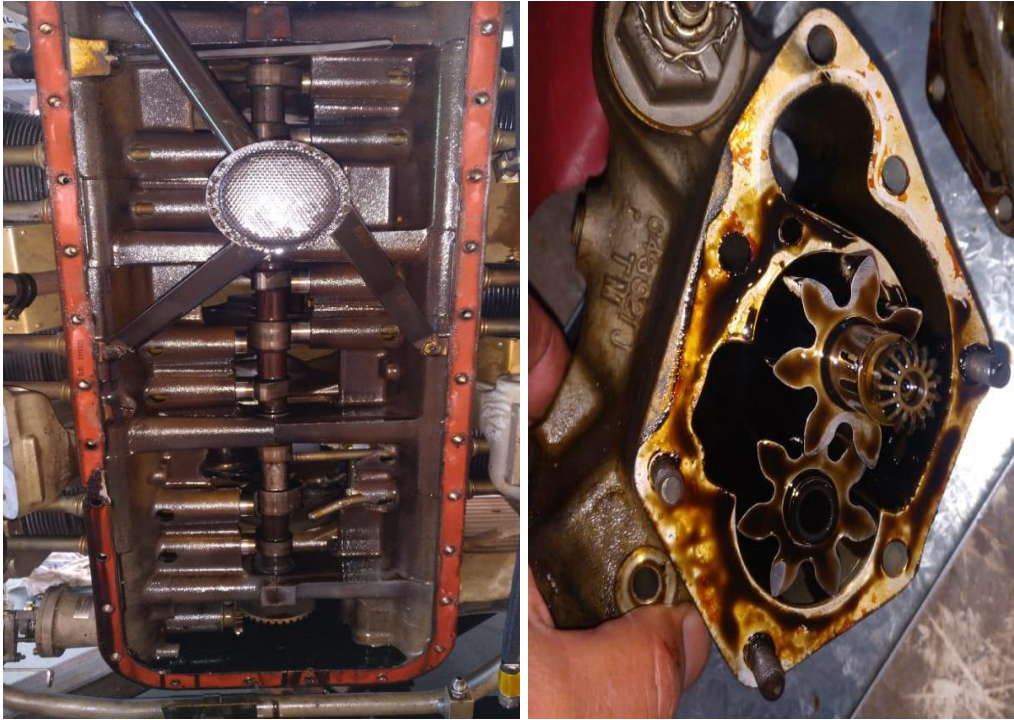
After the oil sump was removed, a large amount of metallic debris was found in the sump, but no significant debris was found that could have originated from external components of the engine. A significant quantity of oil remained in the engine sump and the oil sump pick-up was free of metal particles and/or other contamination. The engine-driven oil pump did not show any signs of abnormal wear.

Figures 4 and 5: A picture of the engine oil sump pick up (left). The engine-driven oil pump (right).

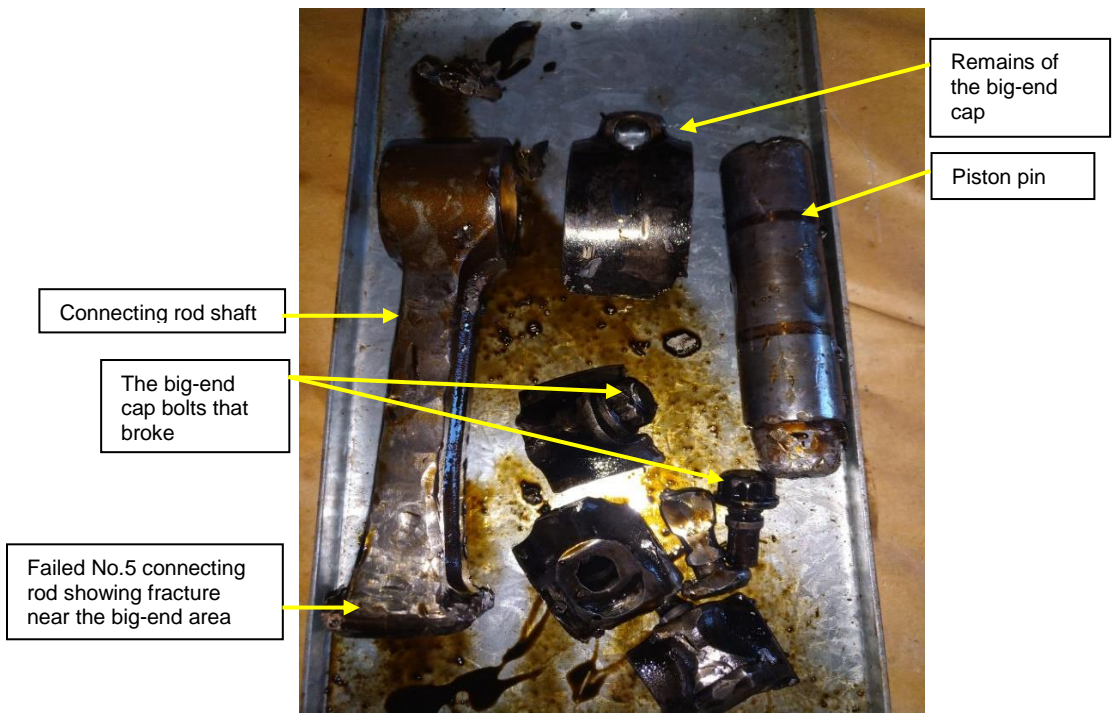
A detailed examination of the engine components revealed that the steel backed copper/lead alloy lined big-end (main) bearing for the No.5 connecting rod had failed, dislodging the connecting rod. This resulted in severe localised damage in the engine. Fragments of a failed connecting rod big-end cap, bearing shells and bolts were found inside the engine. Evidence showed that the No.5 connecting rod fractured near the big-end area. Fragments of the No.5 piston, bushings, piston pin and associated snap rings were found in the oil sump, an indication that the piston skirt was knocked (several times) by the failing No.5 connecting rod until the piston pin separated from the small end. The torque values for all other connecting rods big-end cap nuts were checked and found to be at the required figures as recommended in the operator's manual.

Figure 6: Damaged No.5 piston connecting rod. (Source: AMO)

(xii) Examination of the engine components revealed that the steel backed copper/lead alloy lined big-end (main) bearing for the No.5 connecting rod had failed. The connecting rod detached which resulted in severe localised damage in the engine.
(xiii) No person was injured during the serious incident sequence.
Probable Cause
Successful forced landing on a road after an engine failure that seemed to have been initiated by the failed No.5 big-end bearing, which produced debris that blocked the pressurised oil supply line on the journal area; this led to lack of lubrication.
Contributing Factor
Unknown.
Safety Action(s)
None.
Safety Message and/or Safety Recommendation/s
None.
About this Report
<i>The decision to conduct a limited investigation is based on factors including whether the cause is known and the evidence supporting the cause is clear, the level of safety benefit likely to be obtained from an investigation and that will determine the scope of an investigation. For this occurrence, a limited investigation has been conducted, and the Accident and Incident Investigations Division (AIID) has relied on the information submitted by the affected person/s and organisation/s to compile this limited report. The report has been compiled using information supplied in the initial notification, as well as from follow-up desk top enquiries to bring awareness of potential safety issues to the industry in respect of this occurrence, as well as possible safety action/s that the industry might want to consider in preventing a recurrence of a similar occurrence.</i>

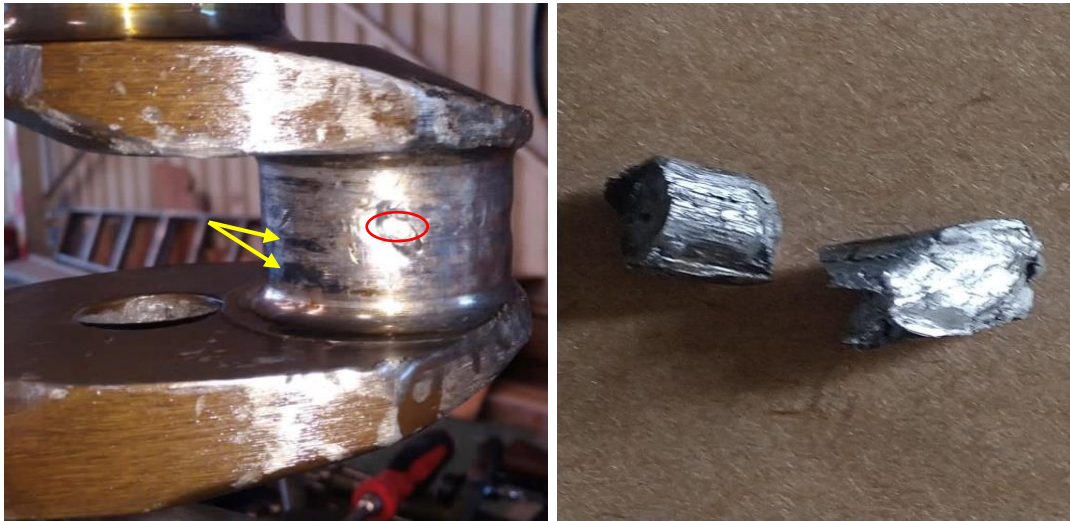
There was evidence of severe heat damage (discolouration) on the No.5 big-end bearing (main) which resulted from a lack of lubrication in the region of the No.5 connecting rod journal surface area. Examination of the engine crankshaft journal revealed a blocked oil supply hole to the No.5 big-end main bearing which contributed to oil starvation and lack of lubrication. This blockage of the pressurised oil flow seemed to have been caused by a failed big-end bearing (main) which further initiated a progressive loosening of the clearance at the journal area, which allowed a gradual increase in piston stroke and increased the contact between the piston and valves. This looseness caused repeated reaction forces on the No.5 big-end bearing, pounding them until the fatigue crack extended to the shells, and breaking them. The journal surface then continued to overheat and to elongate until the connecting rod end cap bolts broke. The material that blocked the oil passage was non-metal and seemed to have originated from the soft bearing lining material (copper lead). Measurements of the engine journal diameters were consistent with the correct bearings having been used or installed on all six big-ends during assembly.

Figures 7 and 8: The crankshaft journal surface showing a blocked oil supply hole (red circle) and discolouration (left picture). The non-metal debris extracted from the hole (right picture).
(Source: AMO)

- (xi) The engine teardown inspection revealed a blocked oil supply channel/oil on the No.5 connecting rod journal surface area.
