**LIMITED OCCURRENCE INVESTIGATION REPORT – FINAL**

<b>Reference Number</b>	CA18/3/2/1406						
<b>Classification</b>	Serious incident	<b>Date</b>	18 February 2023	<b>Time</b>	0915Z		
<b>Type of Operation</b>	Private (Part 91)						
<b>Location</b>							
Place of Departure	Silver Creek Airfield, North West Province		Place of Intended Landing	Silver Creek Airfield, North West Province			
Place of Occurrence	Left of Runway 08 at Silver Creek Airfield in the North West Province						
GPS Co-ordinates	Latitude	25°47'55.42" S	Longitude	27°31'14.02" E	Elevation	4360 ft	
<b>Aircraft Information</b>							
Registration	ZS-MUD						
Make; Model; S/N	Piper PA-28R (Serial Number: 28R-7837202)						
Damage to Aircraft	Minor			Total Aircraft Hours	6354.62		
<b>Pilot-in-command</b>							
Licence Type	Commercial Pilot Licence (CPL)		Gender	Male		Age	60
Licence Valid	Yes	Total Hours	9220.1		Total Hours on Type	116.9	
Total Hours Past 30 Days	0.5		Total Flying Hours on Type Past 90 Days	25.5

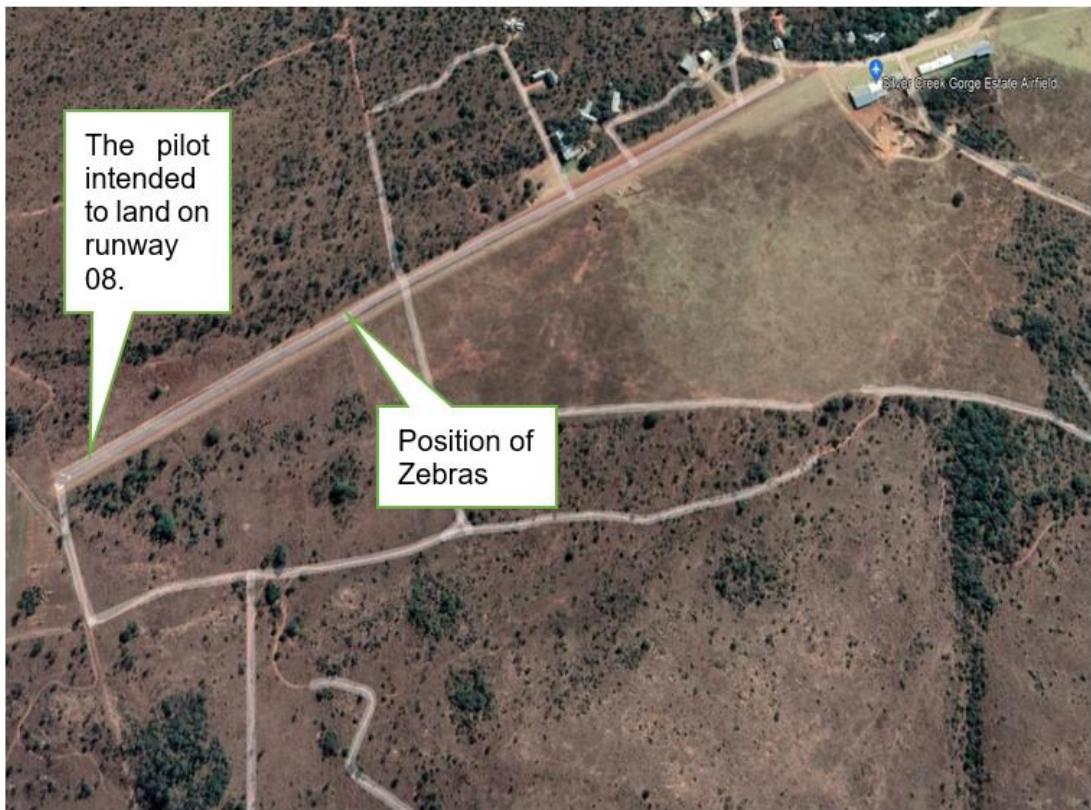
**Figure 1:** The approximate position of the animals on the runway. (Source: Google Earth)

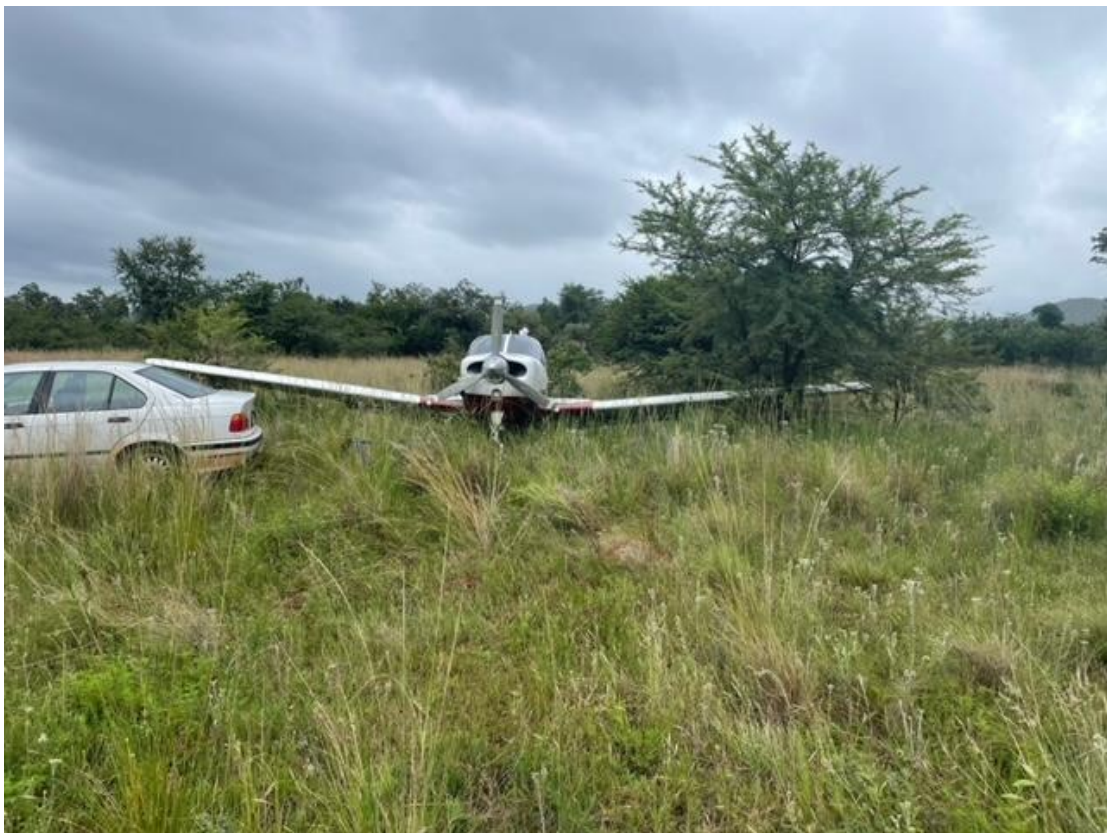
**Figure 2:** The aircraft as it came to rest post-incident. (Source: Pilot)

It is possible that due to poor visibility, the pilot was unable to see the Zebras on the runway which caused him to apply hard brakes on the wet runway. This caused the aircraft to veer off to the left, and the aircraft came to a stop in a nearby bush.

During landing on the wet runway, the pilot applied hard brakes which led to loss of control. The aircraft subsequently veered off to the left of the runway before it came to a stop in a nearby bush.

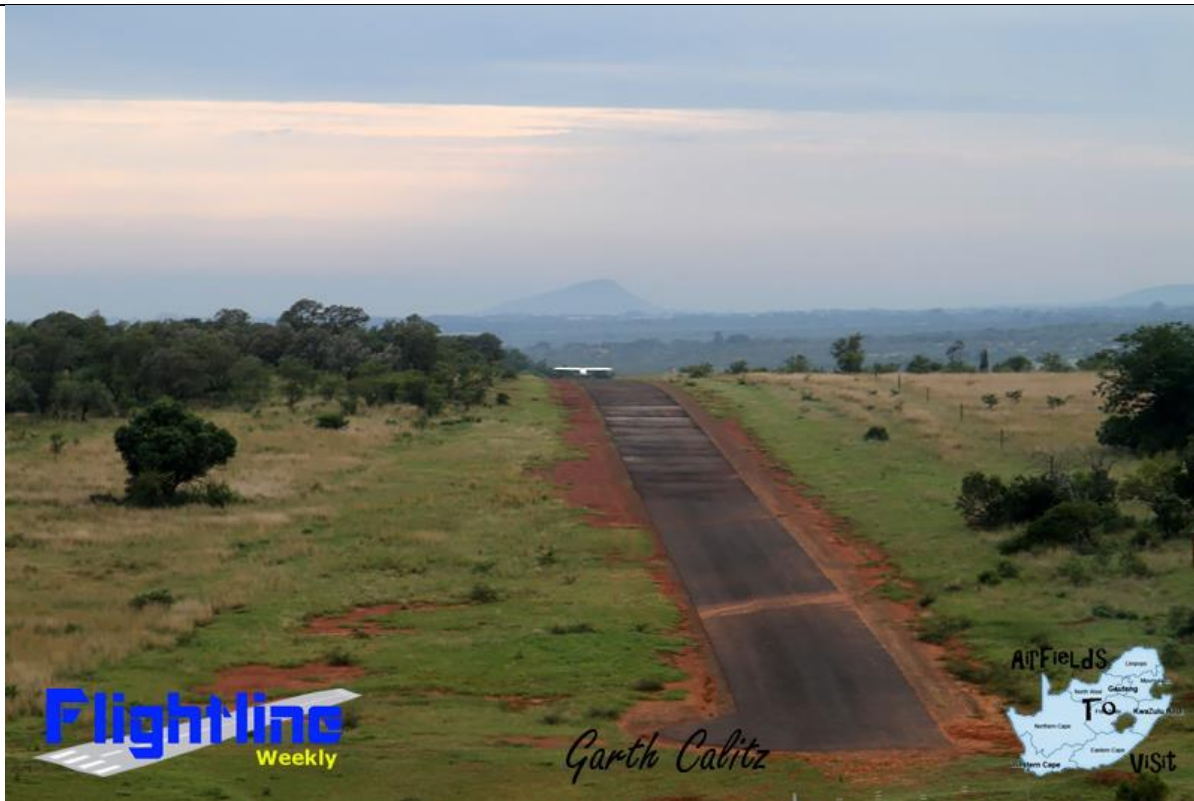
**Figure 4:** The runway at Silver Creek Airfield. (Source: <https://www.flightlineweekly.com/post>)
