**LIMITED OCCURRENCE INVESTIGATION REPORT – FINAL**

<b>Reference Number</b>	CA18/3/2/1407						
<b>Classification</b>	Serious Incident	<b>Date</b>	7 March 2023	<b>Time</b>	1745Z		
<b>Type of Operation</b>	Private (Part 91)						
<b>Location</b>							
<b>Place of Departure</b>	Witbank Airport (FAWI), Mpumalanga Province		<b>Place of Intended Landing</b>	Ultimate Heliport, Gauteng Province			
<b>Place of Occurrence</b>	Esselen Park Substation, Kempton Park, Gauteng Province						
<b>GPS Co-ordinates</b>	Latitude	S 26°00'19"	Longitude	E 28°16'05"	Elevation	5040ft	
<b>Helicopter Information</b>							
Registration	ZT-RHB						
Make; Model; S/N	Robinson R66 (Serial Number: 0082)						
Damage to Helicopter	None		Total Helicopter Hours	1076			
<b>Pilot-in-command</b>							
Licence Type	Commercial Pilot Licence (CPL) Helicopter		Gender	Male	Age	36	
Licence Valid	Yes	Total Hours	4747.1	Total Hours on Type	1400		
Total Hours Past 30 days	12		Total Hours on Type Past 90 days	42.4

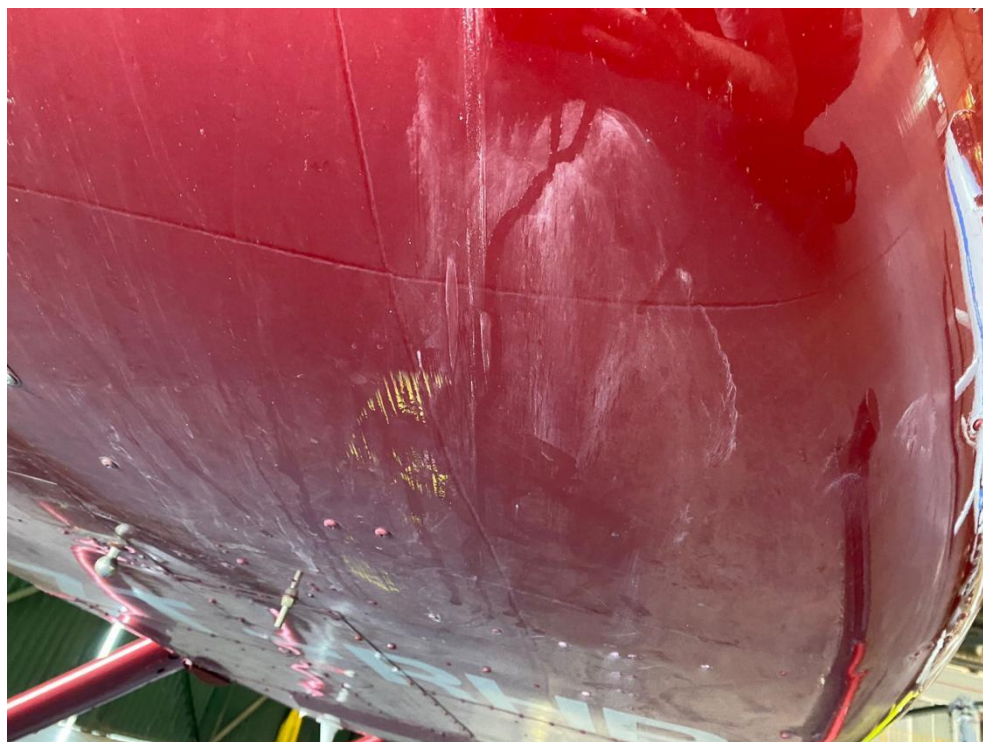
inspected the helicopter and found yellow paint markings on the front of the lower cowling. There was no damage to the helicopter and no persons were injured. The crew continued with the flight to FAGM.

**Figure 1:** Yellow markings on the front of the lower cowling. (Source: Operator)
