AIRCRAFT SERIOUS INCIDENT REPORT AND EXECUTIVE SUMMARY

Reference:		CA18/3/2/1408	
Aircraft Registration	ZS-PKB	Date of Incident	10 March 2023	Time of Incident	0855Z		
Type of Aircraft	Beechcraft 1900D			Type of Operation	Commercial (Part 135)		
Pilot-in-command Licence Type	Airline Transport Pilot Licence (ATPL)		Age	27	Licence Valid	Yes	
Pilot-in-command Flying Experience	Total Flying Hours		1680.1	Hours on Type	43.0		
Last Point of Departure	O.R. Tambo International Airport (FAOR), Gauteng Province						
Next Point of Intended Landing	Margate Airport (FAMG), KwaZulu-Natal Province						
Damage to Aircraft	Minor						
Location of the incident site with reference to easily defined geographical points (GPS readings if possible)							
Global Positioning System (GPS) co-ordinates determined to be 26° 08'16" South (S) 028°13'47"East (E), at an elevation of 5 557.743 feet (ft) above ground level (AGL)							
Meteorological Information							
Number of People On-board	2+19	Number of People Injured	0	Number of People Killed	0	Other (On Ground)	0

Reference Number	: CA18/3/2/1408
Occurrence Category	: Category 1
Type of Operation	: Commercial (Part 135)
Name of Operator	: CemAir
Aircraft

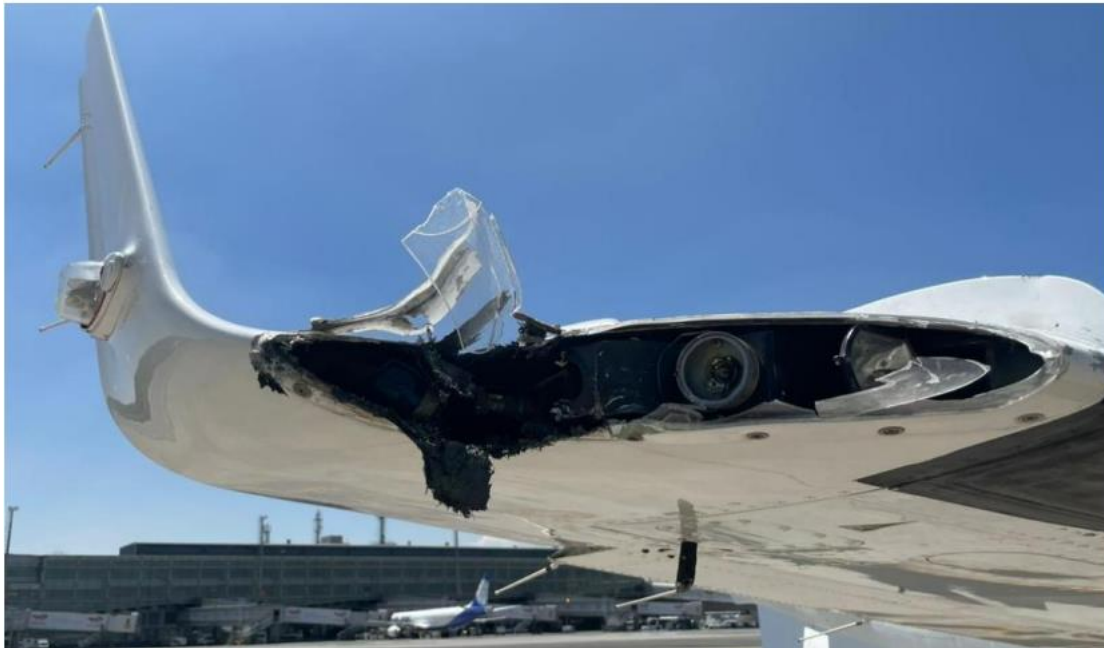
1.1.6. The aircraft sustained damage to the right-wing tip and the underside of the right wing.

1.3.1. The right wingtip and the underside were damaged.

Figure 2: The damaged wingtip.

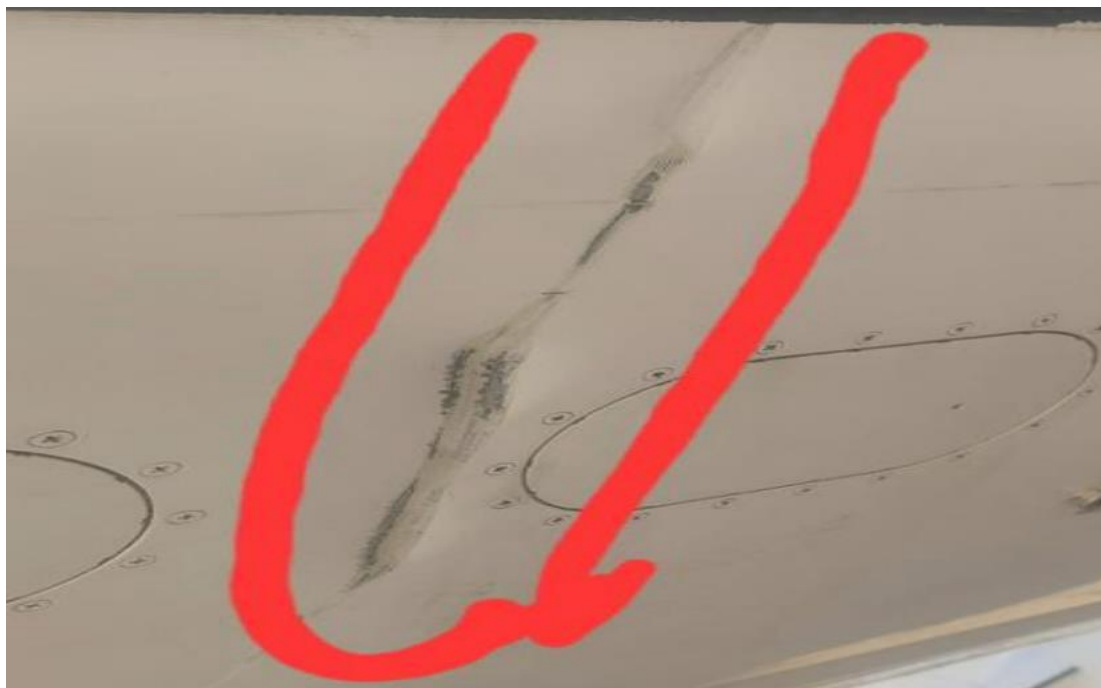
Figure 3: Damage on the underside of the right-wing tip.

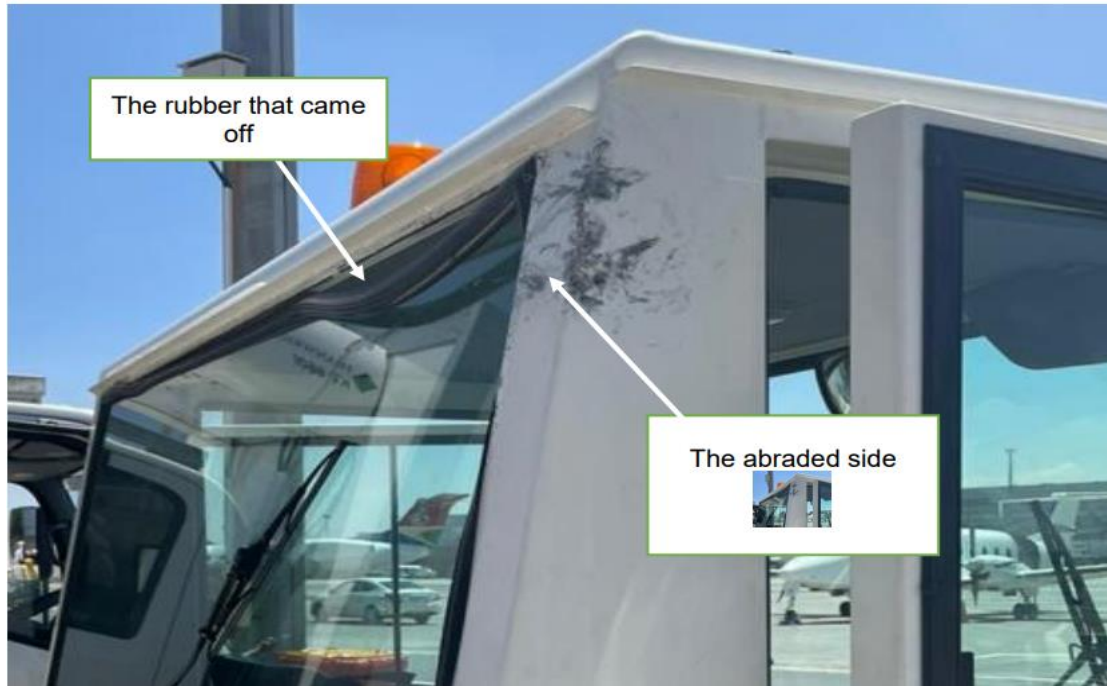
1.4.1. The upper right back side of the tug was abraded, and the rubber lining on the window was partly detached.

Figure 4: The abraded side of the tug.

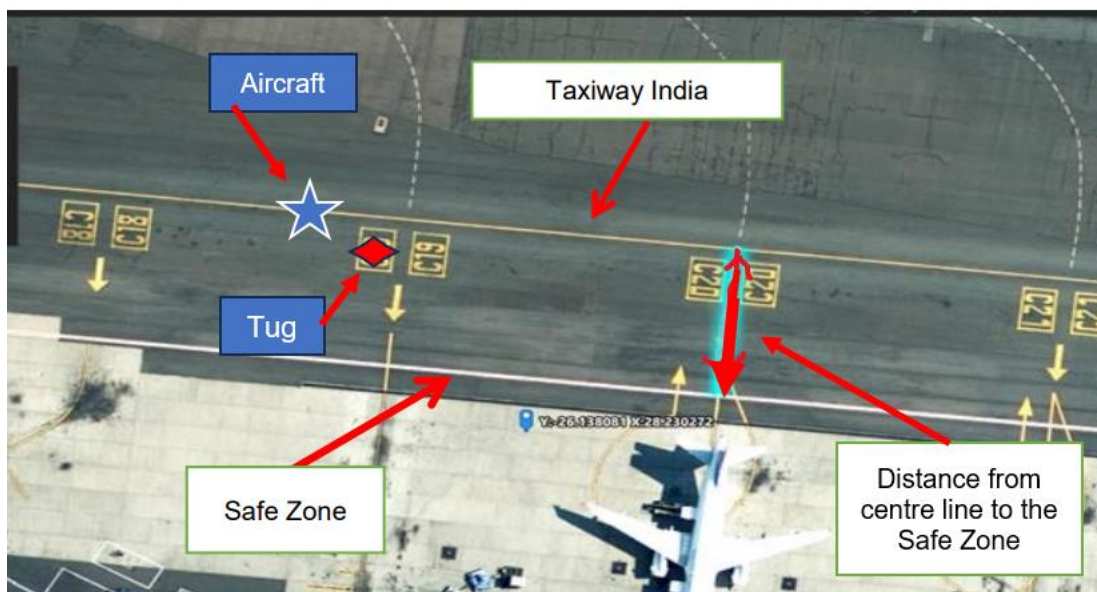
1.10.2. Taxiway India has a yellow centreline; the distance from taxiway India to the safe zone is approximately 24 metres. The distance from taxiway India to where the tug was parked (in front of the aircraft) was approximately 6.5 metres (inside the box marked C19).

Figure 5: C19 layout at FAOR.

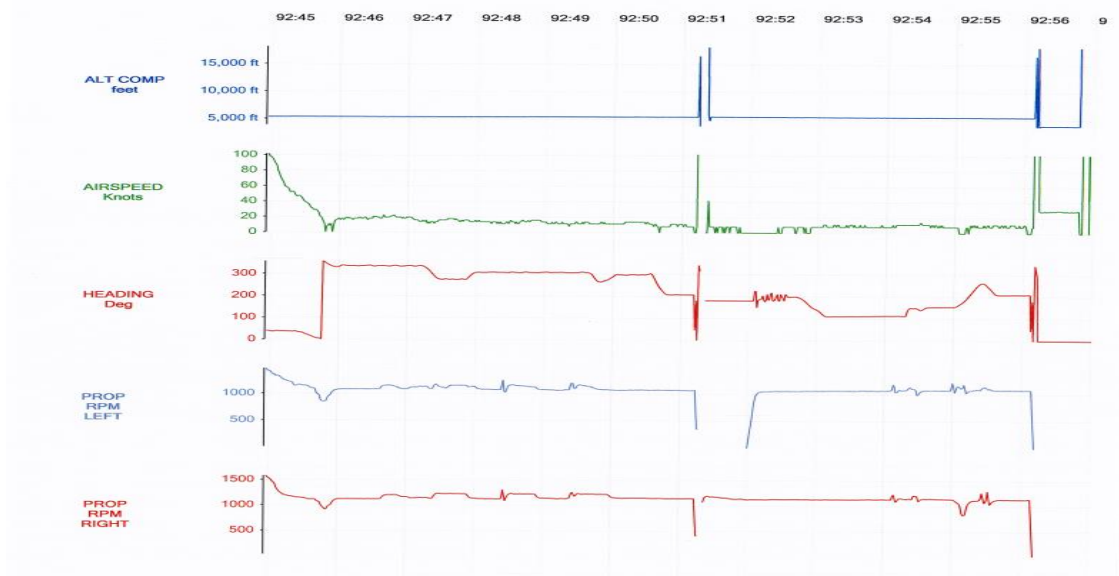
Chart 1: The 1 and 2 engine parameters. (Source: AMO)

1.11.2 The FDR transcript was successfully downloaded on 15 May 2023 at an approved AMO in the presence of the investigator. The Number 1 and 2 engine parameters below indicate that both engines were running normally at the time of the incident.

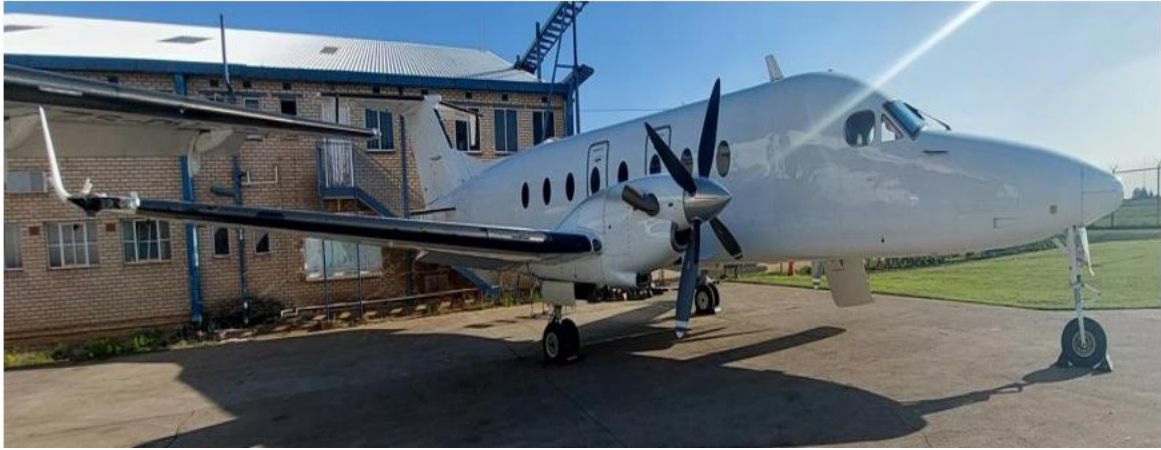
1.12.1. During the second turnaround, the aircraft was parked at C19, and both engines were started whilst it was being pushed back to taxiway India. The aircraft faced a heading of 198°. After the tow bar was disconnected and the tug was still parked in front of the right wing, the aircraft was taxied (started to move) at a ground speed of 7 knots (kts) and it impacted the right back corner of the stationary tug with its right-wing tip. It came to a full stop facing a heading of 225°. The aircraft's right wing and the tug were substantially damaged.

Figure 6: The aircraft after the serious incident.

3.3.1. The aircraft taxied into a stationary tug, which resulted in damage to the right wing due to minimal clearance.

1.12.2. Following the serious incident, the operator grounded the aircraft for inspection and repairs.
