LIMITED OCCURRENCE INVESTIGATION REPORT – FINAL

Reference Number	CA18/3/2/1410						
Classification	Serious Incident	Date	7 April 2023			Time	0655Z
Type of Operation	Private (Part 91)						
Location							
Place of Departure	Wonderboom Aerodrome (FAWB), Gauteng Province		Place of Intended Landing		Chitwa Chitwa Game Lodge Airstrip, Hoedspruit, Limpopo Province		
Place of Occurrence	Runway 19 at Chitwa Chitwa Game Lodge, Hoedspruit, Limpopo Province						
GPS Co-ordinates	Latitude	24°44'02" S	Longitude	031°33'37" E	Elevation	1 200ft	
Aircraft Information							
Registration	ZS-NYU						
Make; Model; S/N	Mooney, M20C (Serial Number: 2726)						
Damage to Aircraft	Substantial			Total Aircraft Hours	3 415		
Pilot-in-command							
Licence Type	Private Pilot Licence (PPL)		Gender	Male		Age	38
Licence Valid	Yes	Total Hours	151.7		Total Hours on Type	74.2	
Total Hours Past 30 Days	0.5		Total Flying Hours on Type Past 90 Days		42.7		
People On-board	1 + 3	Injuries	0	Fatalities	0	Other (on ground)	0

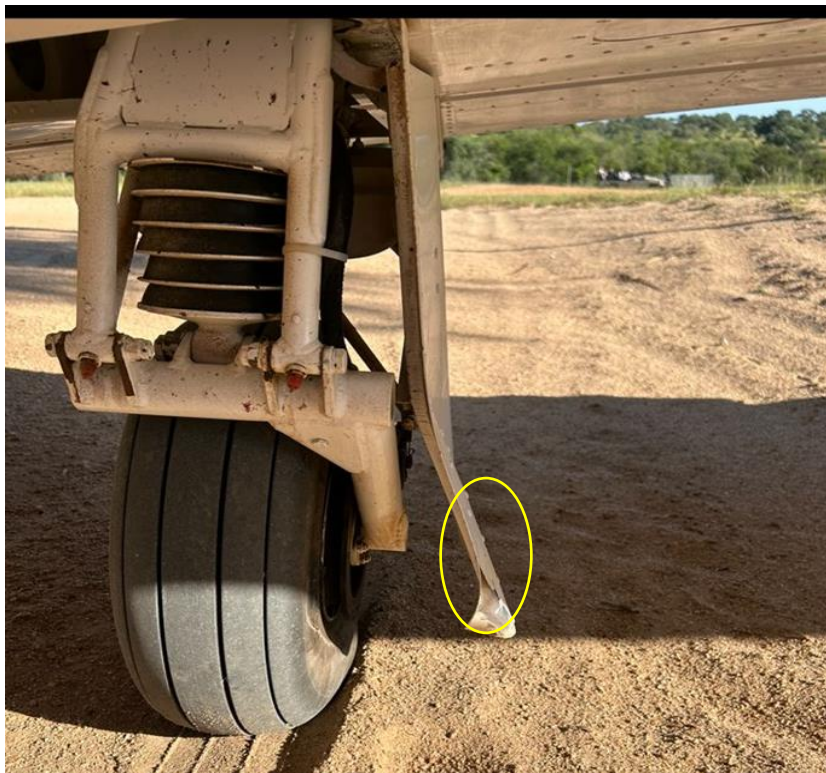
Figure 2: The damaged left main gear door. (Source: Pilot)

Probable Cause
The aircraft landed on a gravel runway and the left main gear ran over a furrow caused by rain; as a result, the propeller blades struck the runway surface and the left main gear door sustained damage.
Contributing Factor
Rain eroded the runway surface.
Safety Action(s)
None.
Safety Message
Pilots and aircraft operators are encouraged to request information about the condition of the runways at their intended destination airports/airfields to minimise the risks of damage to aircraft and injuries as a result of accidents.
About this Report
<i>The decision to conduct a limited investigation is based on factors including whether the cause is known and the evidence supporting the cause is clear, the level of safety benefit likely to be obtained from an investigation and that will determine the scope of an investigation. For this occurrence, a limited investigation has been conducted, and the Accident and Incident Investigations Division (AIID) has relied on the information submitted</i>

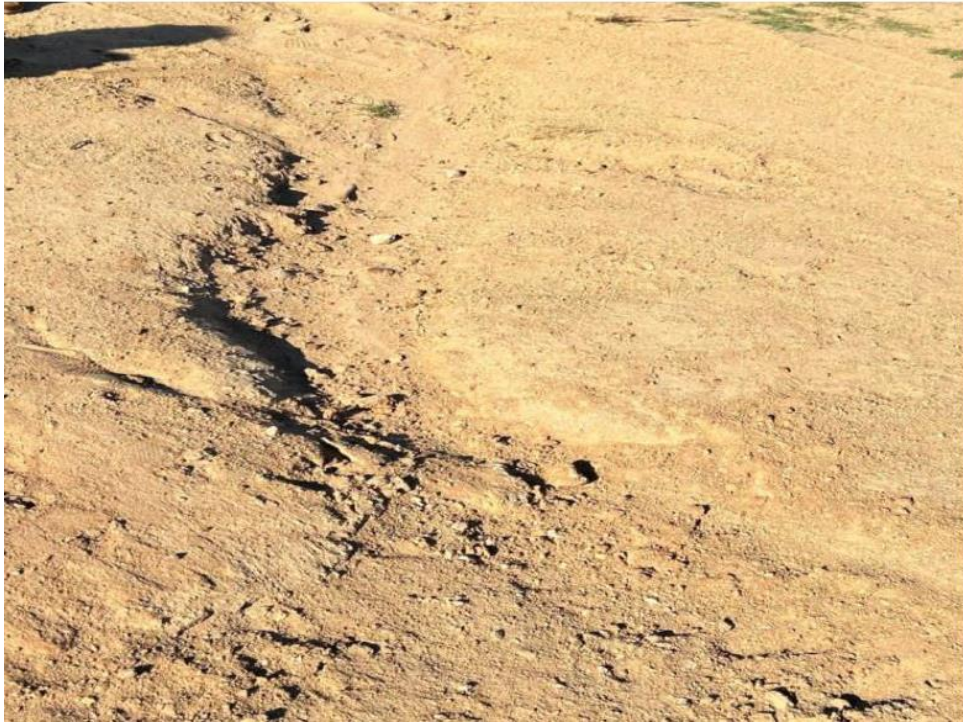
Figure 3: The furrow on the gravel runway caused by rain. (Source: Pilot)

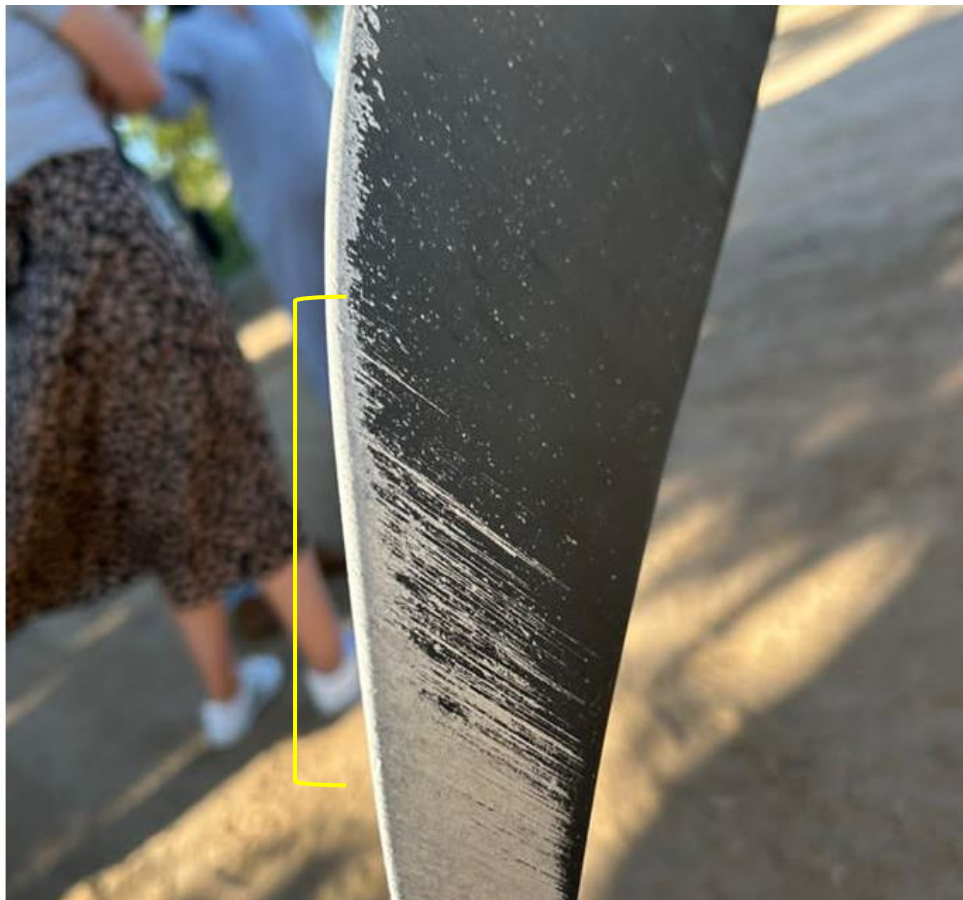
Figure 4: The bent propeller blade. (Source: Pilot)
