LIMITED OCCURRENCE INVESTIGATION REPORT – FINAL

Reference Number	CA18/3/2/1412						
Classification	Serious Incident	Date	30 April 2023		Time	0923Z	
Type of Operation	Air Transport Operations Carriage: Less Than 20 Passengers (Part 135)						
Location							
Place of Departure	Madikwe East Aerodrome, North West Province		Place of Intended Landing	Madikwe West Aerodrome, North West Province			
Place of Occurrence	Madikwe West Aerodrome, North West Province						
GPS Co-ordinates	Latitude	24°49'13.03" S	Longitude	026°13'52.15" E	Elevation	3 630 feet	
Aircraft Information							
Registration	ZS-LEC						
Make; Model; S/N	Cessna Aircraft Company; 208B (Serial Number: 208B-5519)						
Damage to Aircraft	Substantial			Total Aircraft Hours	1 658.1		
Pilot-in-command							
Licence Type	Commercial Pilot Licence (CPL)		Gender	Male		Age	24
Licence Valid	Yes	Total Hours	1 566.9		Total Hours on Type	144.5	
Total Hours 90 Days	172.5		Total Flying on Type Past 90 Days	144.5

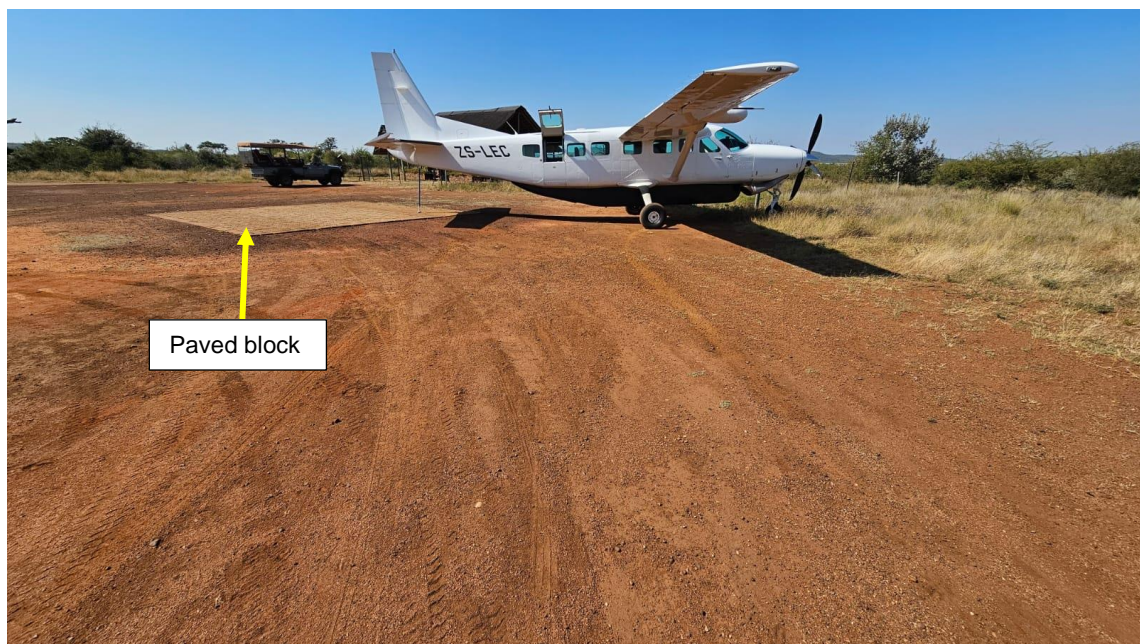
Figure 1: The aircraft as it came to a stop following the serious incident.

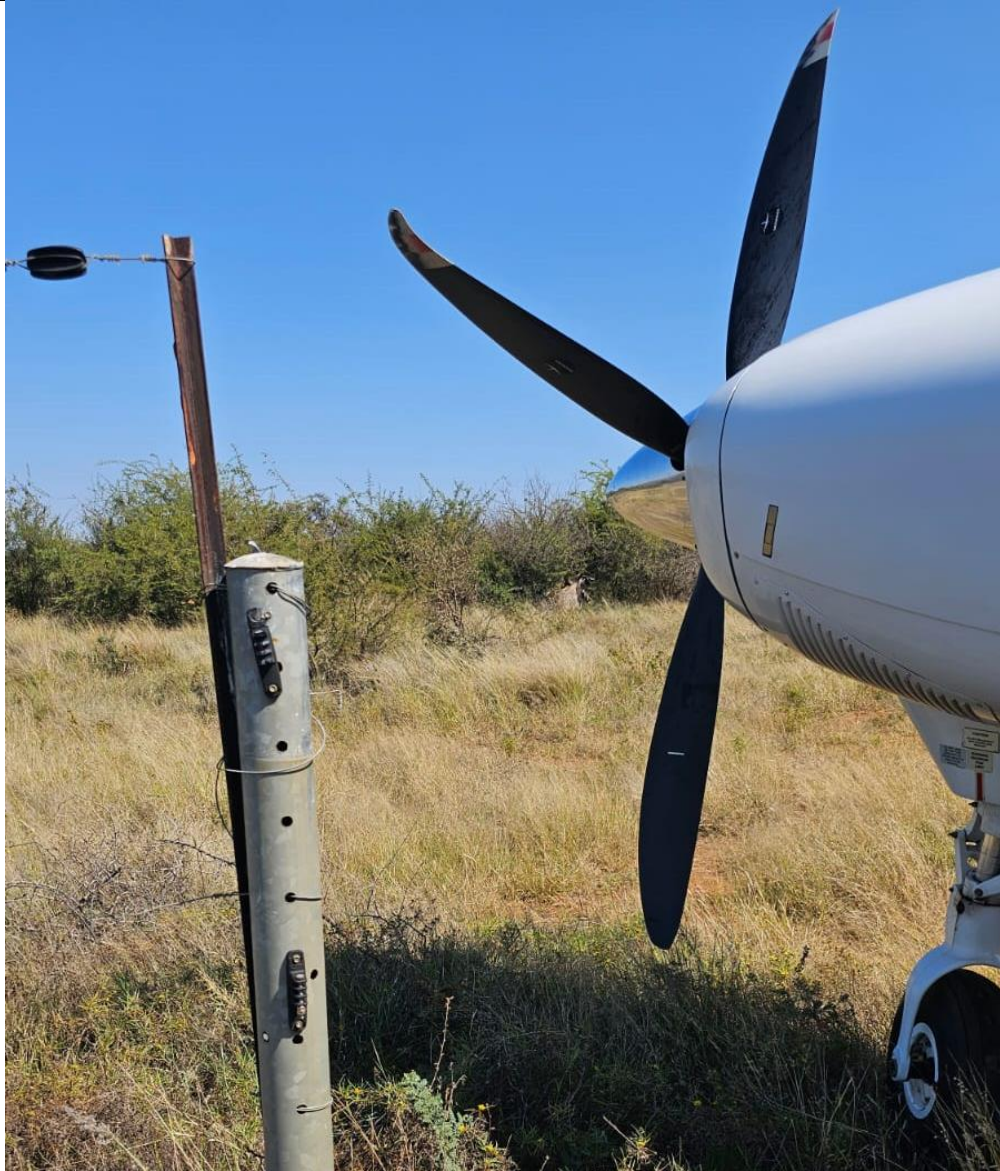
Figure 2: The steel fence post impacted by the propeller.

- (xiv) The other paved area was near the "overnight parking area" close to the fence post that was struck by the propeller of ZS-LEC. The pole was positioned 9.8m from the paved area.

Safety Action
None.
Safety Recommendations
<p>(i) It is recommended that the operator(s) who erected an electric fence (protected overnight parking area) next to the terminal building fence remove it and its supporting poles to prevent a recurrence of the serious incident, which resulted in damage to the aircraft and grounding for nearly five months.</p> <p>It is evident that this “protected overnight parking area” was erected sometime after the aerodrome was operational and, judging by the height of the grass and vegetation within the demarcated area, it seemed that it had not been in use for a lengthy period. The aircraft’s propeller struck one of the electric fence support poles, which was located 9.8m from the corner of the paved area in the apron. The parking procedure as depicted in the Federal Airlines document is not regarded as safe for aircraft operations and needed to be amended. The apron area covers a surface area of 3 136sq metres (56m x 56m), which provided adequate space to operate/park a Cessna 208B or larger aircraft type.</p> <p>(ii) It is recommended that the operator amend its procedure for Madikwe West Aerodrome as the parking method prescribed in the document has the potential to cause a serious incident or accident.</p>

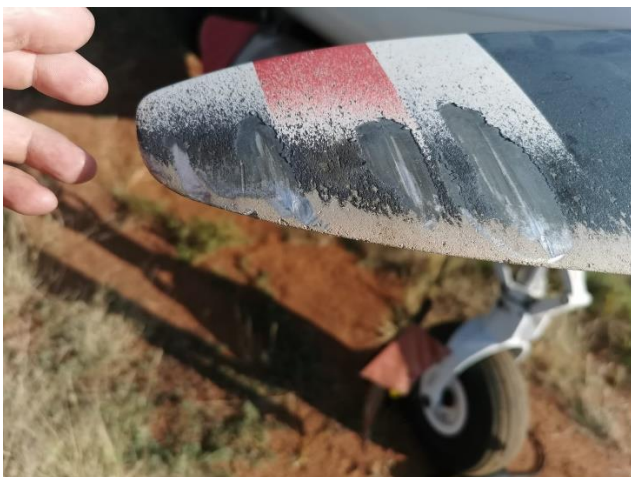
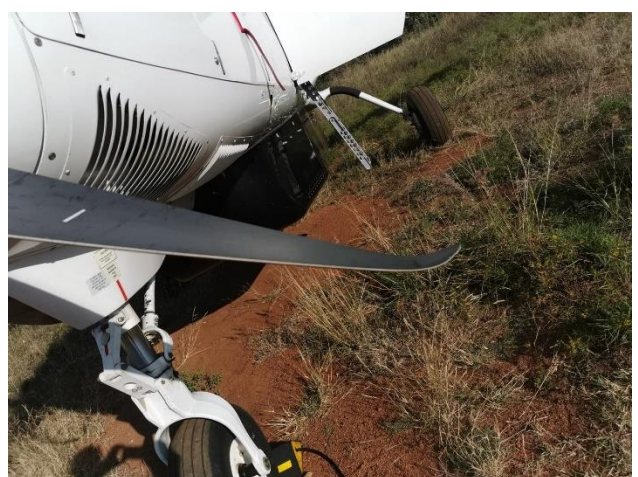
he applied reverse thrust (this is executed by changing the pitch of the propeller blades) as the aircraft was approaching an electric fence. Because the pilot was unable to slow down the aircraft, he made the decision to turn the aircraft sharply to the right. But before he could turn, the propeller struck a steel fence post on the side of the apron area. This resulted in damage to the propeller blades and the engine. No people on-board the aircraft were injured.

Figure 3: Damage to one of the propeller blades (a); and a bent blade tip of one of the propeller blades (b).

The engine was installed on the aircraft on 14 and 15 September 2023 following repairs at an approved engine maintenance facility. The propeller that was removed and accordingly repaired was also installed. As per the maintenance requirements, engine ground runs were performed. On 21 September 2023, the Regulator (SACAA) issued a special flight permit for a flight from Madikwe West Aerodrome to Lanseria International Aerodrome (FALA). The aircraft was flown to FALA the following day, and no technical anomalies were noted.

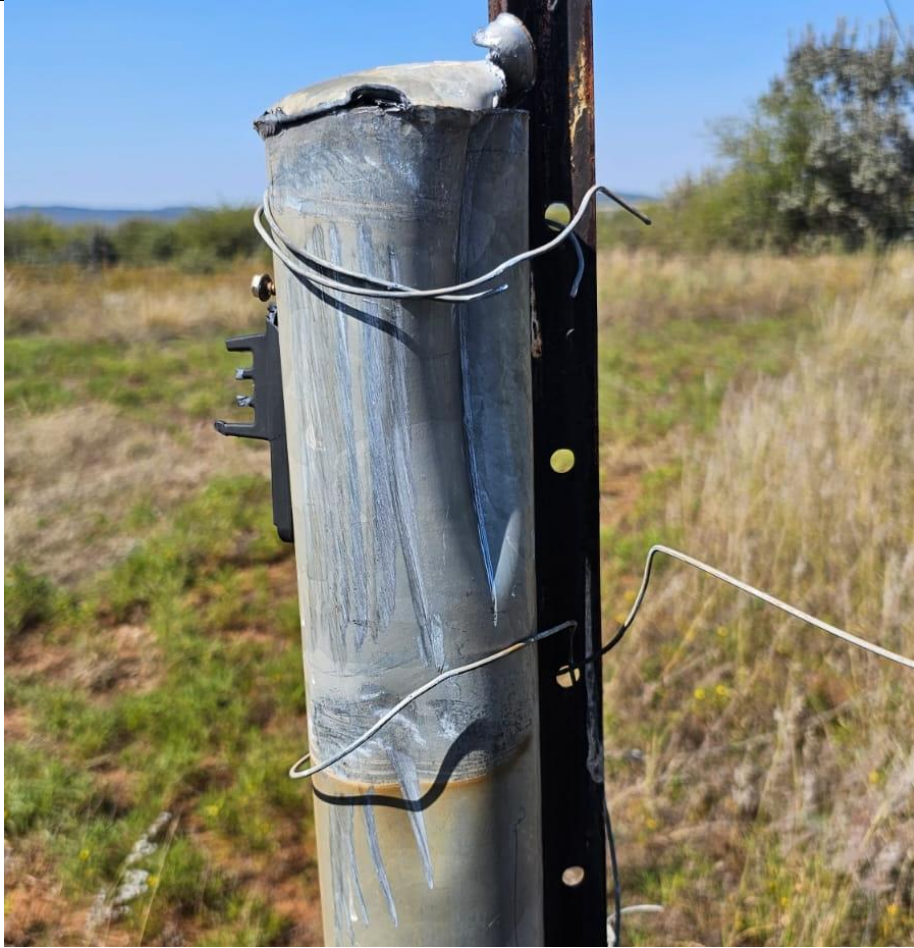
Figure 4: The propeller blade strike marks on the fence post.

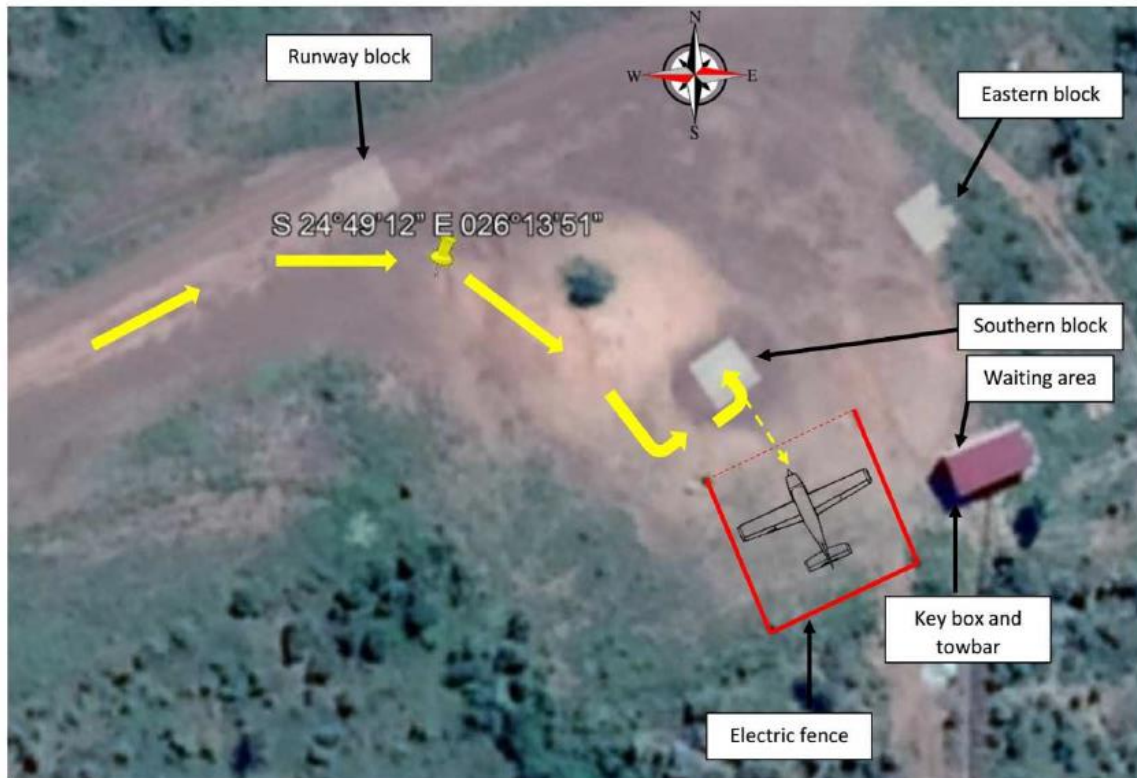
Figure 6: Schematic from the operator's parking procedure at Madikwe West Aerodrome.

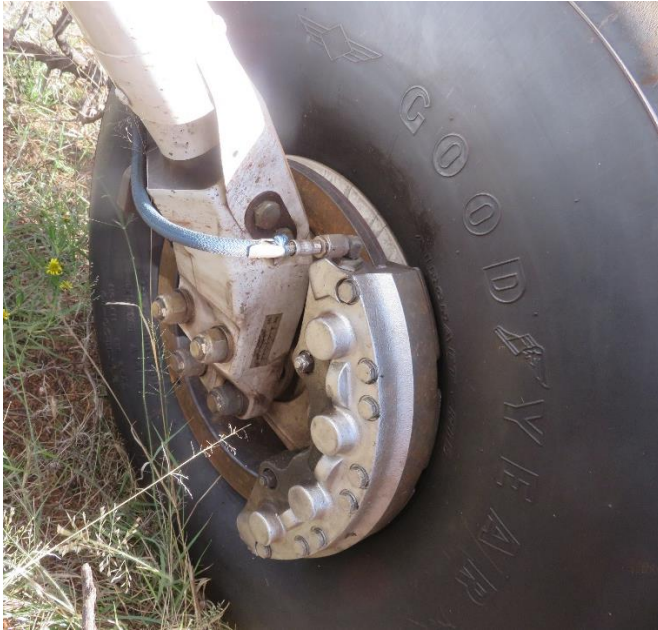
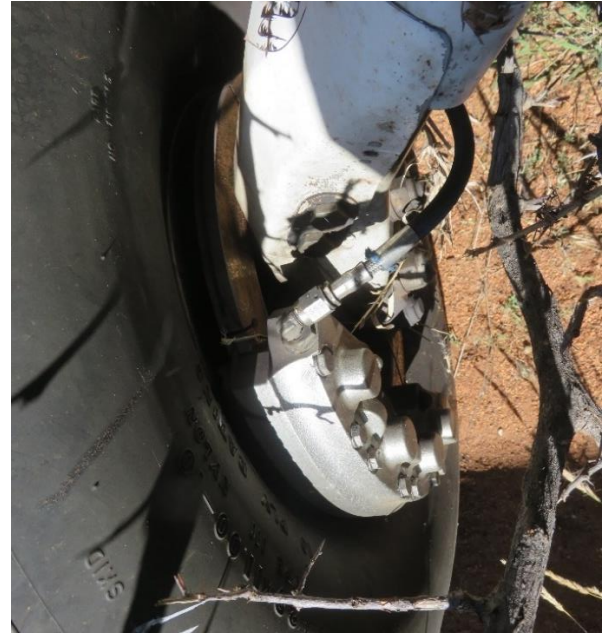
During visual inspection of the aircraft, nothing untoward was observed with the brakes system (i.e., there were no visible leaks, the hydraulic lines to both brake assemblies were not ruptured, there was no mechanical defect with the brake assemblies, and the hydraulic fluid reservoir which is located on the left side of the engine compartment was full).

Figure 7: The two-wheel brake assemblies on the left wheel (a); and the right wheel (b).

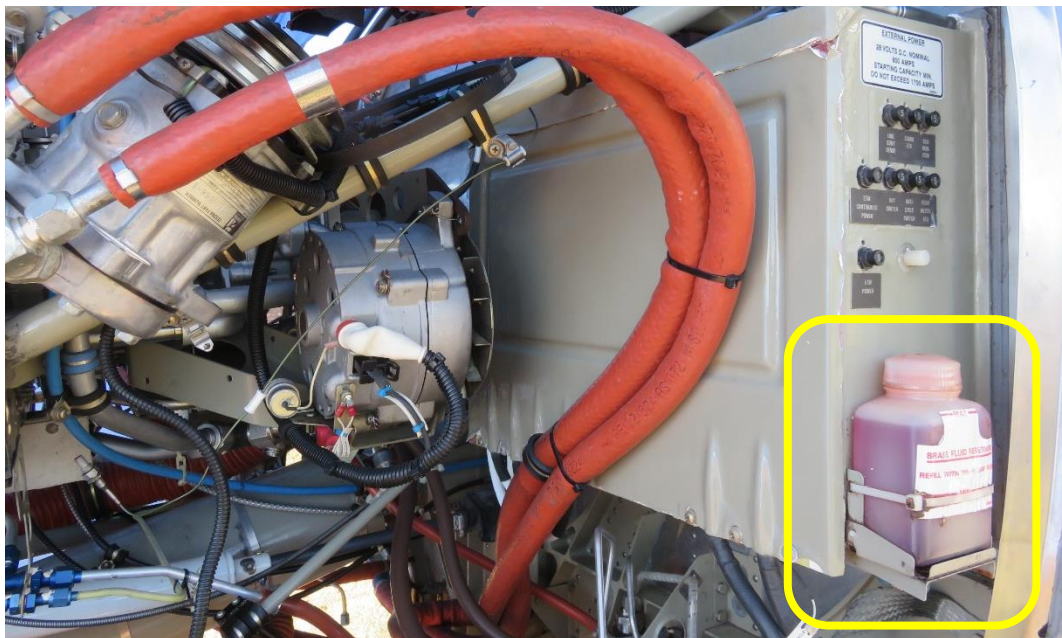
Figure 8: The hydraulic fluid reservoir which is near maximum in the yellow window.

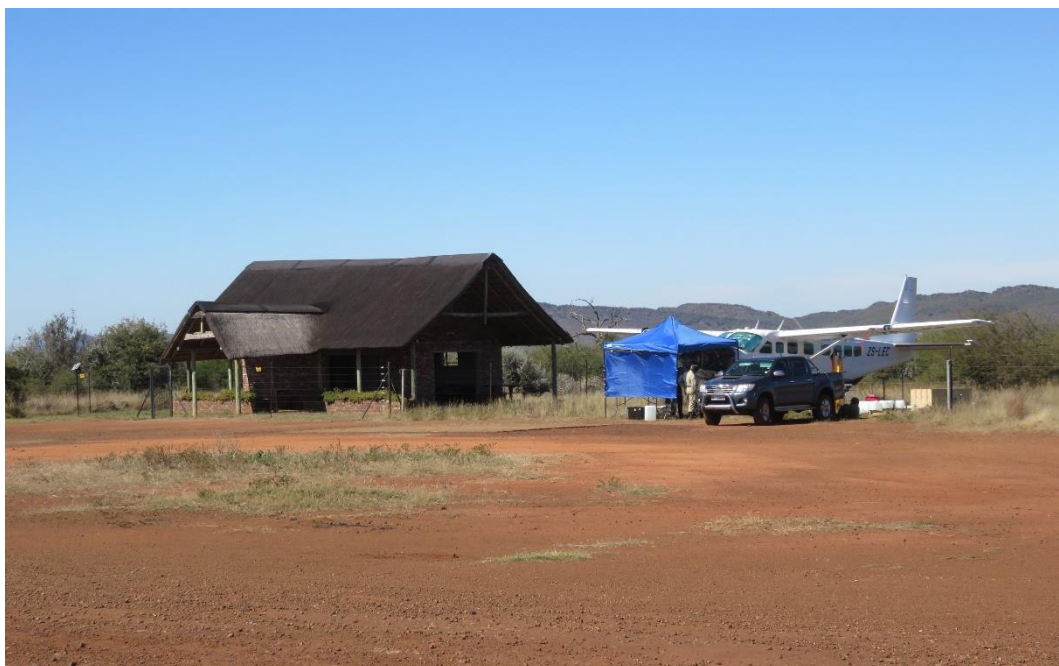
Figure 9: The terminal building with ZS-LEC parked next to it.

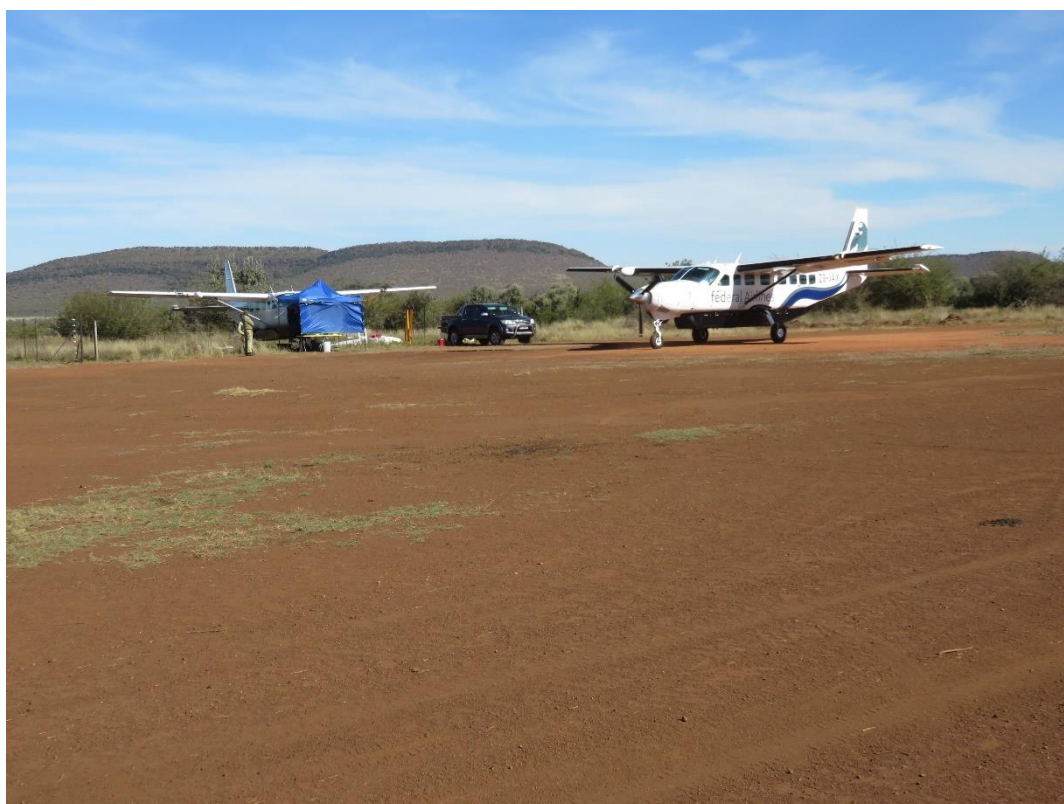
The apron area at Madikwe West Aerodrome had adequate space to park an aircraft the size of a Cessna 208B and larger. Figure 10 depicts a Cessna 208B that landed at the aerodrome to collect passengers (the apron area was more than adequate to accommodate the aircraft).

Figure 10: ZS-LEC parked on the left, and the aircraft collecting passengers on the right.

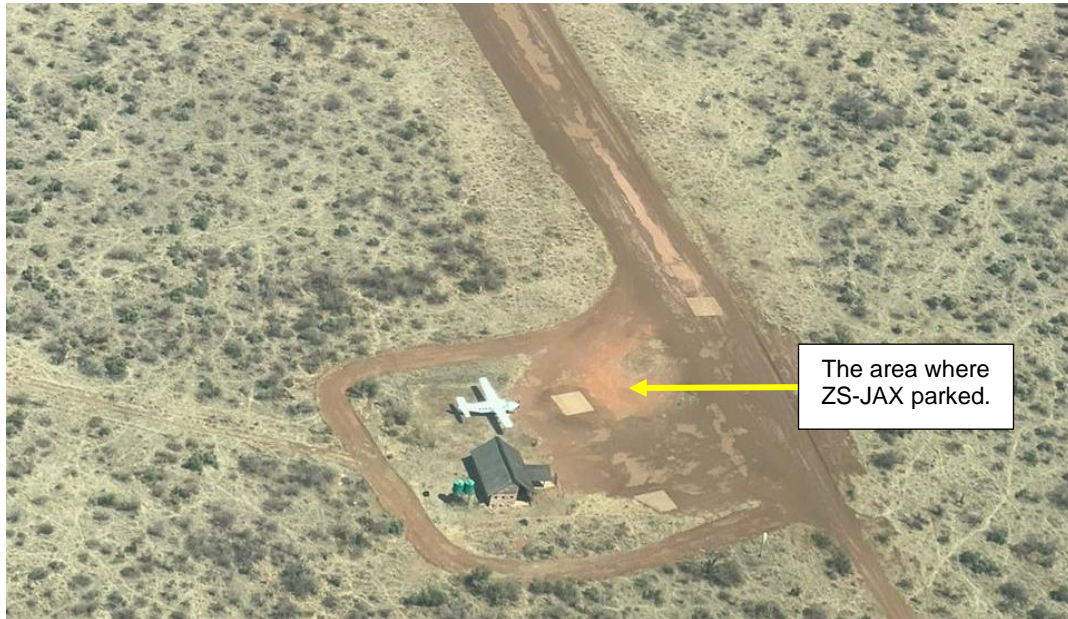
- (xv) It was noted that the aircraft (ZS-JAX) that landed at Madikwe West Aerodrome on the day of the incident parked to the north of the paved area, some distance from the "overnight parking area" (see Figure 11) to allow adequate space as there was a vehicle (that was parked in that area at the time) from the maintenance team. The maintenance personnel were working on ZS-LEC aircraft.

Figure 11: Aerial view of the apron area, with ZS-LEC parked. (Source: Federal Airlines)
