UAS LIMITED OCCURRENCE INVESTIGATION REPORT – FINAL

Reference Number	CA18/3/2/1413						
Classification	Serious Incident	Date	1 June 2023	Time	2014Z		
Type of Operation	Remotely Piloted Aircraft System – Surveillance (Part 101)						
Location							
Place of Departure	Glen Marais Warehouse, Gauteng Province		Place of Intended Landing		Glen Marais Warehouse, Gauteng Province		
Place of Occurrence	Open area at Glen Marais Warehouse, Gauteng Province						
GPS Co-ordinates	Latitude	26°03'36.24" S	Longitude	028°16'59.20" E	Elevation	5 282 feet	
Aircraft Information							
Registration	ZT-YKI						
Make; Model; S/N	Arace; Sirin (Serial Number: SIR137)						
Damage to UAS	Minor		Total UAS Hours		1 046.33		
Pilot-in-command							
Licence Type	Remote Pilot Certificate		Gender	Female		Age	27
Licence Valid	Yes	Total Hours	598.63		Total Hours on Type	598.63	
Total Hours 90 Days	150.0		Total Flying on Type Past 90 Days		150.0		
Injuries	None	Injuries (on ground)	0	Fatalities	0	Fatalities (on ground)	0

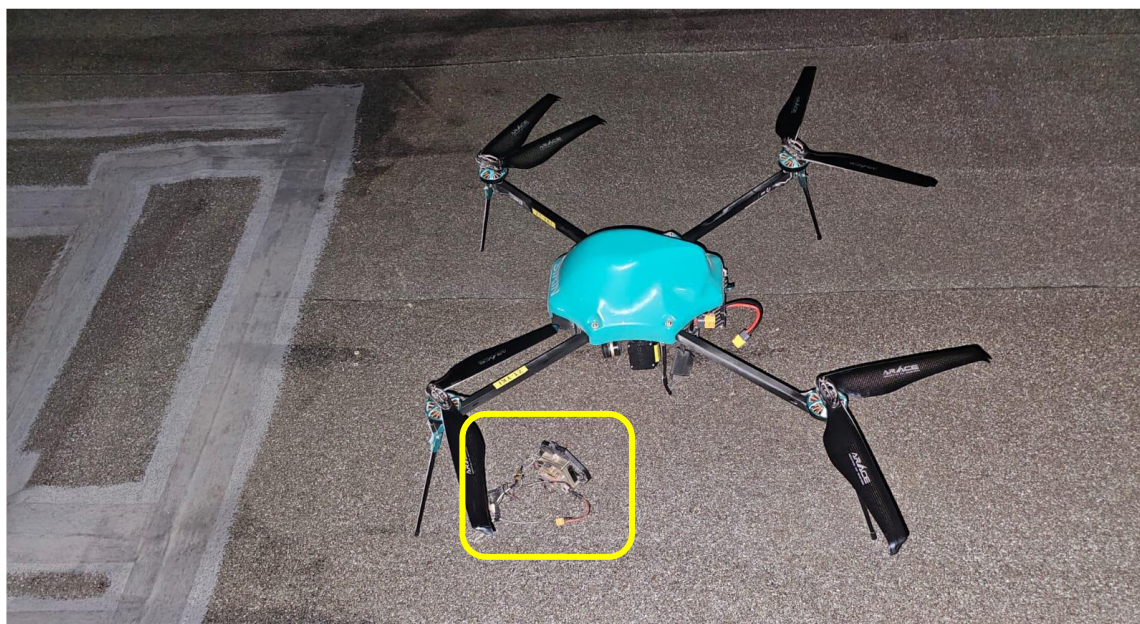
Figure 2: The transponder unit (in the yellow window) that dislodged from the UAS. (Source: Operator)

- 2.6 Apart from the transponder unit that detached from the UAS during the hard landing, no other damage was caused to the UAS.

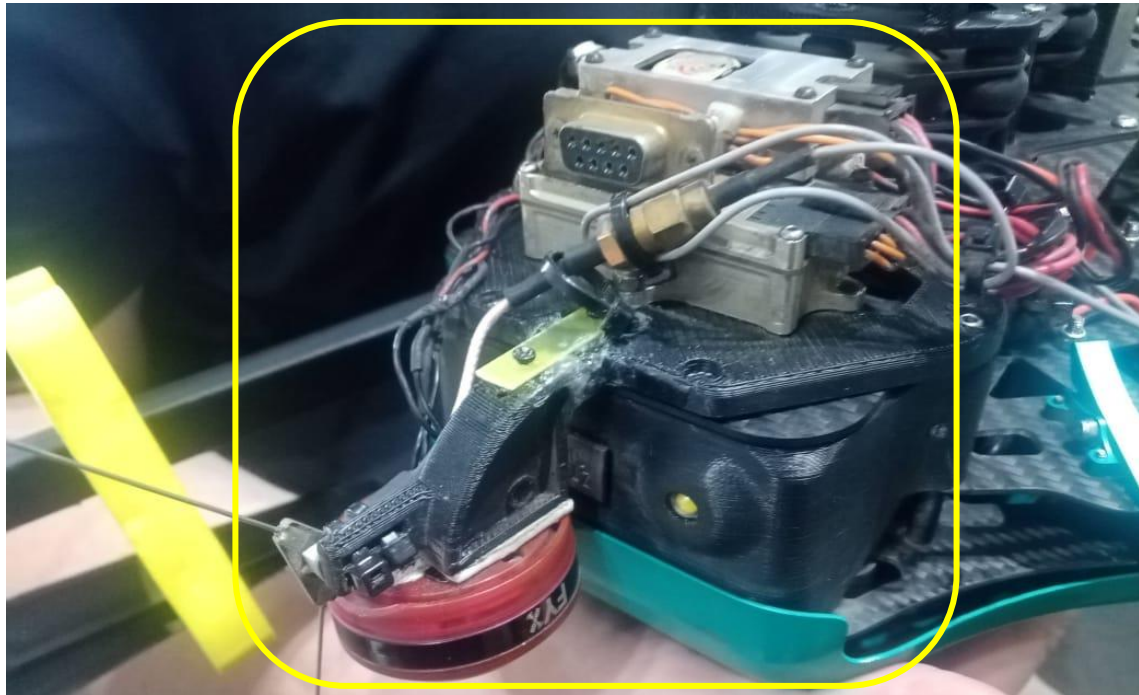
The UAS was fitted with a transponder, which was a supplementary unit to the main frame. The transponder consists of two major components (see Figure3): (i) antenna (the red device), and (ii) a transmitter/receiver (which was attached to the main frame and comprises carbon fiber with four screws). Electrical power to the transponder is drawn from the battery via a special connection.

Figure 3: The transponder and antenna unit that was attached to the UAS are depicted in the yellow window. The picture was taken with the UAS in an inverted attitude. (Source: Operator)

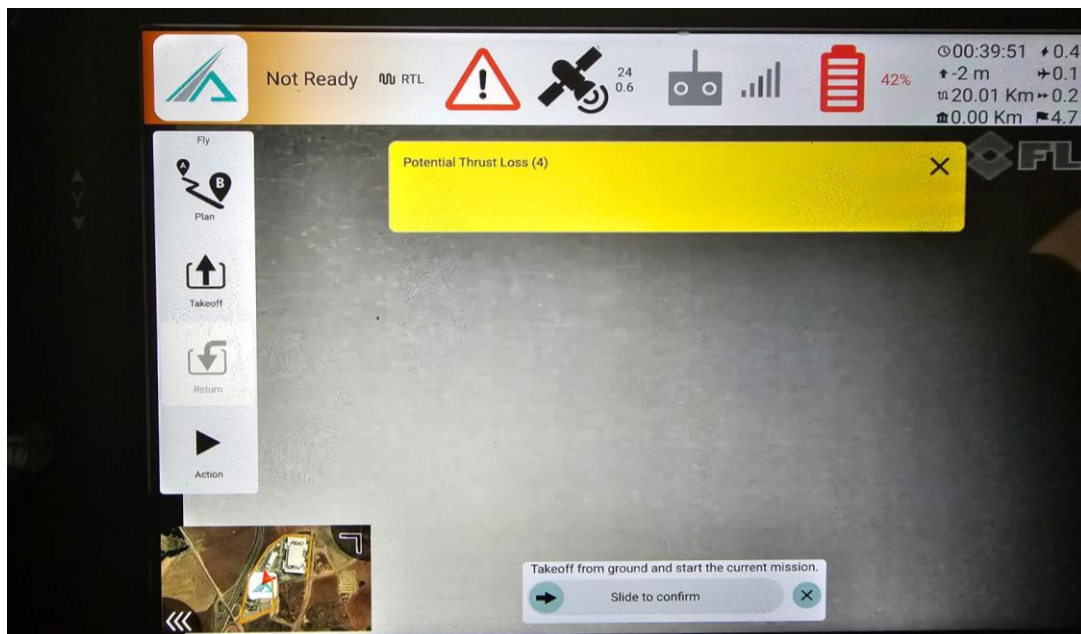
Figure 4: "Potential thrust loss" warning message displayed on the remote pilot station. (Source: Operator)

5.3 The operator engaged the OEM after encountering several incidents related to “potential thrust loss” over a brief period.

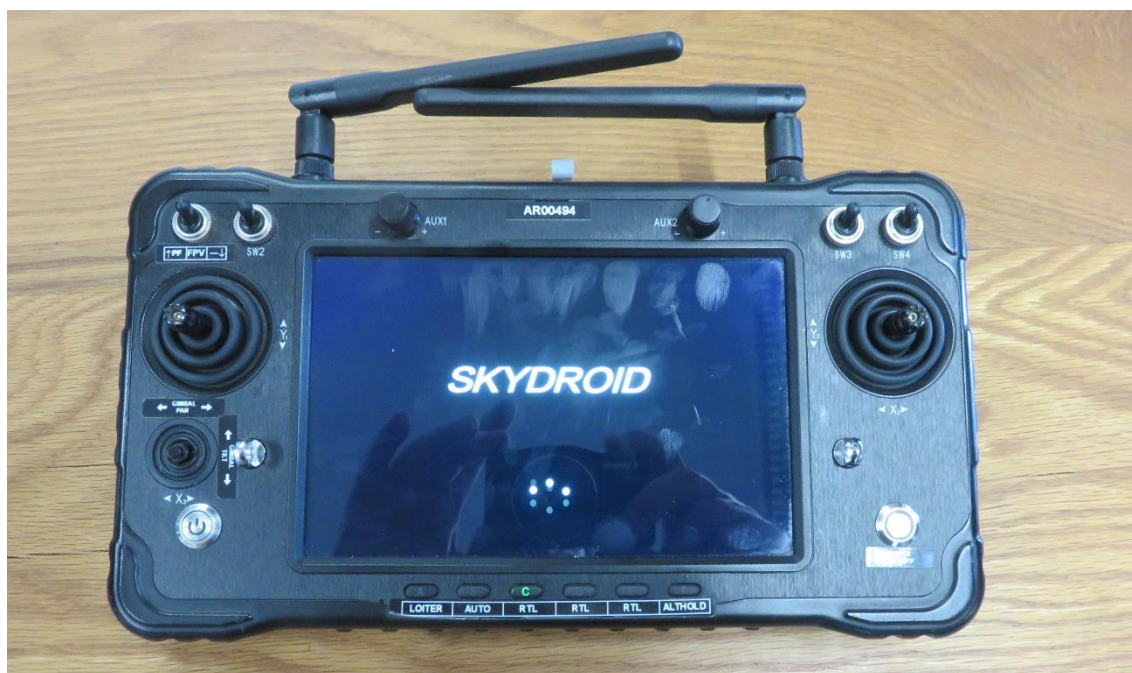
Figure 6: The Sirin remote pilot station with the RTL buttons below the display screen.

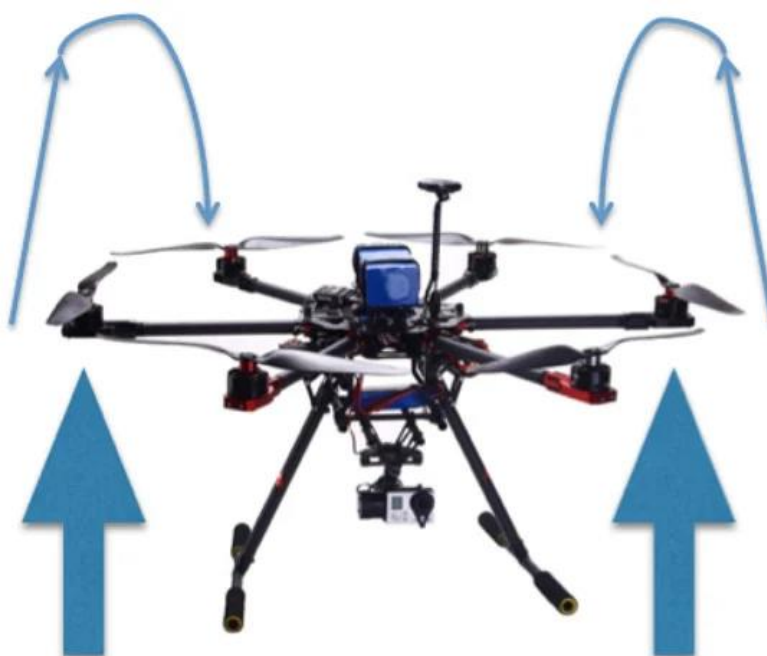
Illustration 1: The effect of vortex ring on a UAS.

The rate of descent (ROD) increased substantially after the activation of the RTL mode. It is possible that during this phase of flight, the UAS entered vortex ring state (settling into its own "dirty air") which resulted in a hard landing.
