UAS LIMITED OCCURRENCE INVESTIGATION REPORT – FINAL
--

Reference Number	CA18/2/3/1414						
Classification	Serious Incident	Date	2 June 2023	Time	2241Z		
Type of Operation	Remotely Piloted Aircraft Systems – Surveillance (Part 101)						
Location							
Place of Departure	Doornpoort, Gauteng Province	Place of Intended Landing	Doornpoort, Gauteng Province				
Place of Occurrence	3.4 nm north-east of Wonderboom Airport, Gauteng Province						
GPS Co-ordinates	Latitude	25°36'31" S	Longitude	28°15'08" E	Elevation	3929ft	
Aircraft Information							
Registration	ZT-XOA	Class	3A				
Make; Model; S/N	Arace Sirin (Serial Number: SIR0021)						
Damage to Aircraft	Minor	Total UAS Hours	1021.7				
Pilot-in-command							
Licence Type	Remote Pilot Licence (RPL)	Gender	Male	Age	22		
Licence Valid	Yes	Total Hours	998.51	Total Hours on Type	998.51		
Total Hours 30 Days	51.53	Total Flying on Type Past 90 Days	92.16				
People controlling	1	Injuries (On ground)	0	Injuries	0	Fatalities (on ground)	0

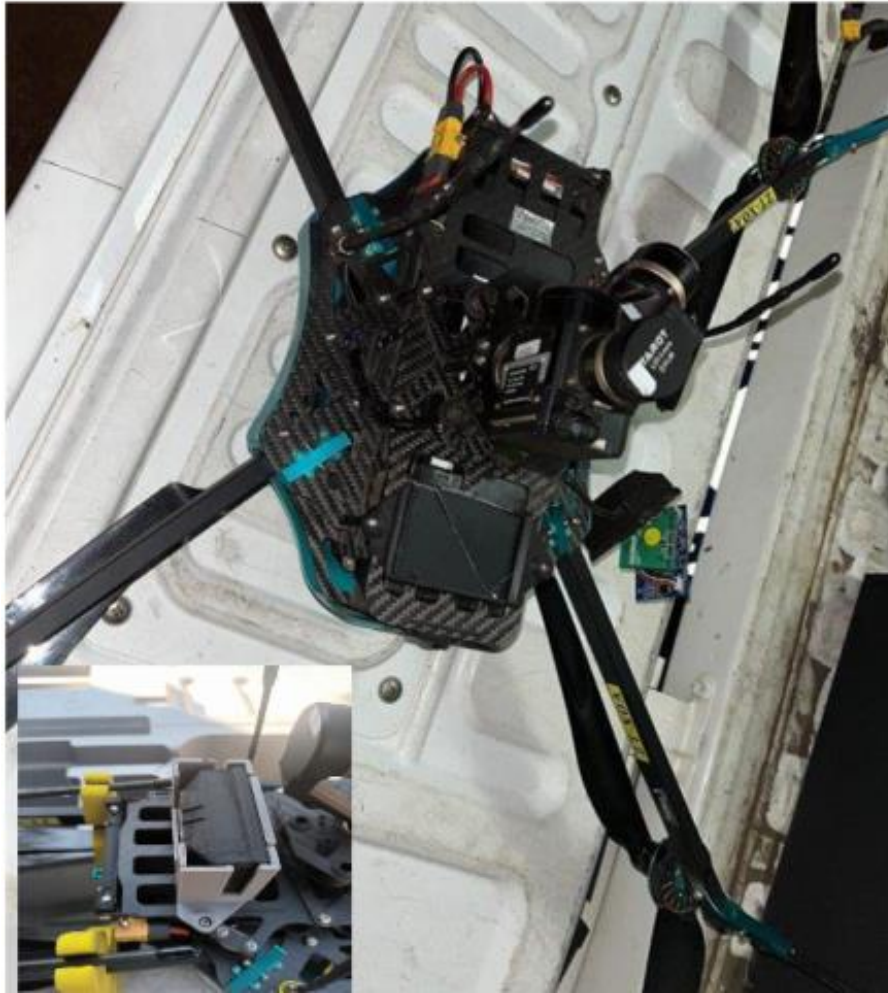
Figure 1: ZT-XOA showing loose tracking device. Inset picture shows ZT-XOA before it was damaged. (Source: Operator)

9. The operator stated that "*The Bidtracker device is encased in a 3D-printed enclosure, which is fastened to the aircraft's fuselage using stainless steel screws. Loctite is applied to secure the screw threads.*"

Probable Cause
The enclosure of the tracking device failed, and the device floated freely; as a result, it impacted the rotating propeller blades several times which caused an imbalance during the flight. This resulted in the inability of the UAS to continue with the automated flight. The pilot manually controlled the UAS back to the launch site.
Contributing Factor(s)
None.
Safety Action(s)
None.
Safety Message and/or Safety Recommendation/s
None.
About this Report
<p><i>The decision to conduct a limited investigation is based on factors including whether the cause is known and the evidence supporting the cause is clear, the level of safety benefit likely to be obtained from an investigation and that will determine the scope of an investigation. For this occurrence, a limited investigation has been conducted, and the Accident and Incident Investigations Division (AIID) has relied on the information submitted by the affected person/s and organisation/s to compile this limited report. The report has been compiled using information supplied in the initial notification, as well as from follow-up desk top enquiries to bring awareness of potential safety issues to the industry in respect of this occurrence, as well as possible safety action/s that the industry might want to consider in preventing a recurrence of a similar occurrence.</i></p> <p><i>All times given in this report are Co-ordinated Universal Time (UTC) and will be denoted by (Z). South African Standard Time is UTC plus 2 hours.</i></p>

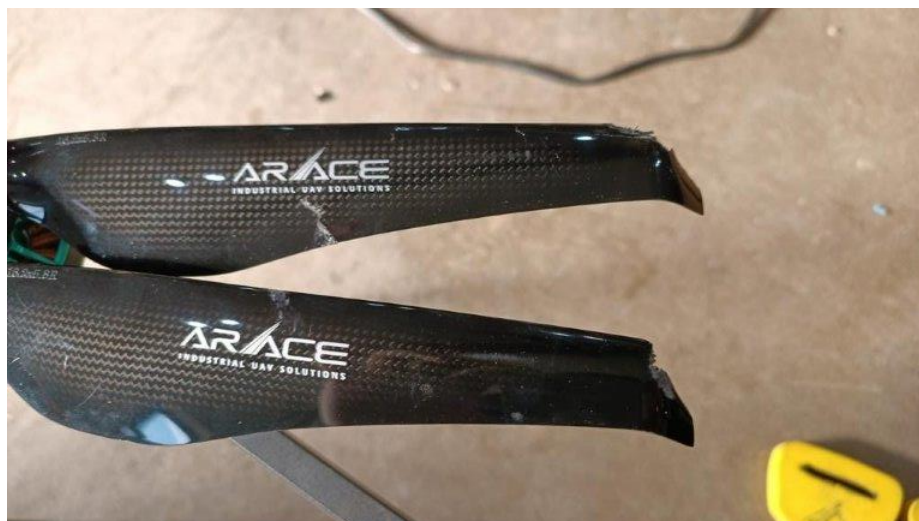
Figure 2: Damage to propellers was caused by contact with the loose tracking device. (Source: Araceuas.com)
