LIMITED OCCURRENCE INVESTIGATION REPORT – FINAL

Reference Number	CA18/3/2/1415						
Classification	Serious Incident		Date	3 June 2023		Time	0900Z
Type of Operation	Private (Part 94)						
Location							
Place of Departure	Kroon Airfield, Gauteng Province		Place of Intended Landing	Private Airstrip at Plot 42, Mogale, Gauteng Province			
Place of Occurrence	Private Airstrip at Plot 42, Mogale, Gauteng Province						
GPS Co-ordinates	Latitude	25° 58'11"S	Longitude	027°59'39"E	Elevation	4 330 ft	
Aircraft Information							
Registration	ZU-FKA						
Make; Model; S/N	ICP SRL Italy; Savannah HL V6 (Serial Number: 09-12-51-881)						
Damage to Aircraft	Substantial			Total Aircraft Hours	675		
Pilot-in-command							
Licence Type	National Pilot Licence (NPL)		Gender	Male		Age	75
Licence Valid	Yes	Total Hours	850		Total Hours on Type	675	
Total Hours 30 Days	25		Total Flying on Type Past 90 Days	25			
People On-board	1+0	Injuries	0	Fatalities	0	Other (on ground)	0

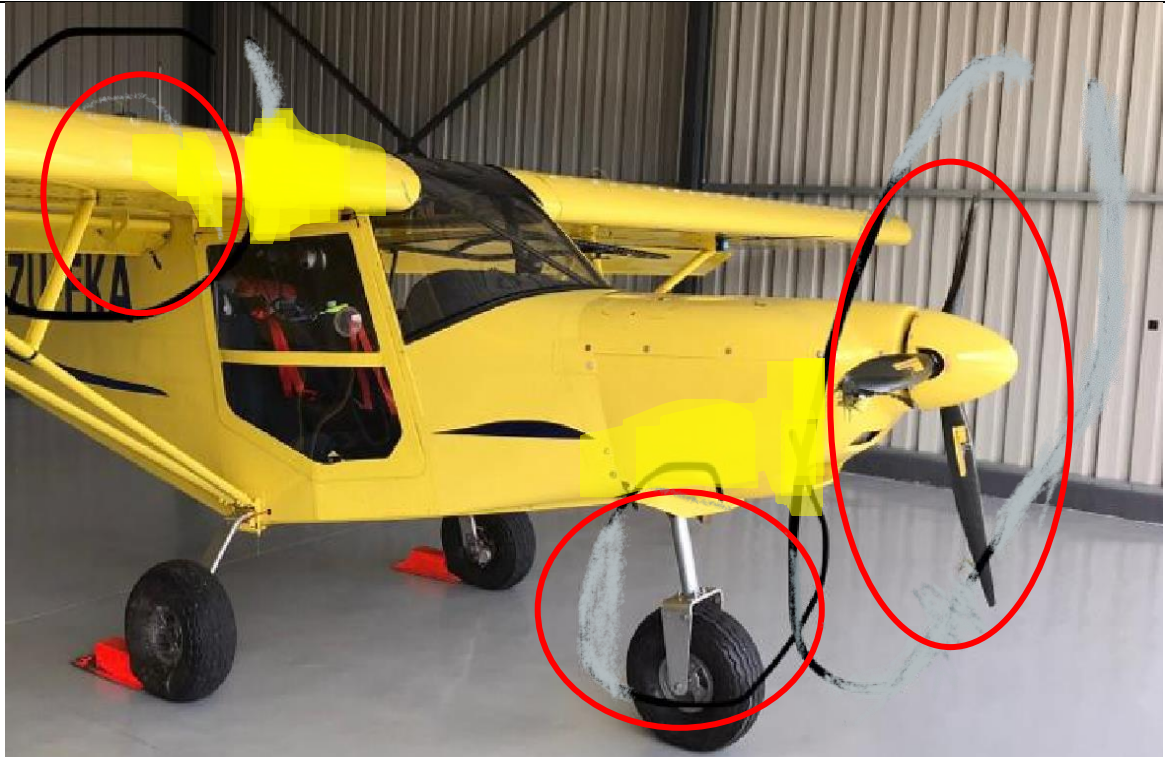
- The aircraft had visible damage to the transponder aerial, the main landing gear was slightly bent, the propeller blades were slightly damaged, and there was a slight crease on the right wing leading edge.

Figure 2: The red circles indicate damage on the aircraft after the incident. (Source: Operator)

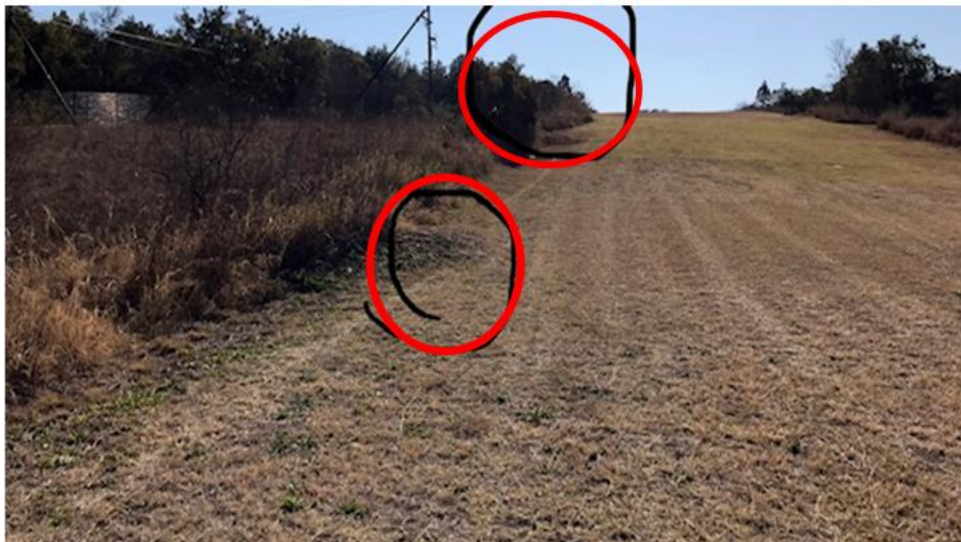
Figure 3: The circles show the mound (raised surface) on the ground. (Source: Operator)

10. The aircraft was unstable on approach, and it landed hard. The pilot lost directional control of the aircraft and it veered off to left of the runway and the left wheel ran over a mound which caused the aircraft to bounce and career over a low embankment before it stopped in the bush.

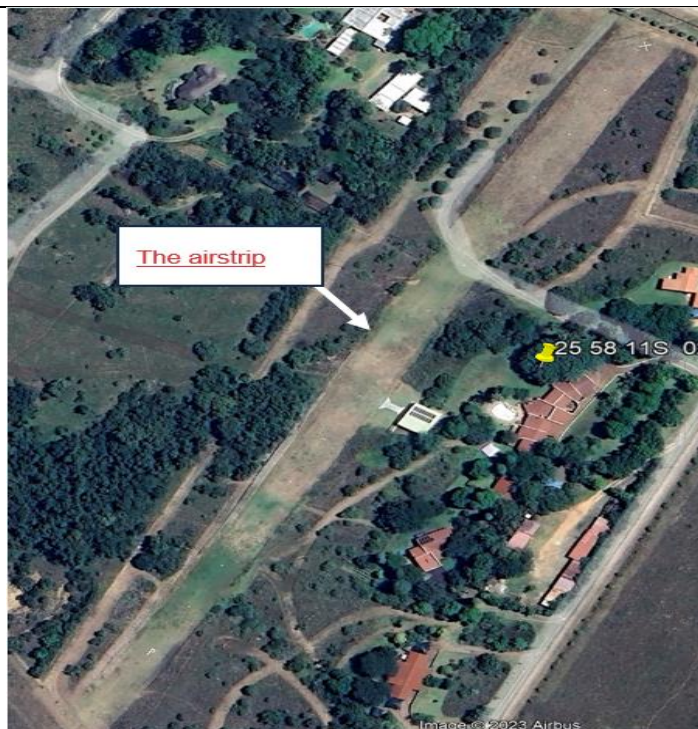
Figure 4: The private airstrip layout. (Source: Google Earth)

- The airstrip is privately owned; thus, it is not registered with the Regulator (South African Civil Aviation Authority).
- The airstrip comprises a single runway, which is 500 metres (m) long and 30m wide and covered in grass.
- On the day of the serious incident, the grass was dry. The runway was suitable for use.
- The weather information below was obtained from the pilot questionnaire.
