UAS LIMITED OCCURRENCE INVESTIGATION REPORT – FINAL

Reference Number		CA18/3/2/1416								
Classification		Serious Incident		Date		10 June 2023	Time		1947Z	
Type of Operation		Remotely Piloted Aircraft System – Surveillance (Part 101)								
Location										
Place of Departure		Sibanye Stillwater Protection Services, Carletonville, Gauteng Province			Place of Intended Landing			Sibanye Stillwater Protection Services, Carletonville, Gauteng Province		
Place of Occurrence		Sibanye Stillwater, Protection Services, Carletonville, Gauteng Province								
GPS Co-ordinates		Latitude	26°23'30" S		Longitude	027°29'44" E		Elevation	5400 ft	
Aircraft Information										
Registration		ZT-WZR			Class		3A			
Make; Model; S/N		Arace Sirin (Serial Number: SIR0011)								
Damage to Aircraft		Substantial			Total UAS Hours		616.46			
Pilot-in-command										
Licence Type		Remote Pilot Licence (RPL)			Gender		Male		Age	34
Licence Valid		Yes	Total Hours		628.53		Total Hours on Type		628.53

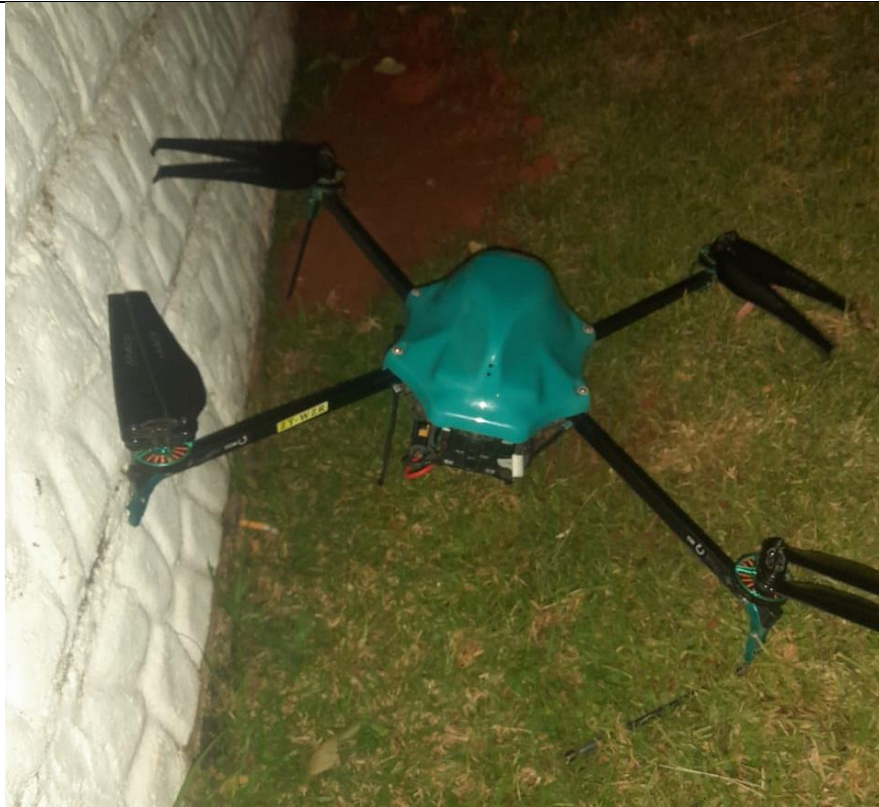
screen. The battery power may have depleted, and thus, likely caused the thrust loss. This led to the UAS crashing against the wall.

Figure 2: The UAS as it came to rest against the wall. (Source: Pilot)

The battery depleted rapidly which led to the loss of thrust and caused the UAS to lose height and impact against the wall.

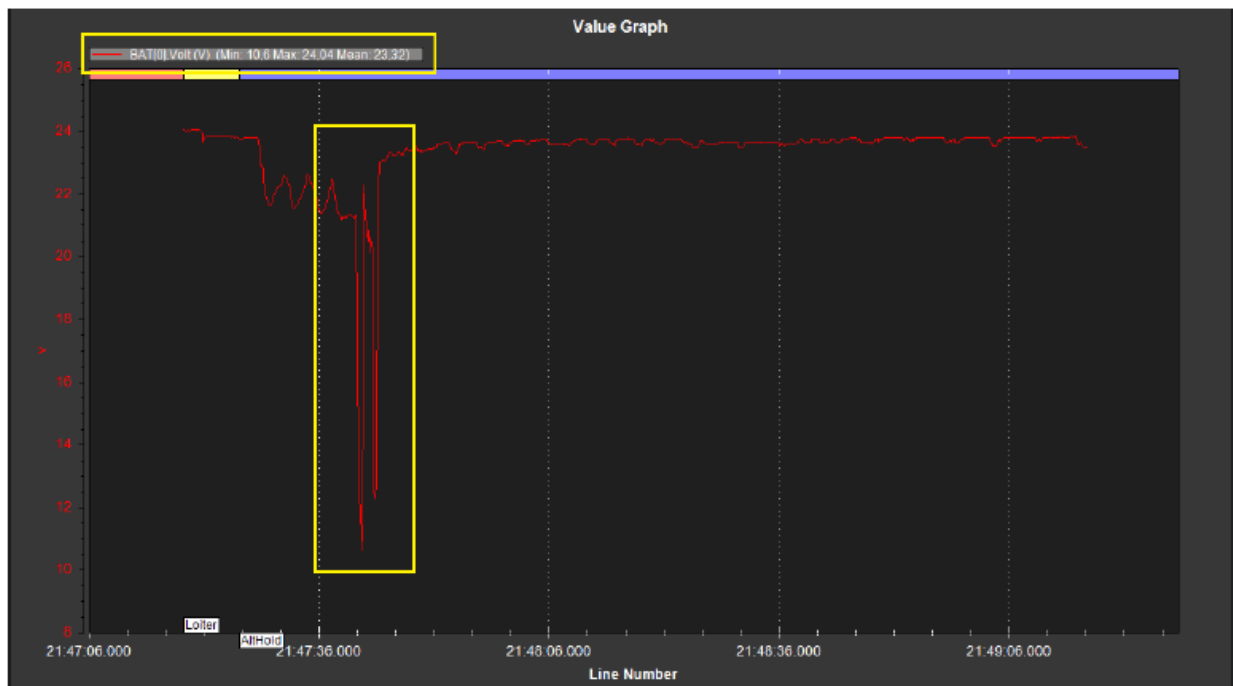
Figure 3: The battery read 10.6 V at take-off. (Source: Operator)

The battery had 10.6 V at the time of take-off; this caused the potential thrust loss.

The battery was more than a year old.

The volts were too low to for the aircraft to generate lift.

All batteries older than a year must be recalled for testing.

The operator recommended that batteries older than a year be recalled for testing. This was implemented by the operator.
