UAS LIMITED OCCURRENCE INVESTIGATION REPORT – FINAL

Reference Number	CA18/3/2/1417					
Classification	Serious Incident	Date	15 June 2023	Time	1754Z	
Type of Operation	Remotely Piloted Aircraft System – Surveillance (Part 101)					
Location						
Place of Departure	Bokgoni Colliery Mine, Mpumalanga Province		Place of Intended Landing	Bokgoni Colliery Mine, Mpumalanga Province		
Place of Occurrence	Bokgoni Colliery Mine in Mpumalanga Province					
GPS Co-ordinates	Latitude	26° 00' 40.00" S	Longitude	29° 13' 23.54" E	Elevation	5051 ft
Aircraft Information						
Registration	ZT-XSG		Class	3A		
Make; Model; S/N	DJI; Mavic 2 Enterprise Advanced (Serial Number: MAV0069)					
Damage to Aircraft	Minor		Total UAS Hours	975.3		
Pilot-in-command						
Licence Type	Remote Pilot Licence (RPL)		Gender	Male	Age	26
Licence Valid	Yes	Total Hours	628.9	Total Hours on Type	628.9	
Total Hours Past 90 Days	234.0		Total Flying Past 90 Days on Type	234.0		
People Controlling	1	Injuries (On Ground)	0	Fatalities	0	Fatalities (On Ground) 0

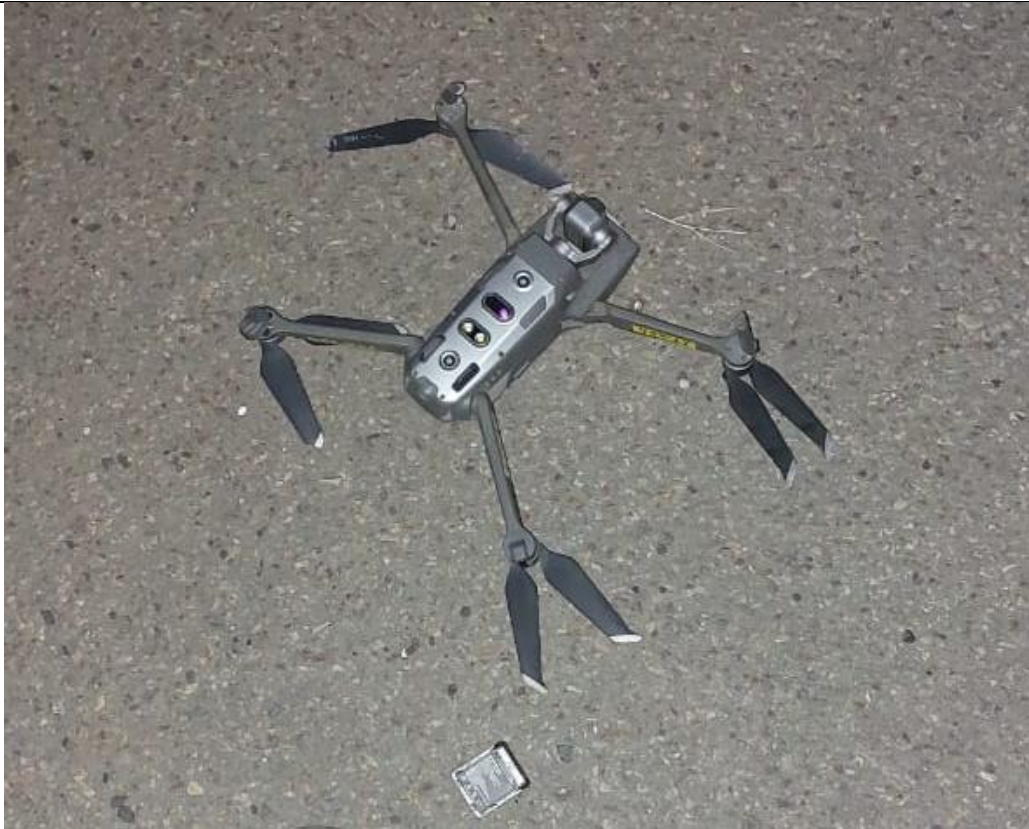
What Happened						
<p>On 15 June 2023, an Unmanned Aircraft System (UAS) with registration ZT-XSG was engaged in a surveillance flight at Bokgoni Colliery Mine in Witbank, Mpumalanga province, when the accident occurred. The flight was conducted under visual line of sight (VLOS) rules by night and under the provisions of Part 101 of the Civil Aviation Regulations (CAR) 2011 as amended.</p> <p>The pilot reported that whilst the UAS was 1.5 kilometres (km) from the take-off point, it lost signal. The pilot then engaged the return-to-home (RTH) button on the remote pilot station and the UAS flew homewards. As the UAS was commencing to land, the pilot deduced that it was going to impact the perimeter fence in the parking lot where he was stationed. The pilot engaged the RTH button again to stop it from landing, thereafter, switched to manual control and increased throttle to effect climb. However, the pilot responded too late as the UAS impacted the perimeter fence and damaged two of its propeller blades and one of the landing gears.</p> <p>The UAS sustained minor damage; there was no injury to persons or damage to property.</p>

Figure 1: The UAS at the incident site. (Source: Operator)

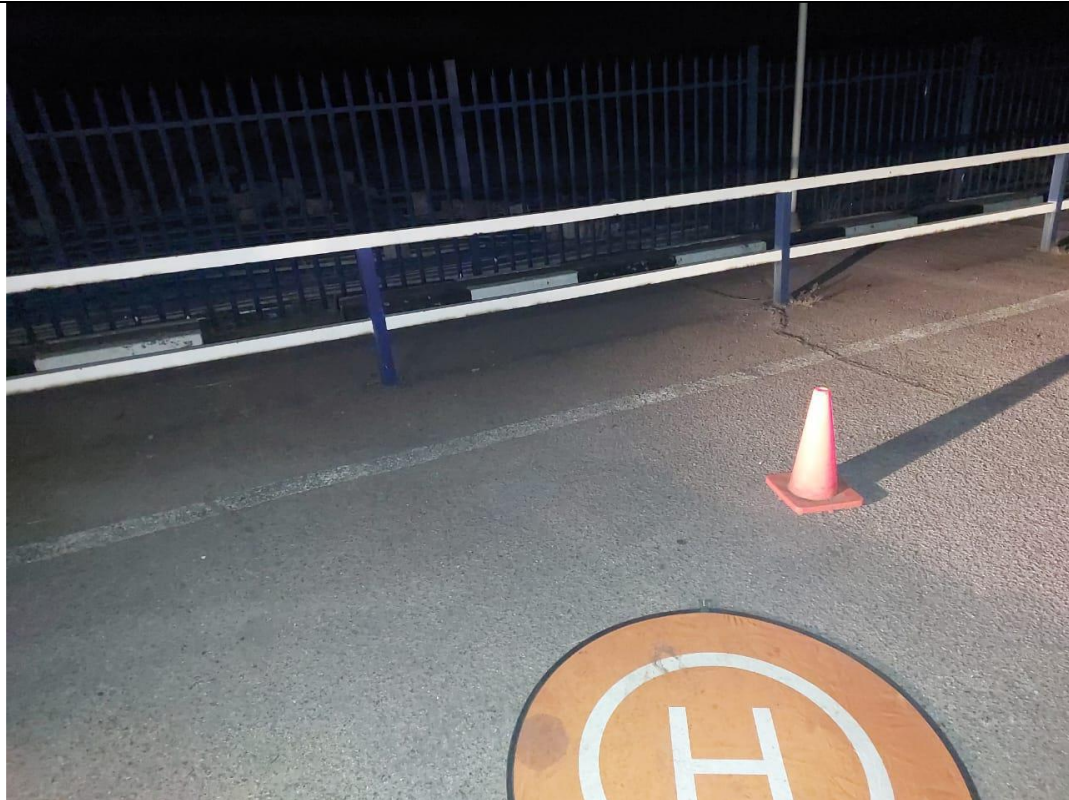
Figure 3: The incident site indicating the proximity of the landing zone to the perimeter fence.
(Source: Operator)

1. The aircraft disconnected from the C2 link and switched to RTL.
2. The pilot did not take back control, leaving the aircraft to auto land.
3. The aircraft hit a fence next to the LZ and flipped upside down.

Disconnection of the UAS from the C2 link and, whilst the UAS was returning to the landing zone, it impacted a perimeter fence. The cause of the link disconnection could not be determined.

1. The home base was too close to the perimeter fence.
2. Situational awareness.

Safety Actions
The pilot was reminded of operational requirements: 1. <i>The pilot must manually land the aircraft and must not leave his aircraft to auto land.</i> 2. <i>The pilot should only fill out the flight folio after the aircraft has been disarmed.</i>
Safety Message and/or Safety Recommendation(s)
None.
About this Report
<i>The decision to conduct a limited investigation is based on factors including whether the cause is known and the evidence supporting the cause is clear, the level of safety benefit likely to be obtained from an investigation and that will determine the scope of an investigation. For this occurrence, a limited investigation has been conducted, and the Accident and Incident Investigations Division (AIID) has relied on the information submitted by the affected person/s and organisation/s to compile this limited report. The report has been compiled using information supplied in the initial notification, as well as from follow-up desk top enquiries to bring awareness of potential safety issues to the industry in respect of this occurrence, as well as possible safety action/s that the industry might want to consider in preventing a recurrence of a similar occurrence.</i>
