UAS LIMITED OCCURRENCE INVESTIGATION REPORT – FINAL
--

Reference Number	CA18/3/2/1418						
Classification	Serious Incident	Date	16 June 2023	Time	1650Z		
Type of Operation	Unmanned Aerial Vehicle (Part 101)						
Location							
Place of Departure	Vryheid, KwaZulu-Natal Province	Place of Intended Landing	Vryheid, KwaZulu-Natal Province				
Place of Occurrence	Vryheid, KwaZulu-Natal Province						
GPS Co-ordinates	Latitude	27°46'16.23" S	Longitude	30°47'42.99" E	Elevation	3 835 ft	
Aircraft Information							
Registration	ZT-XVW	Class	3A				
Make; Model; S/N	Arace Sirin (Serial Number: SIR0074)						
Damage to Aircraft	Minor	Total UAS Hours	654.11				
Pilot-in-command							
Licence Type	Remote Pilot Licence (RPL)	Gender	Male	Age	27		
Licence Valid	Yes	Total Hours	619.31	Total Hours on Type	619.13		
Total Hours 30 Days	4.50		Total Flying on Type Past 90 Days	4.50			
People Controlling	1	Injuries	0	Fatalities	0	Injuries (on ground)	0
What Happened							
<p>On 16 June 2023, an Unmanned Aircraft System (UAS) with registration ZT-XVW was launched for demonstration purposes in Vryheid in KwaZulu-Natal province. The flight was conducted under visual line of sight (VLOS) rules by day an

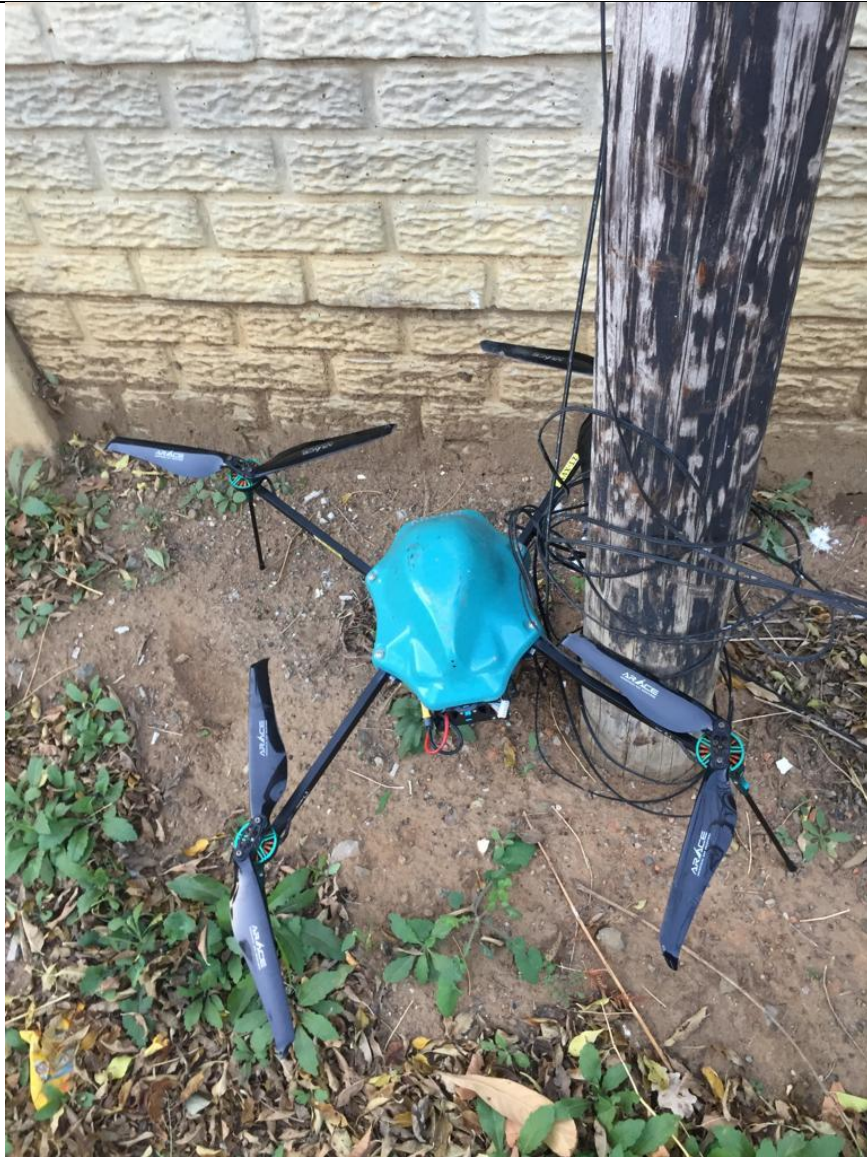
Figure 2: The UAS at the accident site. (Source: Pilot)

The UAS experienced a signal latency which resulted in the pilot losing control and, subsequently, it impacted a pole and crashed to the ground.

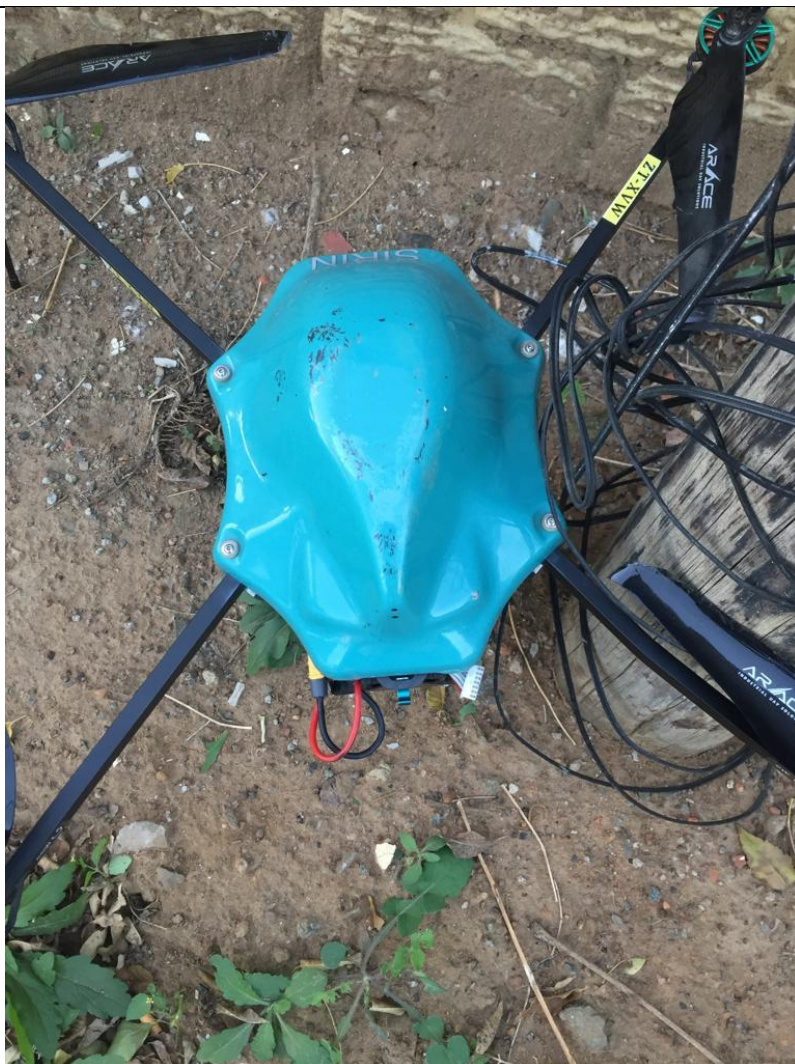
Figure 3: Close up view of the UAS after the accident. (Source: Pilot)
