LIMITED OCCURRENCE INVESTIGATION REPORT – FINAL

Reference Number	CA18/3/2/1419						
Classification	Serious Incident	Date	30 June 2023			Time	1830Z
Type of Operation	Training (Part 141)						
Location							
Place of Departure	Chief Dawid Stuurman International Airport (FAPE), Eastern Cape Province		Place of Intended Landing			Chief Dawid Stuurman International Airport (FAPE), Eastern Cape Province	
Place of Occurrence	On Runway 34 at Grahamstown Airport (FAGT), Eastern Cape Province						
GPS Co-ordinates	Latitude	33° 17'16.39"S	Longitude	26°30'07.08"E	Elevation	2 111 ft	
Aircraft Information							
Registration	ZS-OVY						
Make; Model; S/N	Piper Aircraft Corp; PA28-161 (Warrior III) (Serial Number: 2842156)						
Damage to Aircraft	Substantial			Total Aircraft Hours	11 695.3		
Pilot-in-command							
Licence Type	Commercial Pilot Licence (CPL)		Gender	Male		Age	28
Licence Valid	Yes	Total Hours	654.8		Total Hours on Type	554	
Total Hours 30 Days	6.8		Total Flying on Type Past 90 Days			97.8

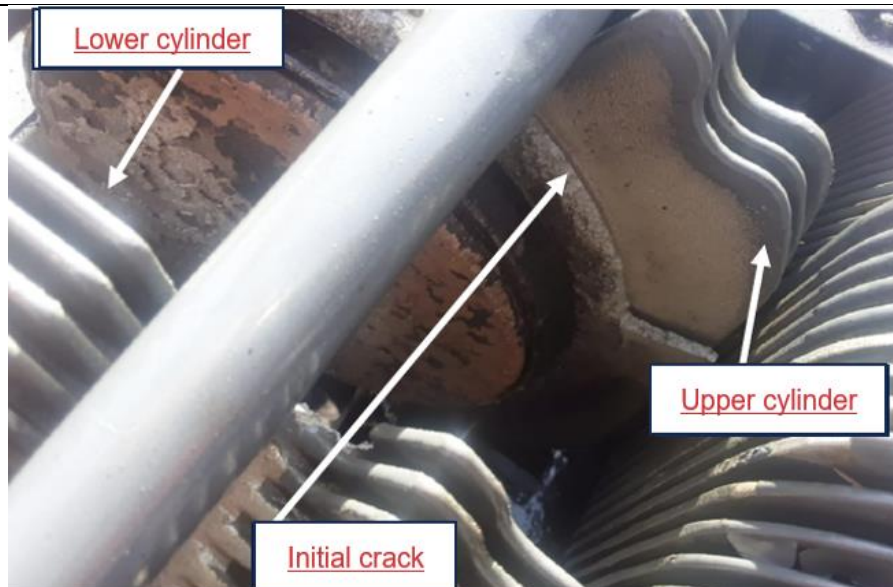
Cylinder number 2 had complete separation between the cylinder (steel) and head section (aluminium). The engine cylinders and heads are screwed and shrunk together, the cause of separation between this cylinder and head was the head material cracking and eventually causing the head to break off. There are signs of an initial crack indicated by blowby residue from the combustion gases escaping through a section about one quarter of the circumference of the cylinder barrel. The cause of the crack is unknown, however, the manufacturer of the cylinder assemblies had trouble with similar occurrences with their products in the past. Please refer FAA AD2007-04-19R1 as well as Superior Air Parts SB 0601. The engine oil sump was drained and a total of 1.2 Liters was measured.

The investigation revealed slight damage to the engine cowling due to impact from the cylinder head coming off, this is mostly paint related. Loss of oil due to the pushrod shrouds that were pulled out of place. Slight damage to the exhaust riser.

Figure 2: The separated cylinders. (Source: Operator)

Following the issuance of the SB B06-01 E and AD 2009-26-12, the operators are still experiencing cracks on cylinder heads. Therefore, it is recommended that the manufacturer conducts further research to prevent future failures/cracks in cylinder heads or reduce the time between overhaul (TBO) from 2200 hours to 1500 hours.

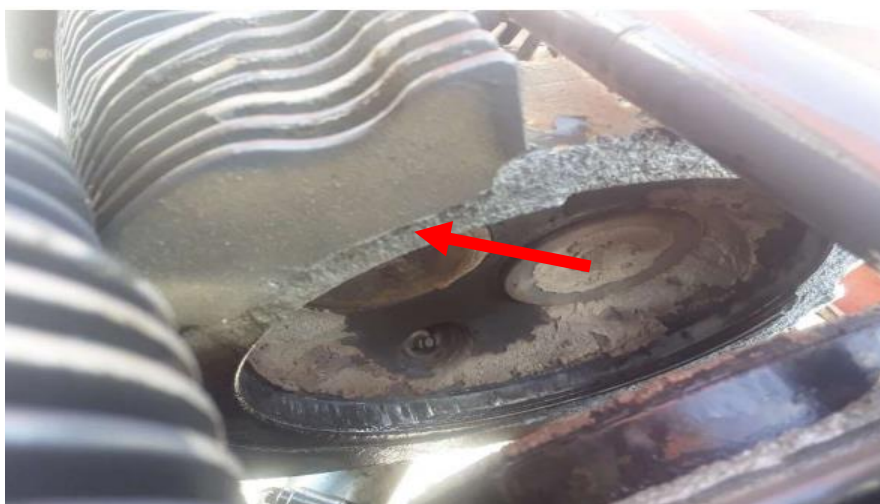
Figure 3: The upper part of the cylinder. (Source: Operator)

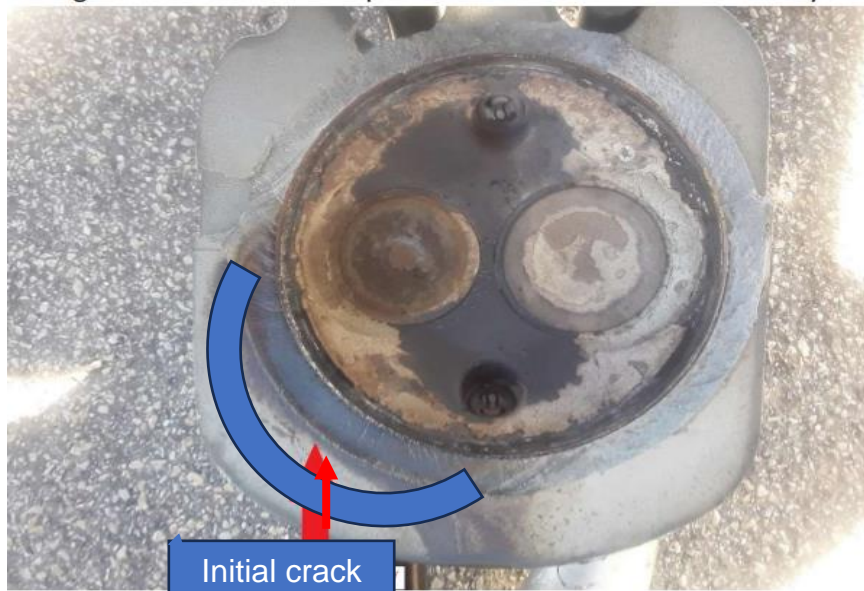
Figure 4: The bottom part of the cylinder. (Source: Operator)

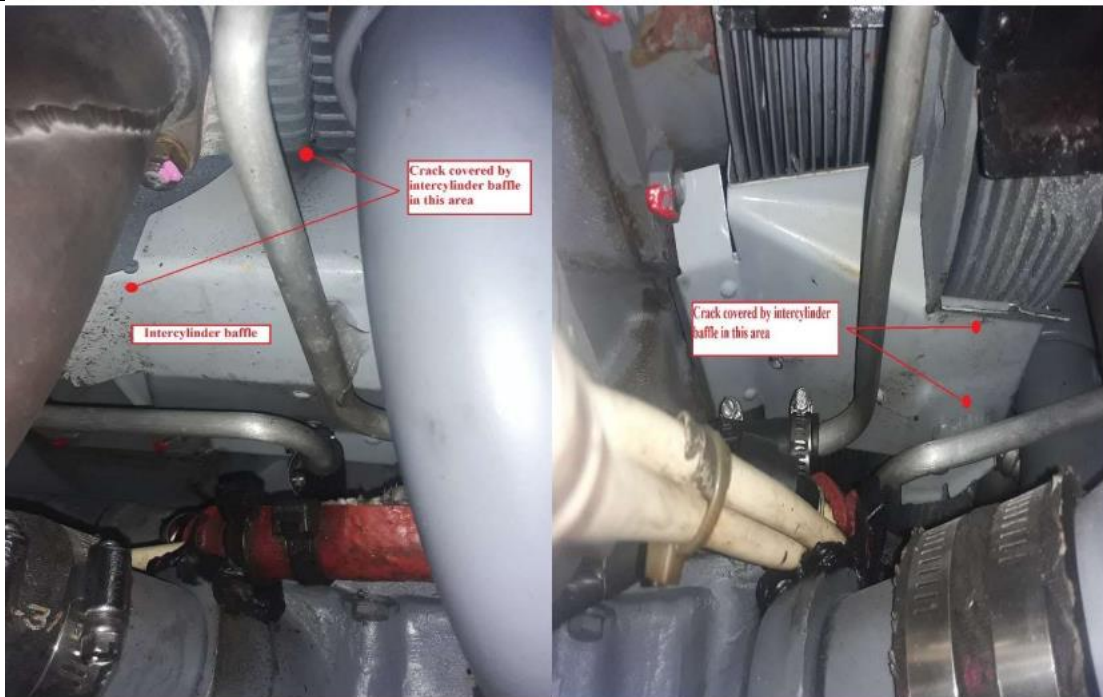
Figure 5: The location of the cracks covered by the baffles. (Source: Operator)

The location of the crack and the fact that it was covered by the baffles would have made it difficult to find. The aircraft was maintained in accordance with Piper Maintenance Manual Part number 761-882 Rev 8/31/2019 and GMRs. The aircraft had flown 11.5 airframe hours since the last annual inspection that was carried out on 4 June 2023 and a compression test (blowby test) (testing for air leakage) showed good compressions on all 4 cylinders. Since engine overhaul the aircraft had flown 1504.3 airframe hours. The time between overhaul (TBO) is 2200 engine hours.

The engine malfunctioned due to power loss caused by a cylinder head failure due to the fatigue crack. The crack started in an area located between the cylinders on the lower side that is covered by inter cylinder baffles. The compression test showed good results. The cylinder fatigue crack is similar to those failures that were recalled by the manufacturer,
