**LIMITED OCCURRENCE INVESTIGATION REPORT – FINAL**

<b>Reference Number</b>	CA18/3/2/1420						
<b>Classification</b>	Serious Incident	<b>Date</b>	8 July 2023	<b>Time</b>	0745Z		
<b>Type of Operation</b>	Private (Part 91)						
<b>Location</b>							
<b>Place of Departure</b>	Vaalkrans Game Farm near Makhanda, Eastern Cape Province		<b>Place of Intended Landing</b>	Vaalkrans Game Farm near Makhanda, Eastern Cape Province			
<b>Place of Occurrence</b>	Vaalkrans Game Farm near Makhanda, Eastern Cape Province						
<b>GPS Co-ordinates</b>	<b>Latitude</b>	33°13'55.06" S	<b>Longitude</b>	026°16'28.13" E	<b>Elevation</b>	1 895 ft	
<b>Aircraft Information</b>							
<b>Registration</b>	ZS-HEW						
<b>Make; Model; S/N</b>	Hughes Helicopters; 269C (Serial Number: 500919)						
<b>Damage to Aircraft</b>	Minor			<b>Total Airframe Hours</b>	1 197.6		
<b>Pilot-in-command</b>							
<b>Licence Type</b>	Private Pilot Licence		<b>Gender</b>	Male		<b>Age</b>	26
<b>Licence Valid</b>	Yes	<b>Total Hours</b>	441.3		<b>Total Hours on Type</b>	121.5

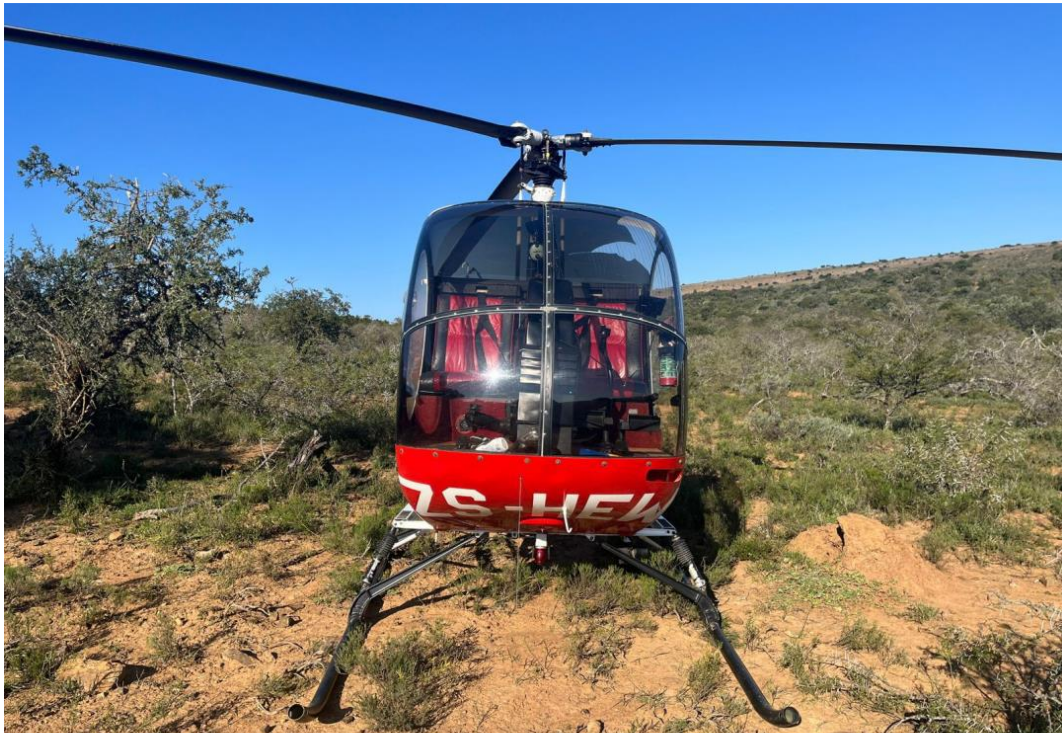
per minute (RPM) in the green arc and landed the helicopter approximately 150m from the place of impact with the power lines. During landing, the main rotor blades struck a small shrub (Figure 1), however, no damage was visible to the main rotor blades apart from the leading-edge blade tape that was worn out. The windshield cracked at two places, and one of the flight controls connecting rods (located next to the main rotor drive shaft) that connects to the non-rotating swash plate bent (see Figure 6). After landing, the pilot secured the helicopter and switched off the master switch. Both occupants disembarked from the helicopter uninjured.

**Figure 1:** The helicopter after landing. (Source: Pilot)

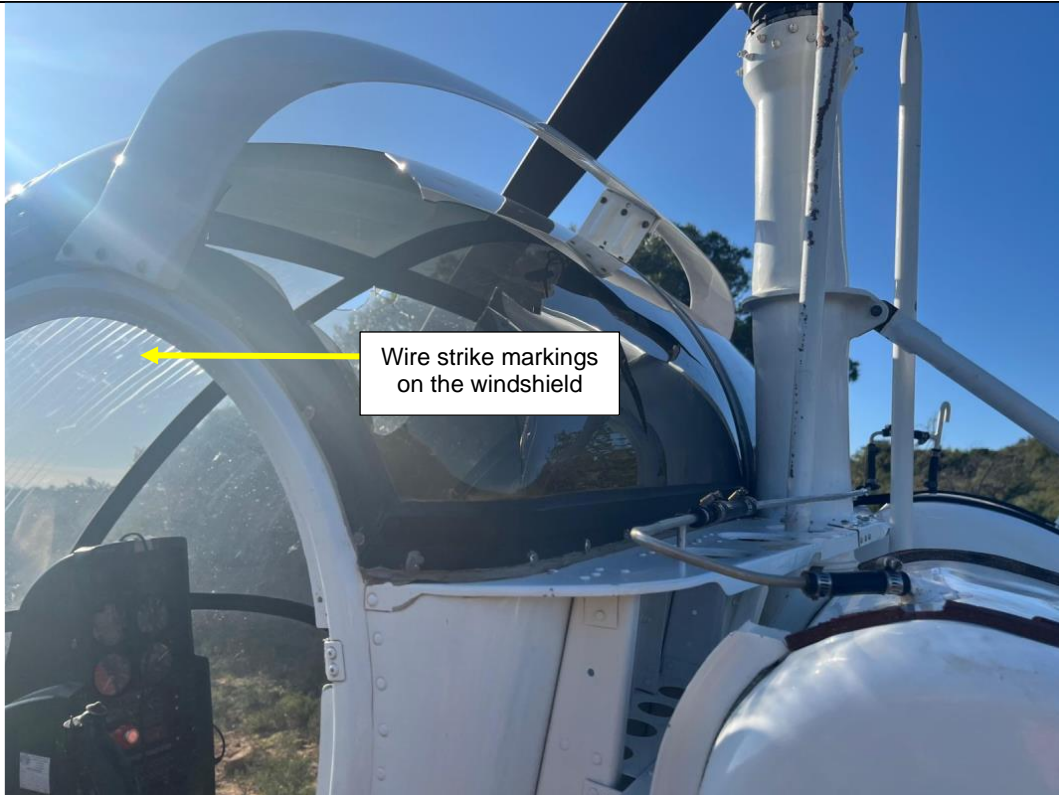
**Figure 2:** The wire strike markings on the windshield. (Source: Pilot)

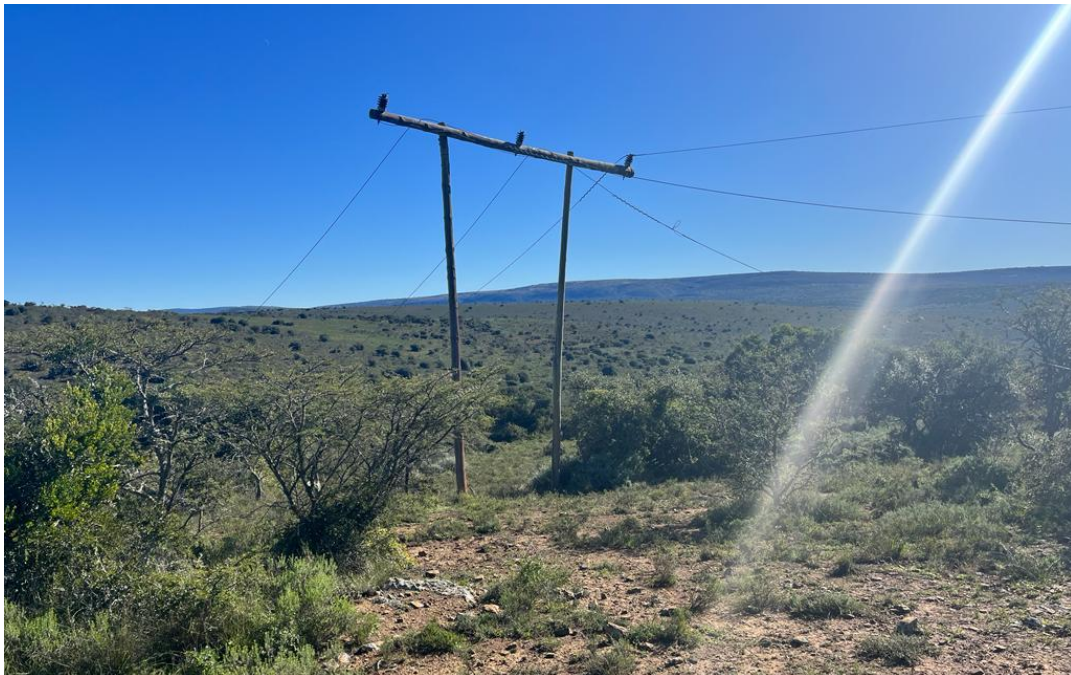
**Figure 3:** A pylon with all three power lines severed during impact. (Source: Pilot)

<b>Probable Cause</b>
The pilot did not keep a proper lookout during the low-level flight, which resulted in the helicopter impacting the power lines during a surveillance flight on a game farm.
<b>Contributing Factor(s)</b>
Failure to maintain safe height above obstacles.
<b>Safety Action(s)</b>
None.
<b>Safety Messages</b>
<p>1. The helicopter pilots should wear helmets and proper safety gear (fire-resistant flight suits) during operation as well as gloves to prevent injuries. This is especially relevant during low-level operations (i.e., game capture, crop-spraying and similar types of operations).</p> <p>2. The helicopter operators should mandate their pilots to adorn helmets and proper safety gear (fire-resistant flight suits) during operation as well as gloves to prevent injuries. This is especially relevant during low-level operations (i.e., game capture, crop-spraying and similar types of operations).</p> <p>3. Helicopter pilots are reminded to always conduct a proper flight planning and be alert of the potential hazards identified during flight planning.</p>

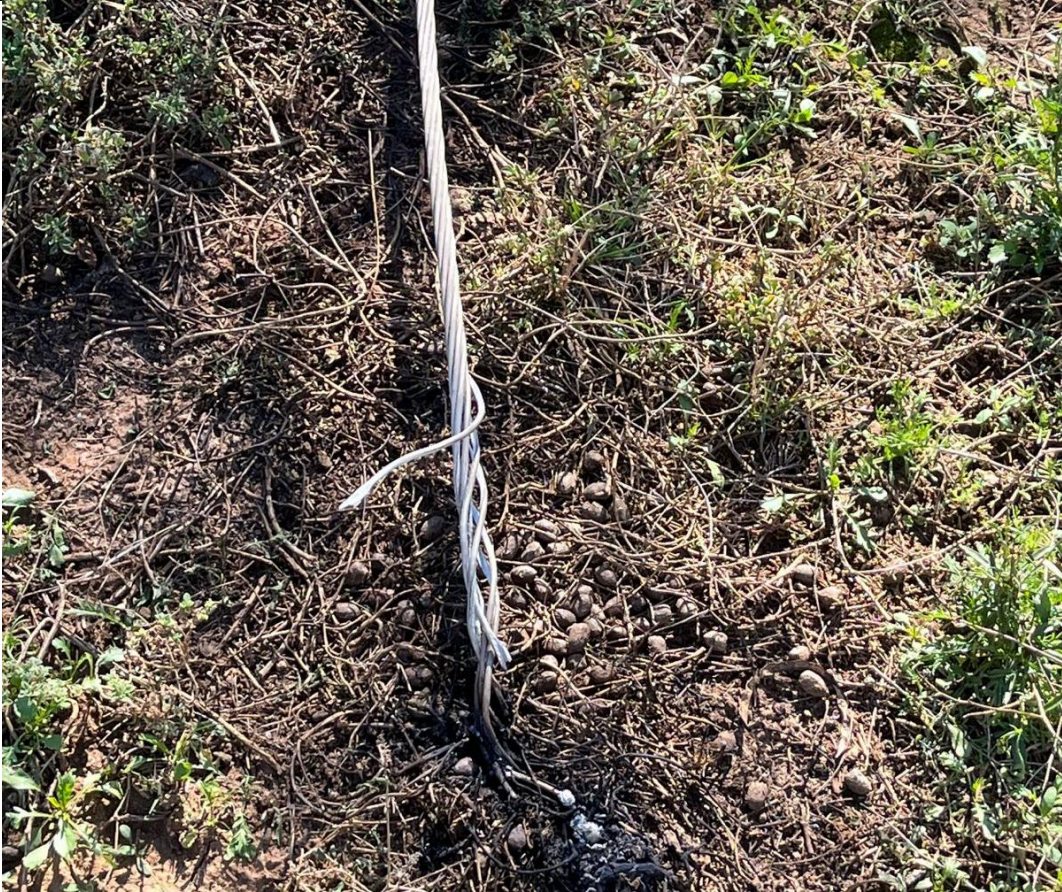
**Figure 4:** One of the severed cables. (Source: Pilot)

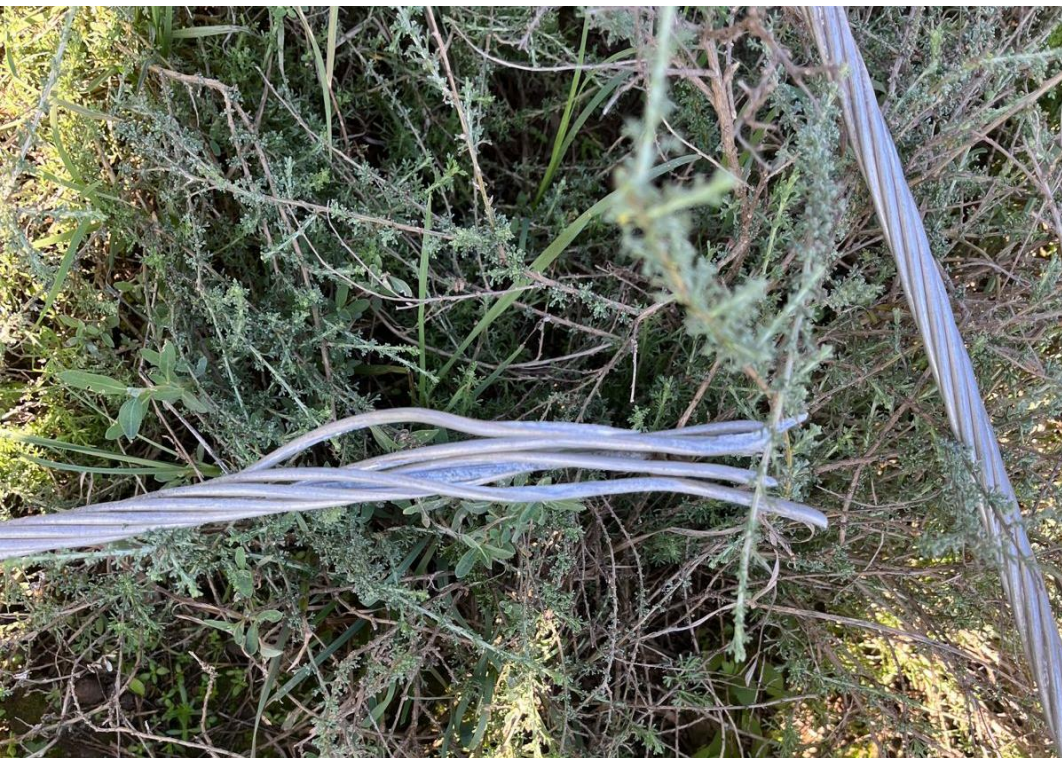
**Figure 5:** Cables that were severed. (Source: Pilot)

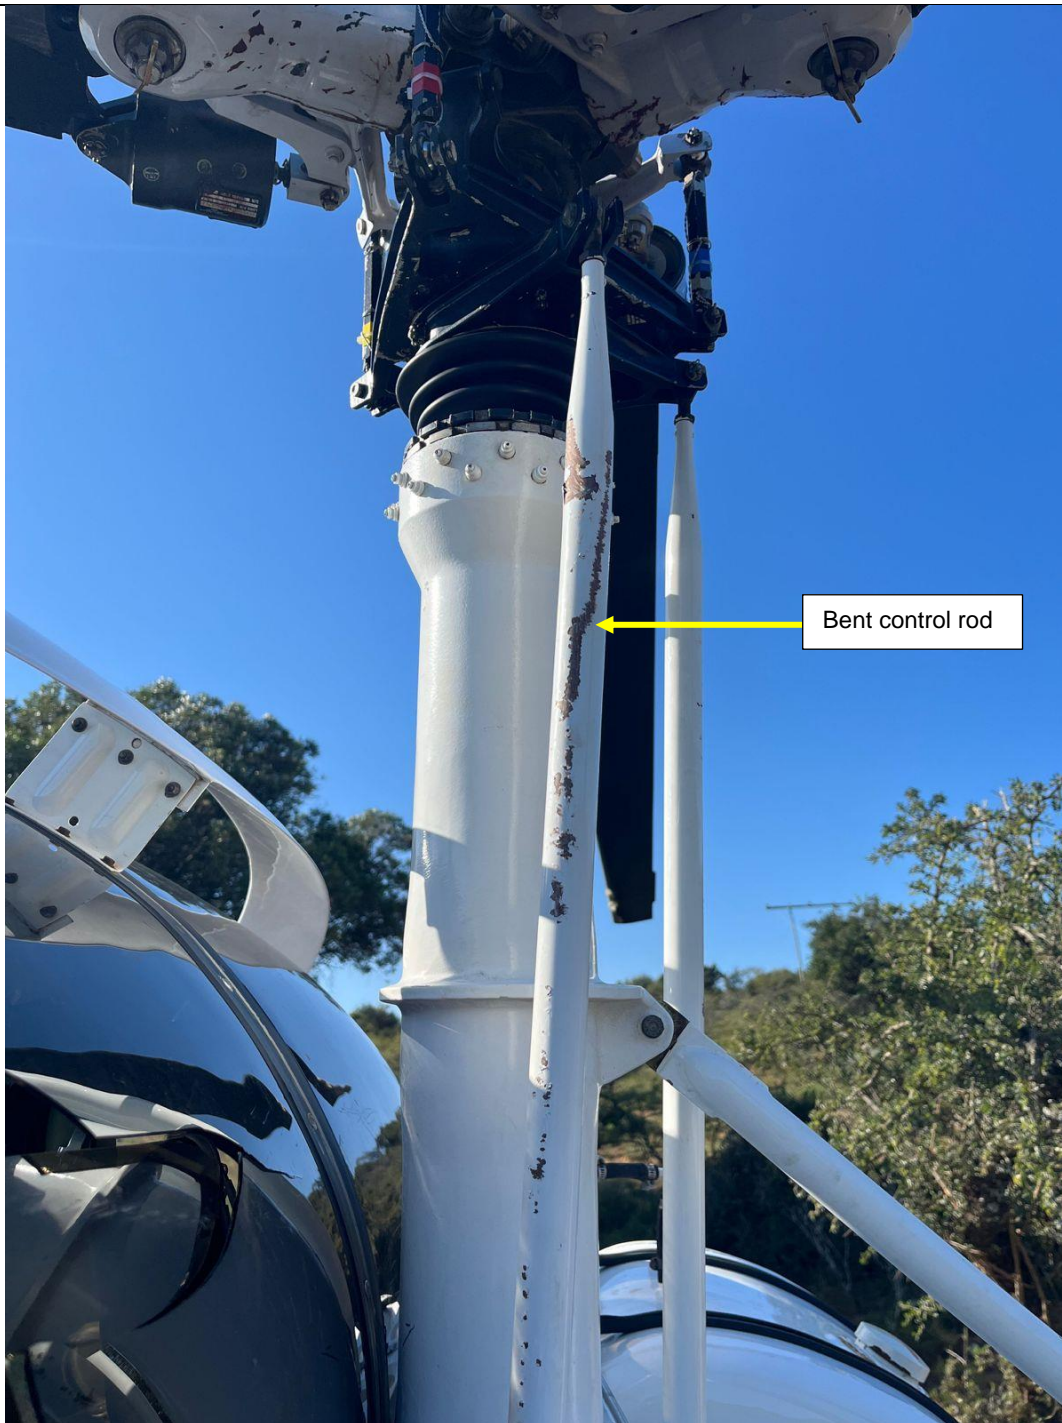
**Figure 6:** One of the control rods that was bent after impact with the power lines. (Source: Pilot)
