**AIRCRAFT SERIOUS INCIDENT REPORT AND EXECUTIVE SUMMARY**

<b>Reference:</b>		CA18/3/2/1421	
<b>Aircraft Registration</b>	G-XLEH	<b>Date of Serious Incident</b>	12 July 2023		<b>Time of Serious Incident</b>	1804Z
<b>Type of Aircraft</b>	Airbus A380-841		<b>Type of Operation</b>		Air Transport (Part 121)	
<b>Pilot-in-command Licence Type</b>		Airline Transport Pilot Licence	<b>Age</b>	53	<b>Licence Valid</b>	Yes
<b>Pilot-in-command Flying Experience</b>		<b>Total Flying Hours</b>		20 000.0	<b>Hours on Type</b>	4 300.0
<b>Last Point of Departure</b>		O.R. Tambo International Aerodrome (FAOR), South Africa				
<b>Next Point of Intended Landing</b>		Heathrow International Aerodrome (EGLL), United Kingdom				
<b>Damage to Aircraft</b>		Minor				
<b>Location of the site concerning easily defined geographical points (GPS readings if possible)</b>						
Approximately 60nm south of the ETMIT waypoint (GPS position: 24°12'32.23" South 027°45'36.32" East)						
<b>Meteorological Information</b>		Surface wind: 030°/11 knots, temperature: 11°C, dew point: 3°C, CAVOK

<b>Reference Number</b>	: CA18/3/2/1421
<b>Occurrence Category</b>	: Serious Incident (Category 1)
<b>Type of Operation</b>	: Ai

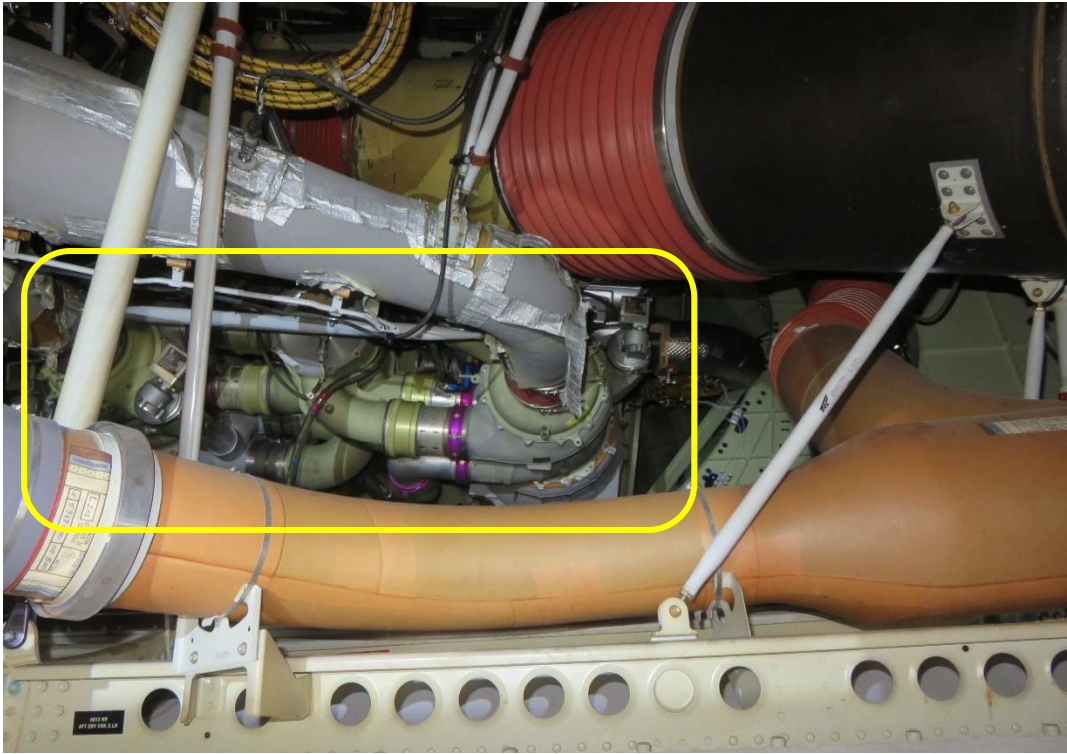
1.16.1 The damaged Air Cycle Machine (ACM) is one of two ACM units in the Air Generation Unit (AGU). There are two AGUs in the aircraft, therefore, there is a total of four ACMs per aircraft. ACM unit 2, which was installed in AGU 1, located on the left side of the aircraft (viewed from the aft) failed; it was removed from the aircraft by an approved aircraft maintenance organisation (AMO) in the United Kingdom. The unit was sent to the original equipment manufacturer (OEM) in Windsor Locks, Connecticut, in the United States of America for examination. The AIID requested oversight during the examination from the National Transportation Safety Board (NTSB) which, in turn, requested the regional Federal Aviation Administration (FAA) office to provide oversight supervision. The examination was performed on Tuesday, 14 November 2023. A brief description of the air-conditioning system on the aircraft is presented in paragraph 1.6.2 of this report.

**Figure 4:** AGU 1 which consists of two ACMs before their removal from the aircraft.

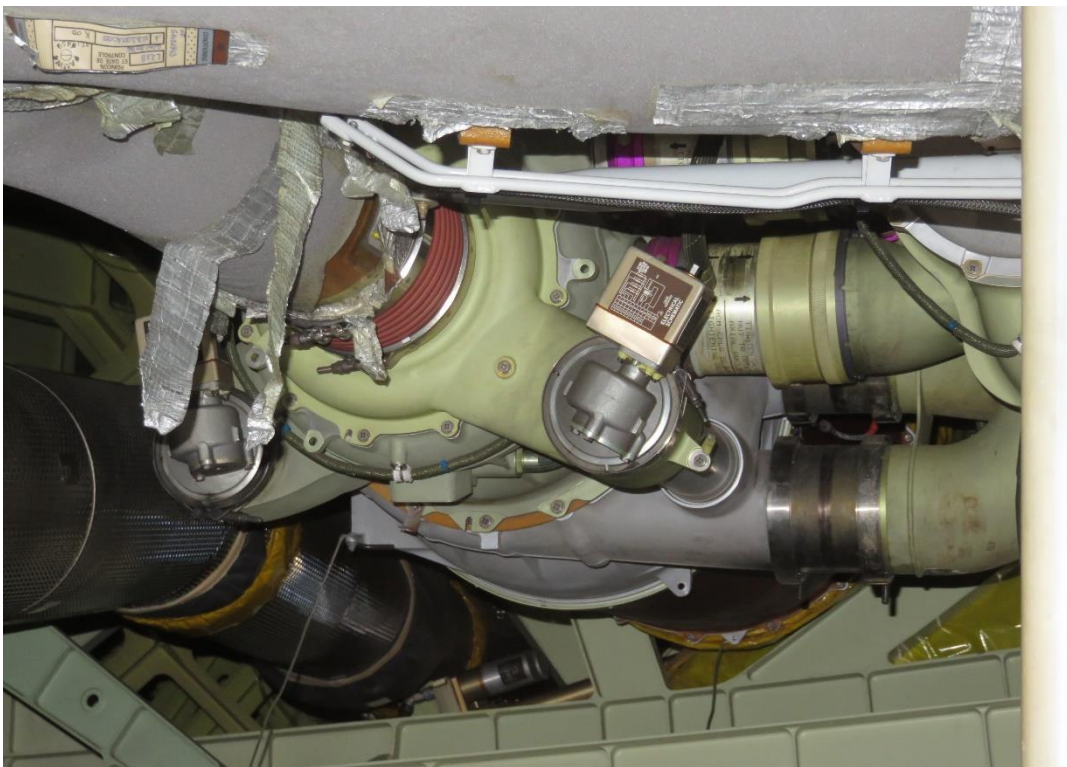
**Figure 5:** A close-up view of the ACM before removal from the aircraft.

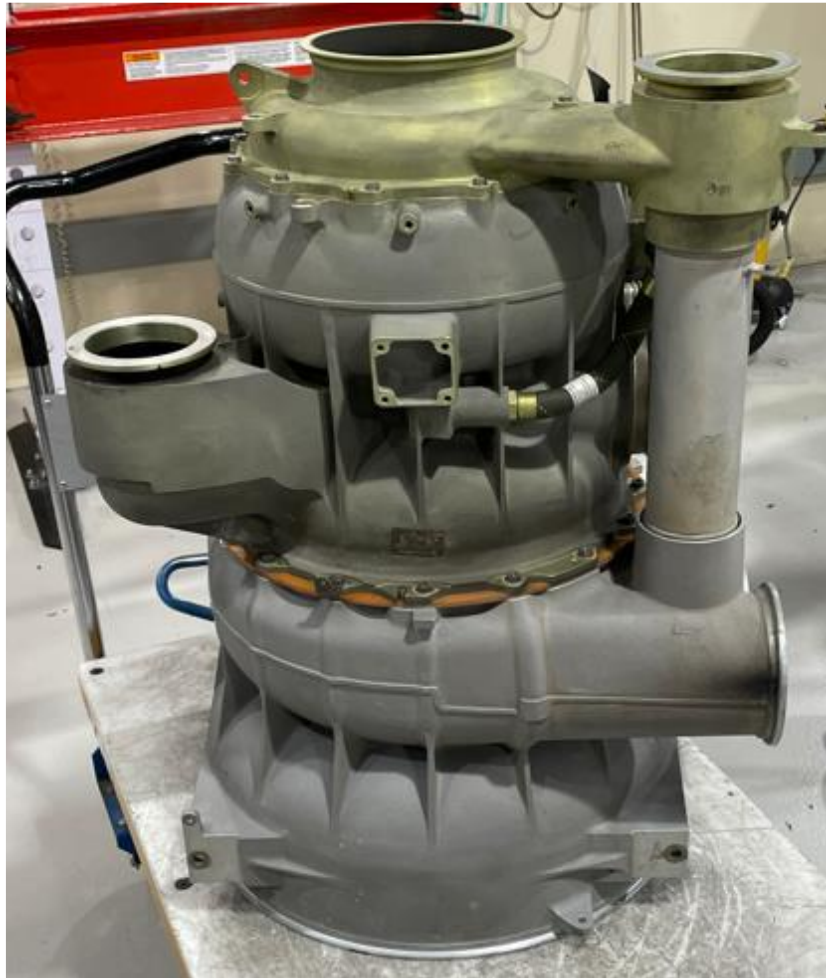
**Figure 6:** The ACM unit before disassembly.

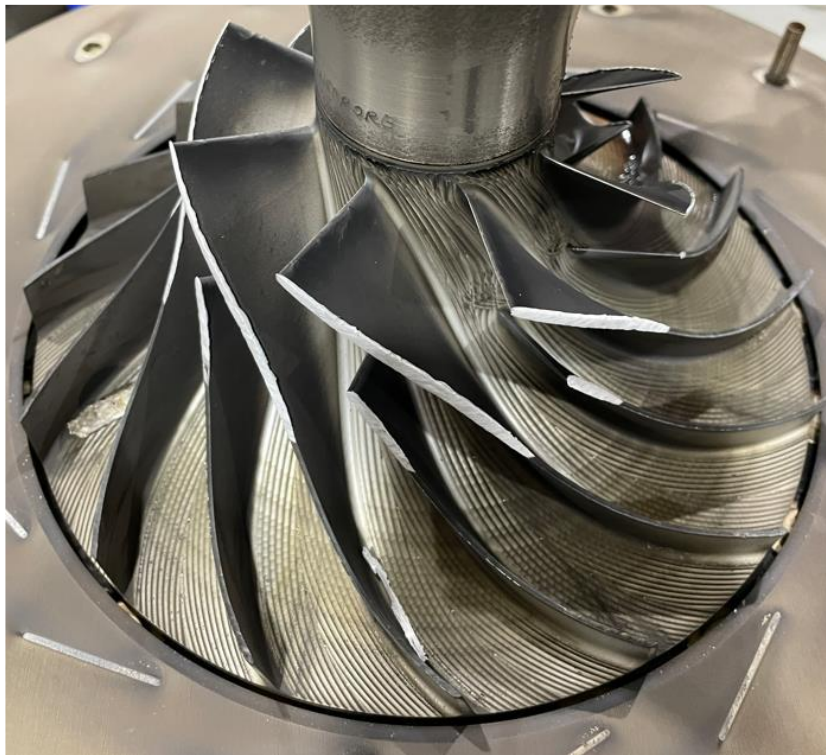
*The compressor rotor had a moderate, predominately radial, rub which was uniform on the shroud and local on the rotor, refer to Figure 8.*

**Figure 8:** Compressor rotor with damage on the blades.

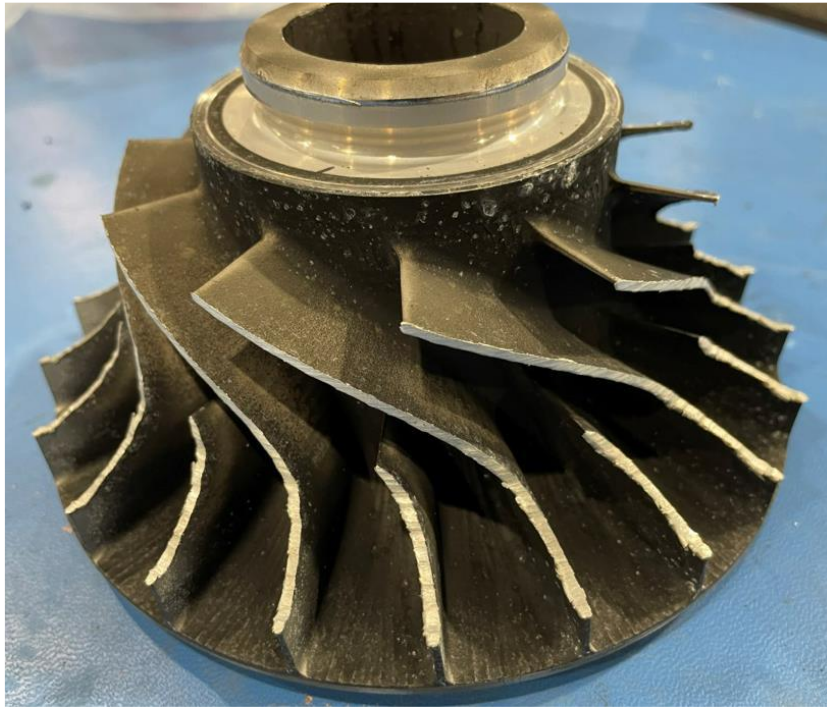
*The Turbine 1 (T1) and Turbine 2 (T2) rotors were both heavily rubbed with their respective shrouds in both the axial and radial directions. The rub patterns on the shrouds were predominately uniform and had a material transfer from the rotors. The rub patterns on both the T1 and T2 rotors were locally heavy, refer to Figures 9 and 10.*

**Figure 9:** First-stage turbine rotor with damaged blades.

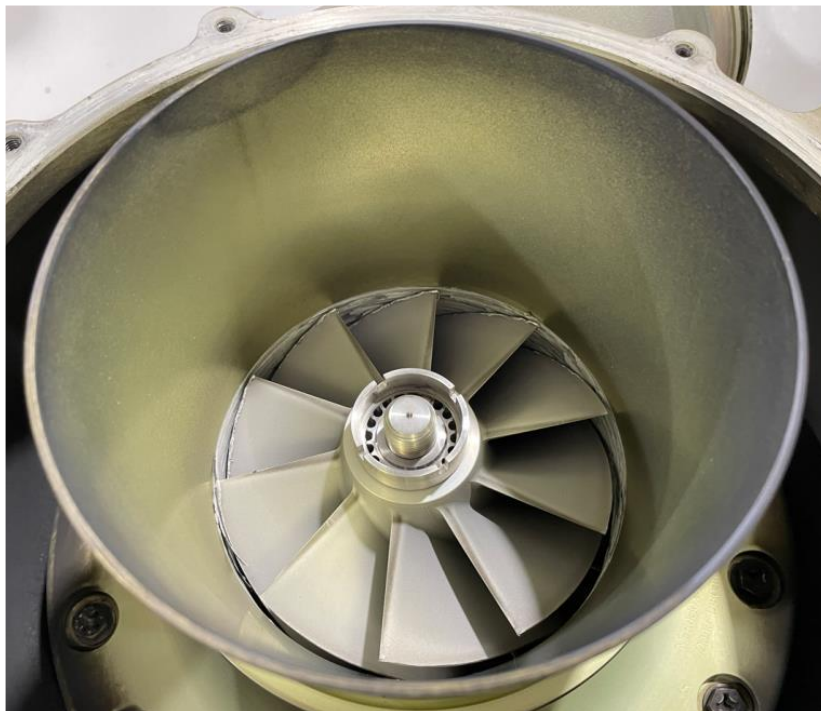
**Figure 10:** The second stage turbine rotor with radial damage.

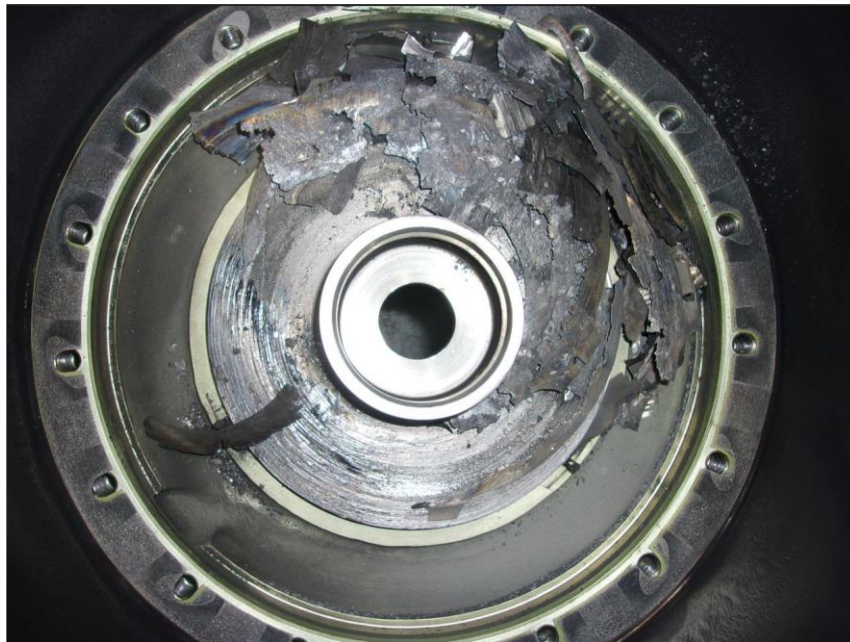
*The condition of the hardware showed a primary failure mode of turbine end journal bearing overload. The thrust bearings and the fan end journal bearing were damaged as a result of the shaft motion that occurred and are considered to be associated with damage. The condition of the ACM parts is shown in the following figures. These images were taken during the disassembly of the unit.*

**Figure 12:** The turbine side thrust bearing was severely damaged during failure. The compressor side thrust bearing was similarly damaged, but as the turbine end shaft could not be removed, an image of that thrust bearing is not available.

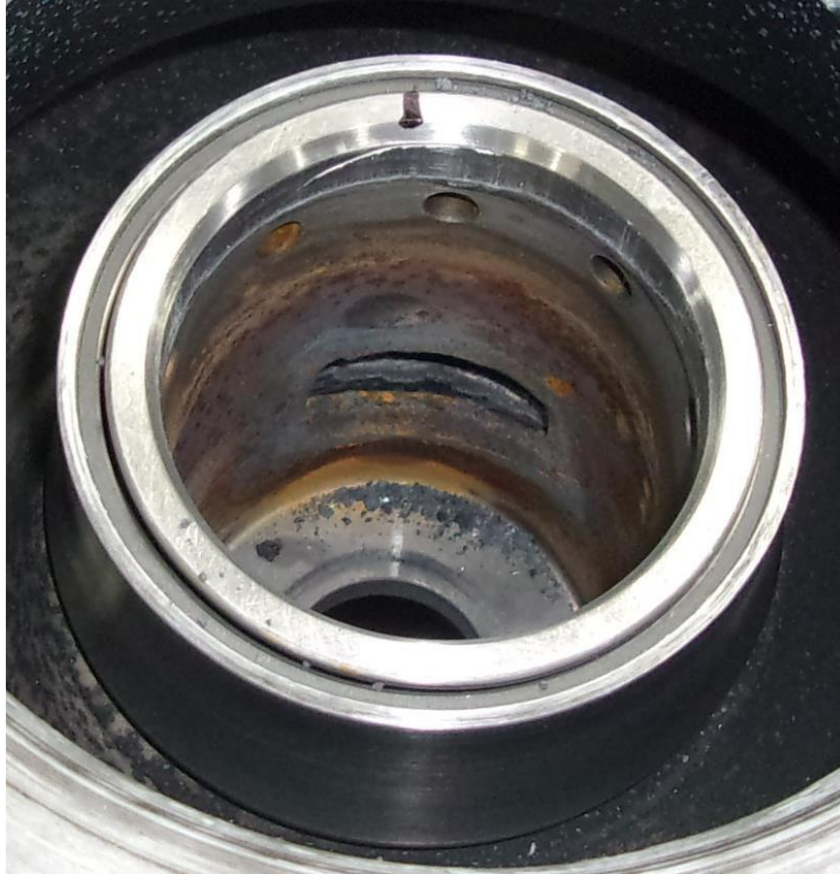
*The degree of damage incurred at the turbine end journal bearing location was proportionately more severe than at any of the other bearing locations. The turbine journal bearing failure resulted in material degradation of the shaft journal surface to the point where a hole formed at the contact point, refer to Figure 12. This area was sufficiently deformed that it interfered with the inner geometry of the turbine journal bearing sleeve to the point where removal of the shaft was not possible in a normal manner.*

**Figure 13:** The inside of the turbine end shaft with a hole that had developed at the point of failure of the turbine end journal bearing. The hole had formed at the tip of the bulge due to the heat generated by contact between the rotating shaft and the stationary parts.

3.2.13 It was discovered that the failure of the Air Cycle Machine (ACM) unit 2 which forms part of the Air Generation Unit 1 had failed, and the fretting observed on the turbine end journal bearing was likely the source of the acrid smell.
