**LIMITED OCCURRENCE INVESTIGATION REPORT – FINAL**

<b>Reference Number</b>	CA18/3/2/1422						
<b>Classification</b>	Serious Incident	<b>Date</b>	23 July 2023			<b>Time</b>	1449Z
<b>Type of Operation</b>	Training Part 141						
<b>Location</b>							
Place of Departure	Lanseria International Airport (FALA), Gauteng Province			Place of Intended Landing	Lanseria International Airport (FALA), Gauteng Province		
Place of Occurrence	West of Runway 07 at FALA, GPS: 25°56'15.95" South 027°55'35.45" East at an elevation of 4 465 feet						
GPS Co-ordinates	Latitude	25°56'15.95" S	Longitude	027°55'35.45" E	Elevation	4 465 feet	
<b>Aircraft Information</b>							
Registration	ZS-PPB						
Make; Model; S/N	Piper; PA28-161 Warrior III (Serial Number: 28-7816457)						
Damage to Aircraft	None			Total Aircraft Hours	8 109.06		
<b>Pilot-in-command</b>							
Licence Type	Student Pilot Licence (A)		Gender	Male		Age	27
Licence Valid	Yes	Total Hours	41		Total Hours on Type	41

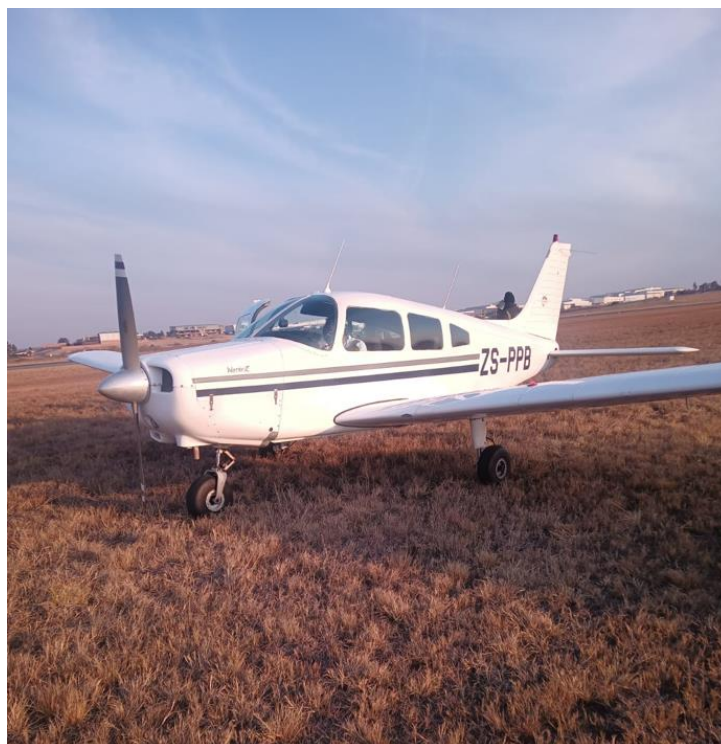
with stage 3 flaps (full flaps) at the threshold of RWY07. After touchdown whilst the student pilot was initiating a take-off run and selecting flaps (up position at 0° flaps) the aircraft lost directional control and veered off to the left of the runway and onto the grass area, after which he applied the brakes. The aircraft came to a stop a few metres from the runway edge before he shut down the engine.

**Figure 1:** The aircraft after it vacated the runway. (Source: ARFFS)

Loss of directional control after initiating take-off during the touch-and-go landing exercise. The loss of control was due to the application of power before selecting the flaps to the up position, this caused the aircraft to yaw sharply to the left because of the torque effects of the engine and propeller.

To mitigate the risks associated with runway excursion, the CFI conducted a roundtable safety meeting on 27 July 2023 with all instructors and student pilots to discuss safety matters with the emphasis on prioritising aviate, navigate and communicate (ANC) systemic approach during high workload situations, as well as the benefit of following procedures on the checklists. The maximum hours and the number of circuits a solo student pilot could fly were also discussed with the aim to minimise the possibility of prolonged flights.

On 1 August 2023, the ATO developed the touch-and-go procedure as part of the mitigation process to reduce the risk of runway excursions.

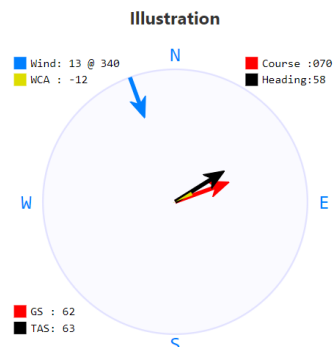
Course :	<input type="text" value="070"/>
True Air Speed :	<input type="text" value="63"/>
Wind Direction :	<input type="text" value="340"/>
Wind Speed :	<input type="text" value="13"/>
Wind Correction Angle :	<input type="text" value="-12"/>
Heading :	<input type="text" value="58"/>
Ground Speed :	<input type="text" value="62"/>

**Illustration 1:** Wind direction and runway heading. (Source: [E6B Calculator | Flight Computer with Illustrations | Online Aviation Calculators \(e6bx.com\)](#)).
