LIMITED OCCURRENCE INVESTIGATION REPORT – FINAL

Reference Number	CA18/3/2/1423						
Classification	Serious Incident	Date	23 July 2023	Time	1330Z		
Type of Operation	Private (Part 94)						
Location							
Place of Departure	Parys Aerodrome (FAPY), Free State Province		Place of Intended Landing	Parys Aerodrome (FAPY), Free State Province			
Place of Occurrence	Runway 24 at Parys Aerodrome						
GPS Co-ordinates	Latitude	26° 53' 09.15" S	Longitude	27° 30' 25.90" E	Elevation	4 694 ft	
Aircraft Information							
Registration	ZS-UZV						
Make; Model; S/N	H3 Aerospace GmbH & Co KG; Grob 109B (Serial Number: 6235)						
Damage to Aircraft	Minor		Total Aircraft Hours	±717.5			
Pilot-in-command							
Licence Type	Commercial Pilot Licence (CPL) Aeroplane		Gender	Male		Age	35
Licence Valid	Yes	Total Hours	1 195.0		Total Hours on Type	4.5	
Total Hours 30 Days	1.1		Total Flying on Type Past 90 Days	1.9			
People On-board	1 + 0	Injuries	0	Fatalities	0	Other (on ground)	0

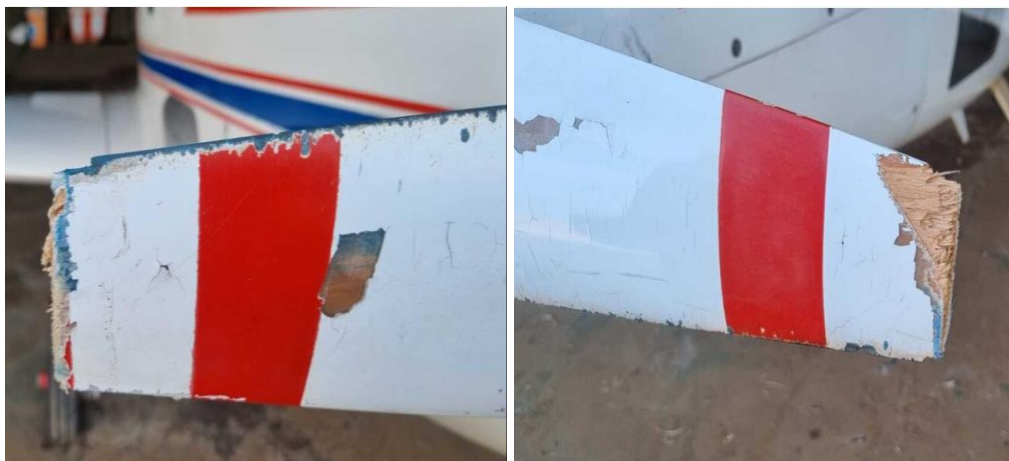
What Happened							
<p>On 23 July 2023, a pilot on-board a Grob 109B aircraft with registration ZS-UZV took off on a private flight from Parys Aerodrome (FAPY) in the Free State province with the intention to land back at FAPY. Visual meteorological conditions (VMC) by day prevailed at the time of the flight which was conducted under the provisions of Part 94 of the Civil Aviation Regulations (CAR) 2011 as amended.</p> <p>The pilot stated that he lost directional control of the aircraft during take-off on Runway 24 due to the crosswind component from the right after the tailwheel lifted off from the ground. This caused the propeller blades to strike the runway surface. Later, the pilot regained control of the aircraft and steered it to the runway centreline and rotated. The pilot flew a circuit and performed an uneventful full stop landing on Runway 24. The pilot was not injured during the incident. The aircraft's ground speed at the time of take-off was approximately 54 knots (kts). <i>According to the Grob 109B Flight Manual (FM), the recommended take-off speed is between 48-59 kts.</i></p> <p>During post-flight inspection, the pilot noticed that the propeller blade tips were damaged.</p>

Figures 2 and 3: Damage sustained by the propeller blade tips. (Source: Pilot)

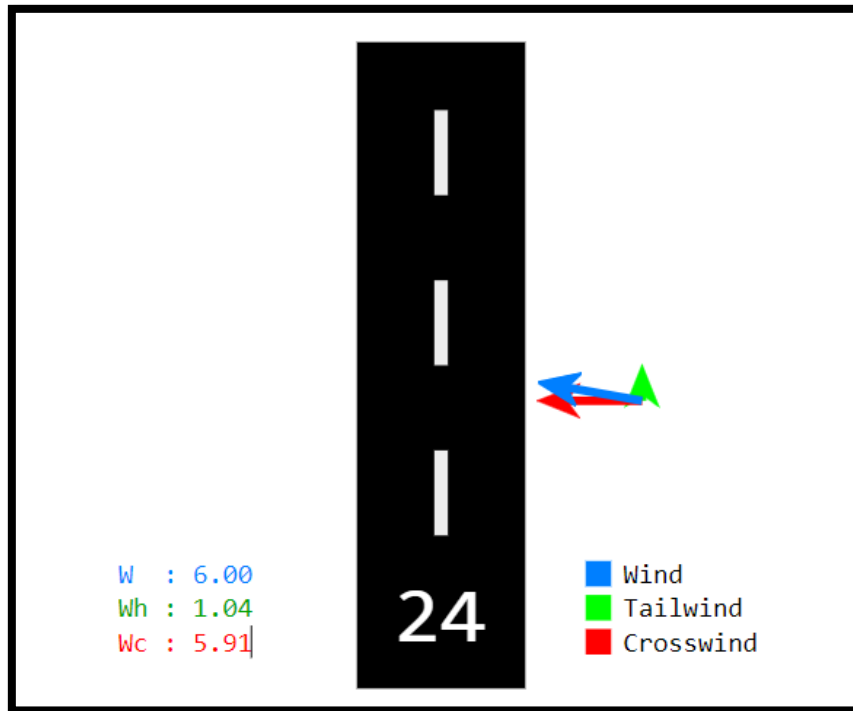
Figure 4: Crosswind component.

The wind blew north-westerly at approximately 6 kts to 7 kts at the time of the incident; the dew point depression was approximately 20°C which indicated dry conditions near the surface.

6. The aircraft took off with the crosswind component of approximately 5.91 kts. According to the aircraft's flight manual, page 27, the <i>maximum cross wind component for take-off and landing on dry and wet surfaces is 20 km/h (11 kts).</i>
Probable Cause(s)
Loss of directional control during take-off which caused the aircraft's nose to pitch down, followed by the propeller strikes on the runway.
Contributing Factor(s)
Failure to maintain directional control of the aircraft during take-off.
Safety Action(s)
None.
Safety Message and/or Safety Recommendation/s
None.
About this Report
<i>The decision to conduct a limited investigation is based on factors including whether the cause is known and the evidence supporting the cause is clear, the level of safety benefit likely to be obtained from an investigation and that will determine the scope of an investigation. For this occurrence, a limited investigation has been conducted, and the Accident and Incident Investigations Division (AIID) has relied on the information submitted by the affected person/s and organisation/s to compile this limited report. The report has been compiled using information supplied in the initial notification, as well as from follow-up desk top enquiries to bring awareness of potential safety issues to the industry in respect of this occurrence, as well as possible safety action/s that the industry might want to consider in preventing a recurrence of a similar occurrence.</i>
