LIMITED OCCURRENCE INVESTIGATION REPORT – FINAL

Reference Number	CA18/3/2/1424						
Classification	Serious Incident	Date	7 August 2023		Time	1230Z	
Type of Operation	Air Transport Operations Carriage (less than 20 passengers) – Part 135						
Location							
Place of Departure	Arathusa Safari Lodge (FAAR) Airstrip, Mpumalanga Province		Place of Intended Landing	Mala Mala Airfield (FAMD), Mpumalanga Province			
Place of Occurrence	Mala Mala Airfield (FAMD)						
GPS Co-ordinates	Latitude	24°48'39.83" S	Longitude	031°32'19.78" E	Elevation	1 070 feet	
Aircraft Information							
Registration	ZS-JEM						
Make; Model; S/N	Cessna Aircraft Company; 208B (Serial Number: 208B-0912)						
Damage to Aircraft	Minor		Total Aircraft Hours	15 762.16			
Pilot-in-command							
Licence Type	Commercial Pilot Licence (CPL)		Gender	Male	Age	27	
Licence Valid	Yes	Total Hours	2 009.3	Total Hours on Type	479.7		
Total Hours 30 Days	60.8		Total Flying on Type Past 90 Days	182.4

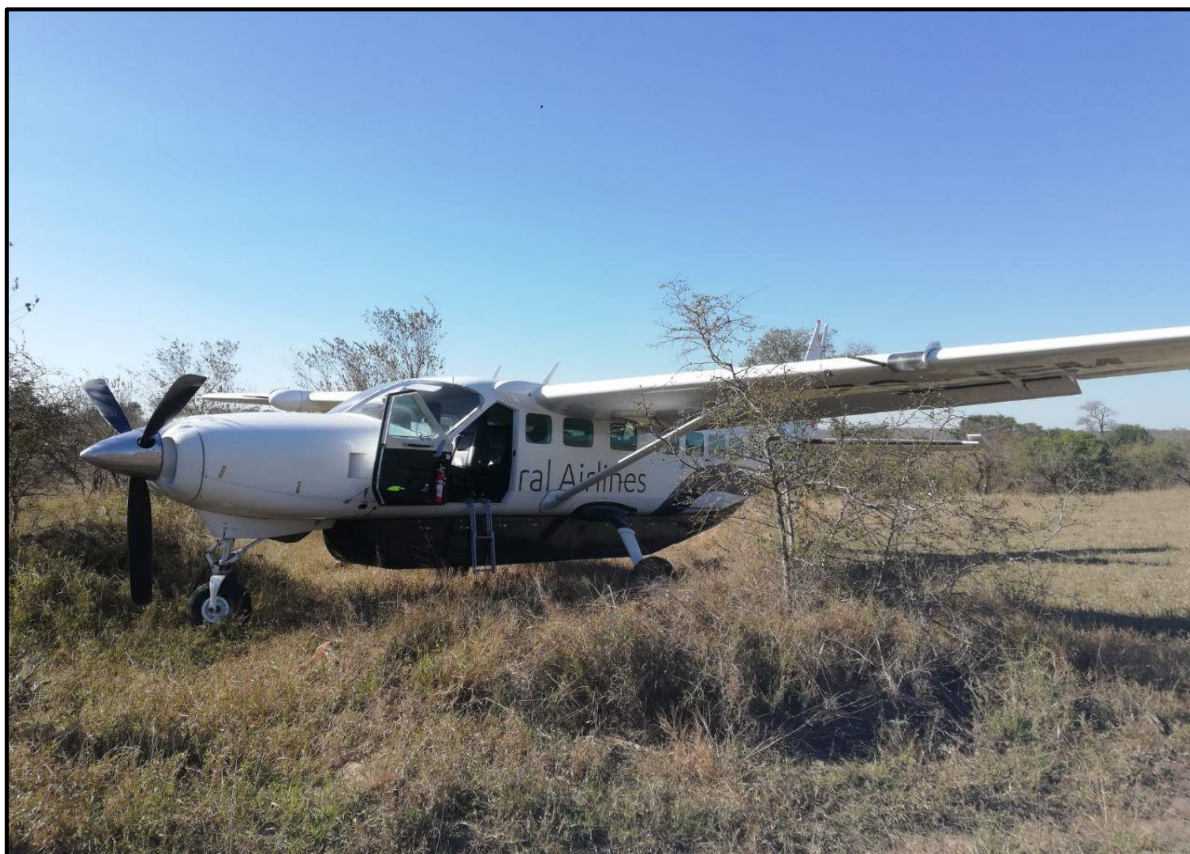
According to the PIC, the runway is an upslope when landing on Runway 34. He stated that the aircraft's regulated 92% maximum take-off weight (MTOW) made it difficult to bring the aircraft to a stop. The PIC stated that he steered the aircraft 90° to avoid impacting the shrubs and trees.

Figure 1: The aircraft as it came to rest. (Source: PIC)

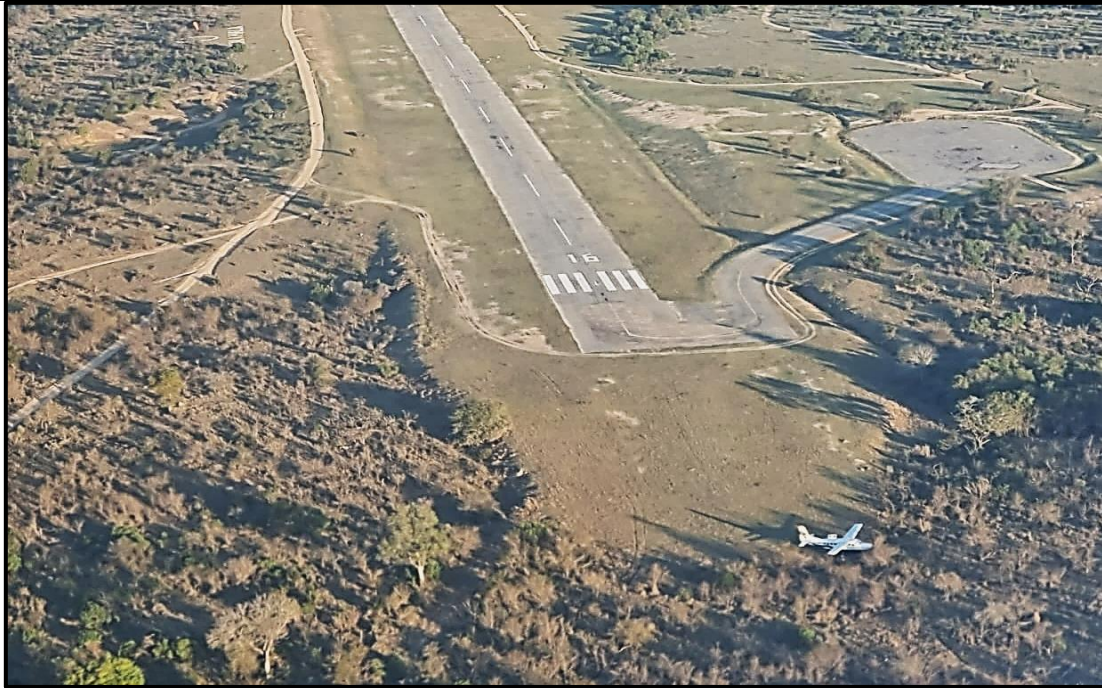
Figure 2: Aerial view of the threshold of Runway 16 and ZS-JEM's resting position.
(Source: Operator)

The aircraft's speed was high which resulted in the aircraft floating during a flare, followed by a deep landing. The aircraft veered off to the left of the centreline and overshot the runway by 180m before it came to a stop. The cause was attributed to the right calliper bleed valve leak which resulted in the drop in brake pressure on the right, and which caused the aircraft to veer off to the left of the centreline.

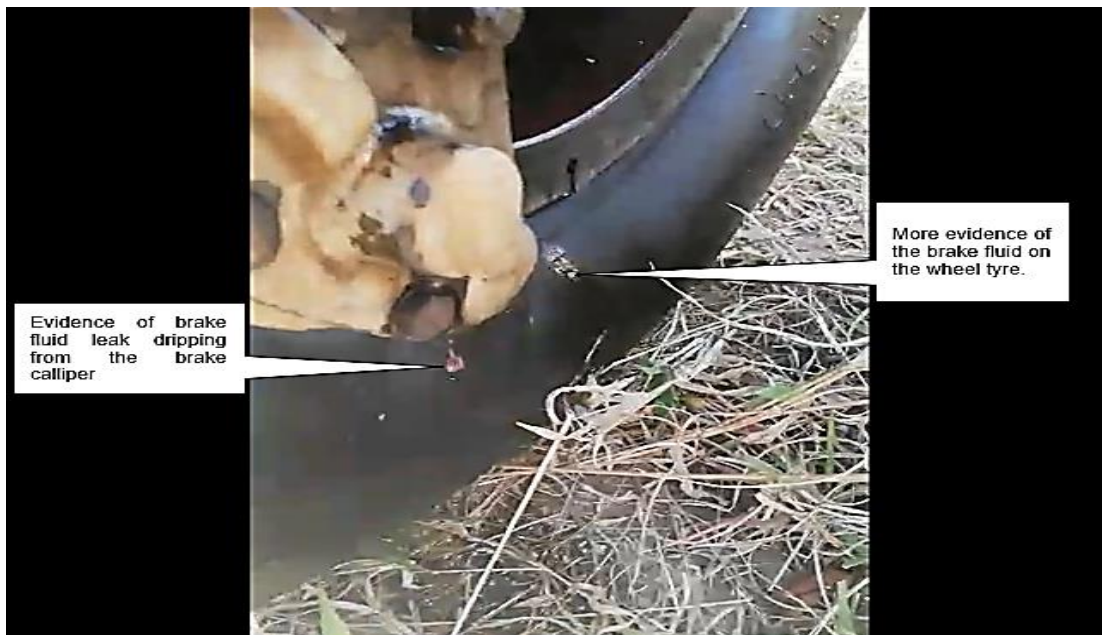
After seeking help from the fire-fighting personnel and game rangers, the passengers and their luggage were transported in the game ranger's vehicle to a safe place at the lodge. The crew conducted further inspection on the aircraft, and they noticed skid marks on the left wheel. As they went around to the right wheel to inspect it, they noticed brake fluid seeping from the bottom part of the right brake calliper.

Figure 3: A snapshot taken from the video footage. It shows the brake fluid leaking from the brake calliper, and evidence of brake fluid on the tyre. (Source: PIC)

- 1.7. The aircraft's right landing gear wheel brake calliper O-ring was found damaged, probably due to pinching during fitment. Although the Number 3 piston O-ring was pinched during fitment, there was no evidence of fluid leak on the Number 3 piston area. The only leak observed was on the right calliper bleed valve.

Maintenance crew and AMOs should develop procedures that will ensure that the brake calliper O-rings are fitted correctly to prevent possible leaks and brake failure during operations.

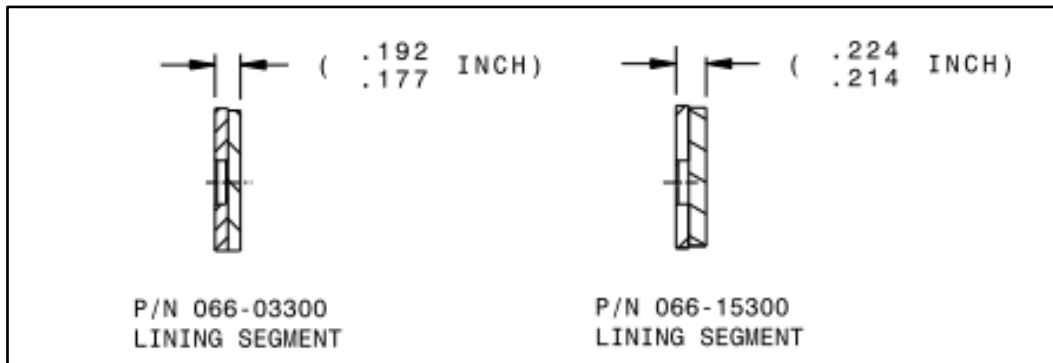
Reason: A complete design of a new brake lining, 066-15300 that offers brake lining life. Brake lining 066-15300 is thicker with more wearable friction material than existing lining. There is sufficient running clearance in existing brake frame designed to fit 066-15300 linings.

Description: Lining P/N 066-03300 used in the P/N 30-182 brake assembly is superseded by P/N 066-15300 used in the P/N 30-182A brake assembly.

Caution: Lining must be used in complete set on each brake assembly. The 066-15300 lining is 0.035 inch thicker than the 066-03300 lining.

Figure 4: Difference in brake lining.

The operator has, since this incident, embarked on upgrading all its fleet brake assembly units as advised in the manufacturer's Service Bulletin 7105, as well as implemented measures to monitor the O-ring's durability during operations.

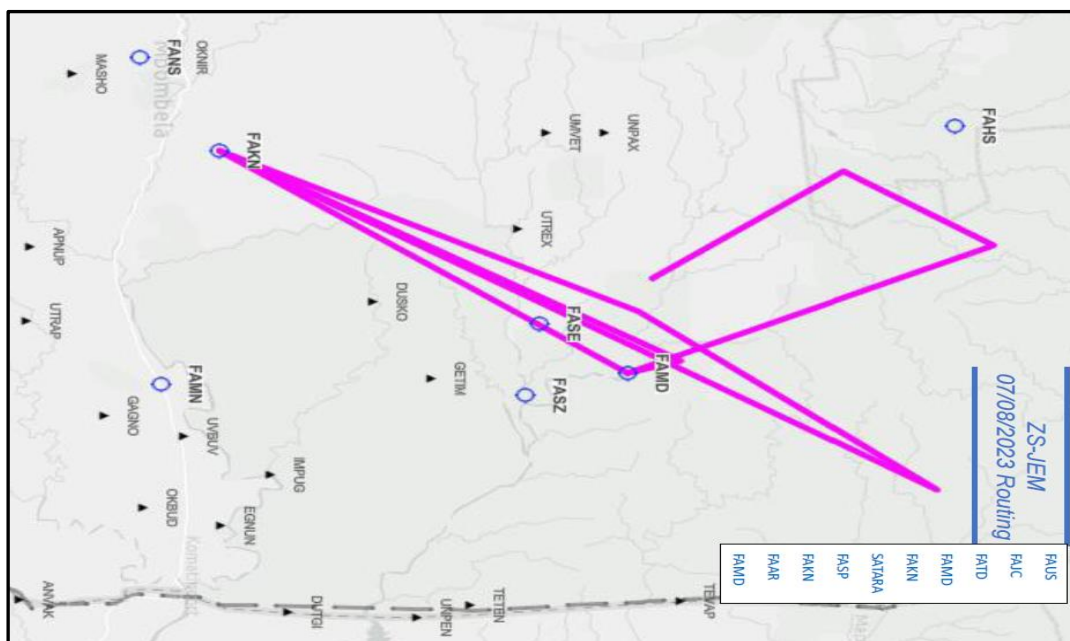
The investigation found that the daily scheduled 13 sector flights are conducted within a 40 nm radius with most airfields located in proximity to each other, and range about 12 nautical miles. The longest range is 40 nm. Moreover, the airfields conditions differ, with some runways covered in gravel and grass, and others in asphalt. In addition, some runways are short, whilst others have sufficient length. It should be noted that the runway at FAMD was sufficient during this incident, with a total length of approximately 1308 metres (m) and a width of 23m. *Figure 5 shows all 13 daily scheduled sectors for ZS-JEM within a 40 nm radius.*

Figure 5: The aircraft's daily 13 sectors route.

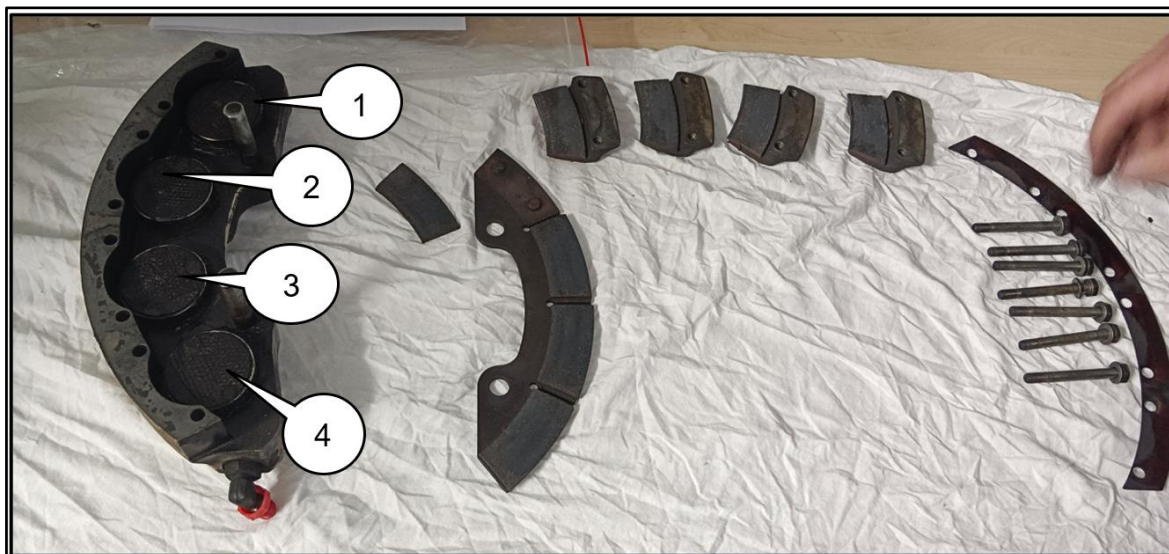
Figure 6: The brake calliper components with numbers pointing to the brake cylinder pistons.

The brake linings were found to be within limits; they measured 0.13 inches (inch). During disassembly, it was found that the Number 3-cylinder O-ring was damaged. Although other O-rings had evidence of hardness condition which could be related to brake heat generated during the operation of the aircraft over a lengthy period, only the Number 3-cylinder O-ring was damaged. The O-ring had peeled off, which indicated damage that could be attributed to high friction whilst engaging brake mechanism. It was also noted that the O-ring calliper was changed in the last maintenance inspection on the aircraft on 15 June 2023 prior to the incident. The Number 3 brake calliper O-ring was likely damaged during operation, which could also be associated with excessive heat generated during brake application. The Number 3 piston displayed signs of overheating and had traces of thick black hydraulic fluid film around it.

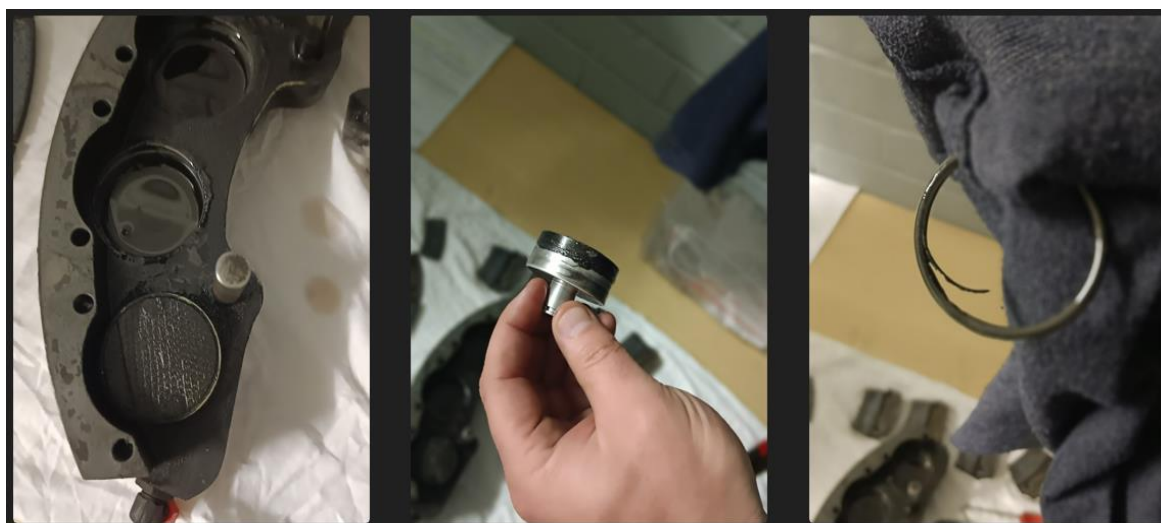
Figure 7: Brake calliper's third piston and the O-ring.

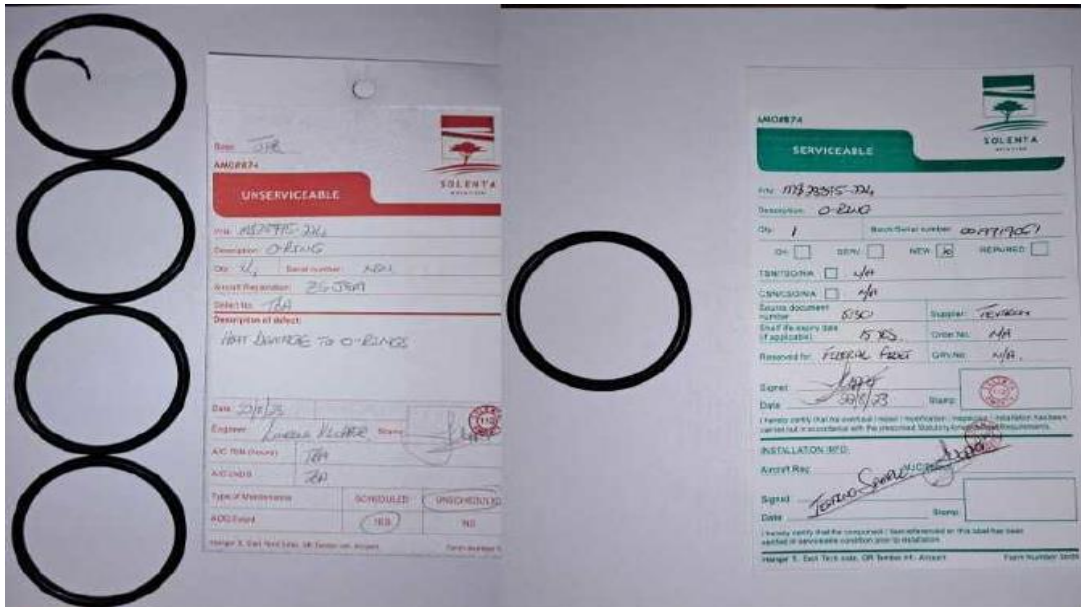
Figure 8: Four submitted O-rings (left) and a reference O-ring (new) on the right.

The shore hardness tests revealed an average increase of $\pm 26\%$ between the new and used O-rings. This is indicative of exposure to operational time (a function of operating temperature variations, type of fluids and pressure) and total time since manufacture (natural ageing; a function of material composition, storage conditions etc.).

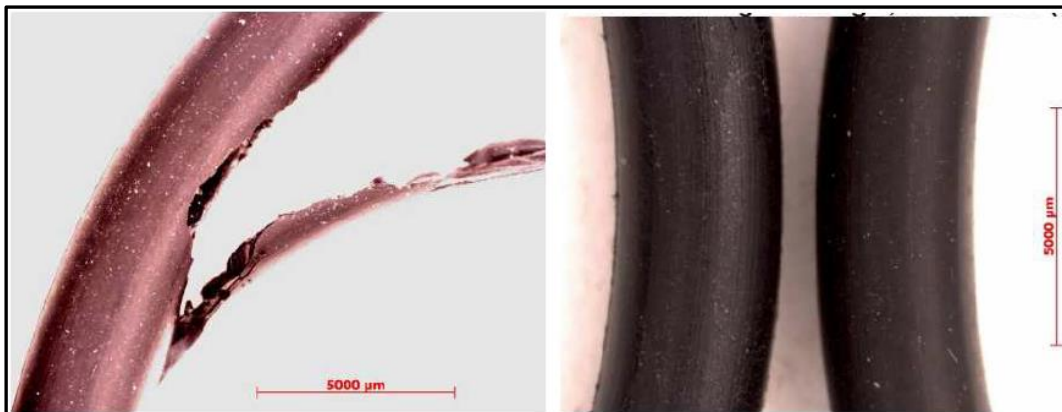
The visual inspection revealed a single O-ring with a tear within the inner circumference (Refer to Figure 9).

Figure 9: Damaged O-ring (left) and a comparison of new and used O-ring surfaces (right).

- The used O-ring revealed a fracture (tear) to a single unit and some indications of surface imprints.
- The new and used O-rings compared favourably under the unloaded and loaded tests (ASTM D1414) with no clear transverse cracking.
- The used O-ring revealed no clear indications of exceedingly high temperature exposure/s.
- The fractured O-ring revealed clear indications of pinching corresponding with the initio on location of the fracture (tear). This could be attributed to incorrect fitment.
- The shore A hardness and dimensional test results compared favourably to the expected NBR O-rings exposed to a period of operation. However, the exact period of operation was not disclosed to this investigation.

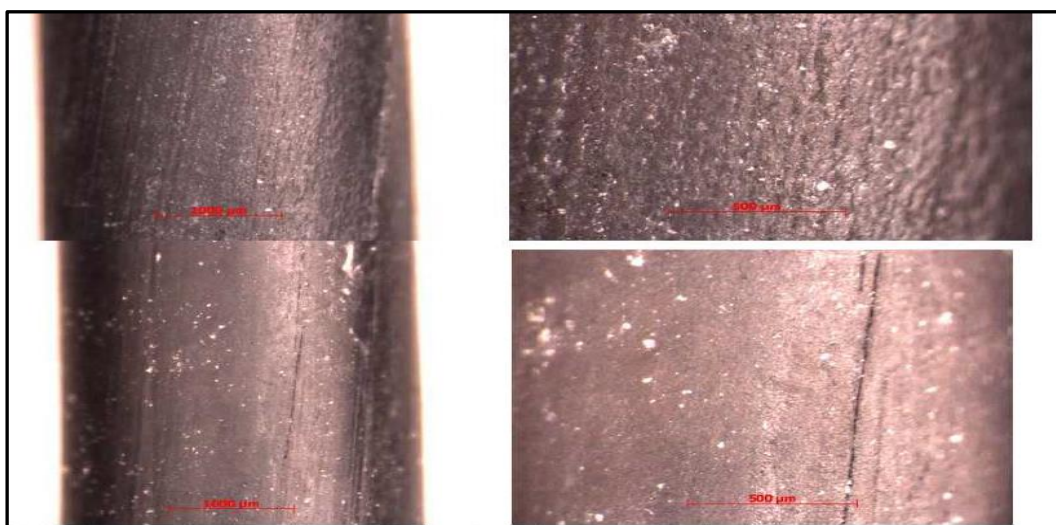
Figure 10: New (top) vs used (bottom) surfaces morphologies (stereo).

Surface imprints were noted on O-ring 2.

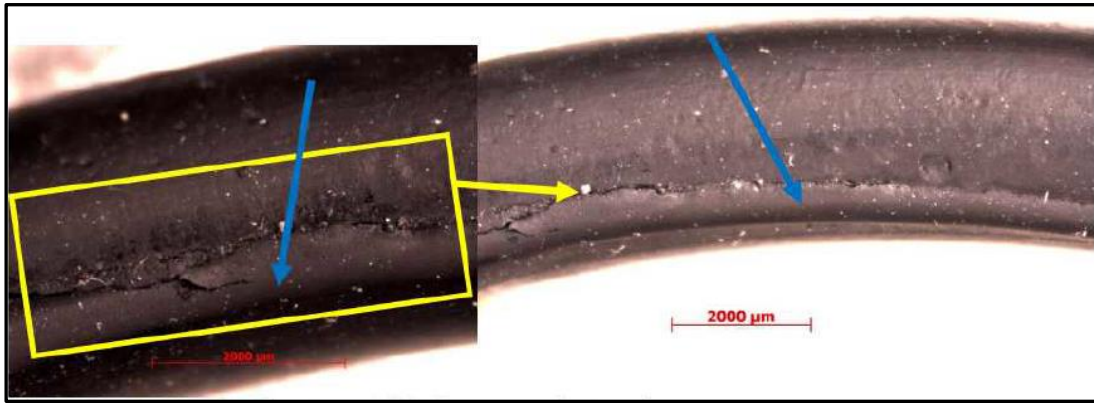
Figure 11: Fractured initiation zone (stereo).

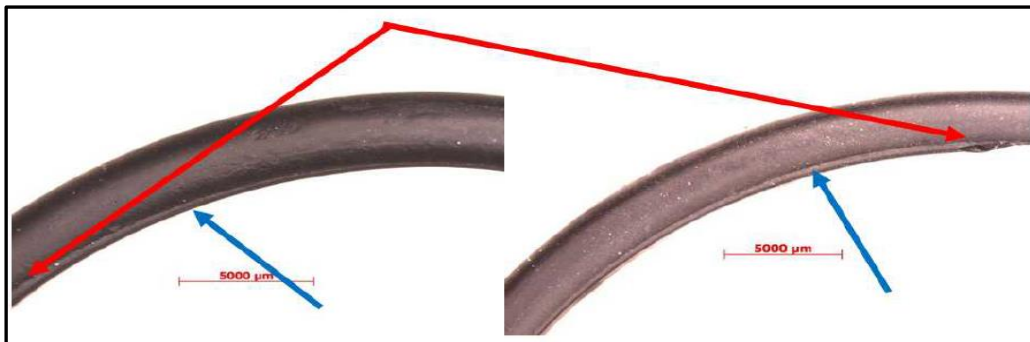
Figure 12: O-ring fracture initiating zone and lipped area (stereo).

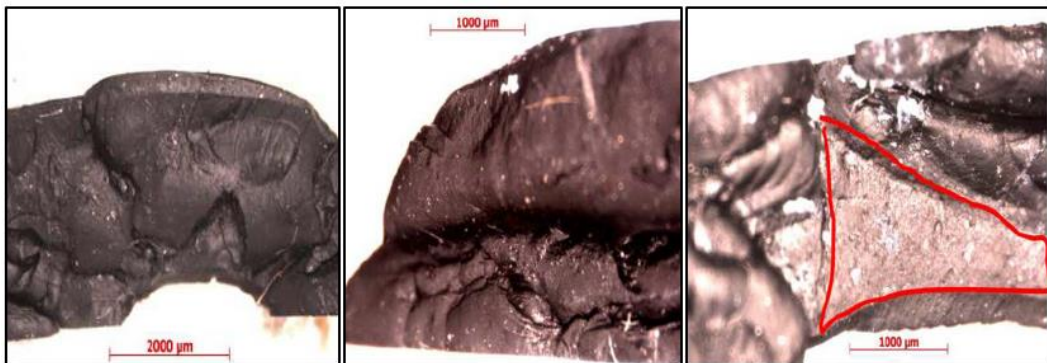
Figure 13: Three stages of fracture surface morphology (stereo).
