AIRCRAFT SERIOUS INCIDENT REPORT AND EXECUTIVE SUMMARY

Reference:	CA18/3/2/1425	
Aircraft Registration	ZS-JLD & ZS-JGD		Date of Incident	4 August 2023	Time of Incident	1100 Z
Type of Aircraft	Piper-28R-200 & Piper-28-180		Type of Operation		Training (Part 141)	
Pilot-in-command Licence Type (ZS-JLD)	Student Pilot Licence	Age	23	Licence Valid	Yes	
Pilot-in-command Flying Experience (ZS-JLD)	Total Flying Hours		108	Hours on Type	98	
Pilot-in-command Licence Type (ZS-JGD)	Commercial Pilot Licence	Age	29	Licence Valid	Yes	
Pilot-in-command Flying Experience (ZS-JGD)	Total Flying Hours		532.8	Hours on Type	83	
Last Point of Departure (ZS-JLD)	Port Alfred Aerodrome, (FAPA) Eastern Cape Province					
Next Point of Intended Landing (ZS-JLD)	Port Alfred Aerodrome, (FAPA) Eastern Cape Province					
Last Point of Departure (ZS-JGD)	Port Alfred Aerodrome, (FAPA) Eastern Cape Province					
Next Point of Intended Landing (ZS-JGD)	Port Alfred Aerodrome, (FAPA) Eastern Cape Province

Reference Number : CA18/3/2/1425
Name of Owner/Operator : 43 Air School
Manufacturer : Piper Aircraft Company
Model : Piper-28R-200 and Piper-28-180
Nationality : South African
Registration Mark : ZS-JLD and ZS-JGD
P

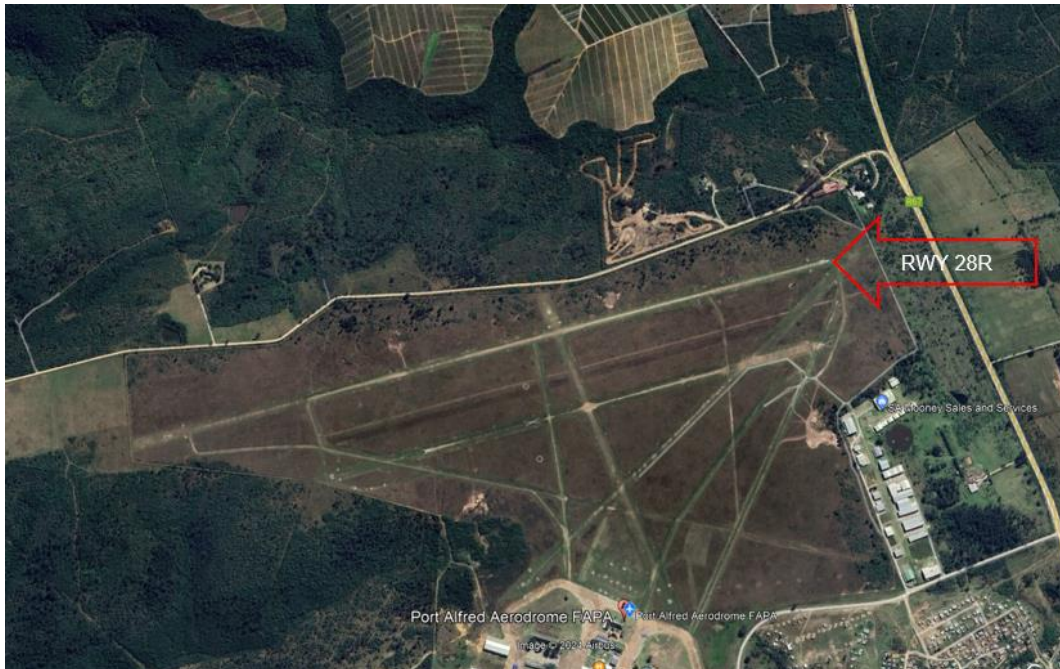
- 1.1.6 The serious incident occurred during daylight on late right downwind RWY 28R at FAPA and at Global Positioning System (GPS) co-ordinates determined to be 33° 32' 53" South 26° 53' 36" East, at an elevation 288 feet).

Figure 1: Serious incident location showing RWY28R. (Source: Google Earth)
