AIRCRAFT SERIOUS INCIDENT REPORT AND EXECUTIVE SUMMARY

Reference:		CA18/3/2/1426					
Aircraft Registration		ZS-TWF & ZS-CPL	Date of Incident		13 August 2023		Time of Incident		1510Z		
Type of Aircraft		Pilatus PC 12 and Cessna 172		Type of Operation		Private (Part 91)					
Pilot-in-command Licence Type		Commercial Pilot Licence (CPL) and Private Pilot Licence (CPL)		Age		25 and 27		Licence Valid		Yes	
Pilot-in-command Flying Experience			Total Flying Hours			2 154.5 and 1 49.7		Hours on Type		462.7 and 123.2	
Last Point of Departure		Welkom Aerodrome (FAWM) and O.R. Tambo International Airport (FAOR)									
Next Point of Intended Landing		Lanseria International Airport (FALA)									
Damage to Aircraft		None									
Location of the incident site with reference to easily defined geographical points (GPS readings if possible)											
At 6 000 ft on right downwind Runway 07 at FALA Lanseria International Airport (FALA)											
Meteorological Information		Wind velocity: 220° at 11KT; Temperature: 26°C; Dew Point: -09°C; Visibility: ≥10000m; Cloud: CAVOK; QNH: 1023 hPa

Probable Cause/s and/or Contributory Factors											
Loss of vertical separation due to an instrument e

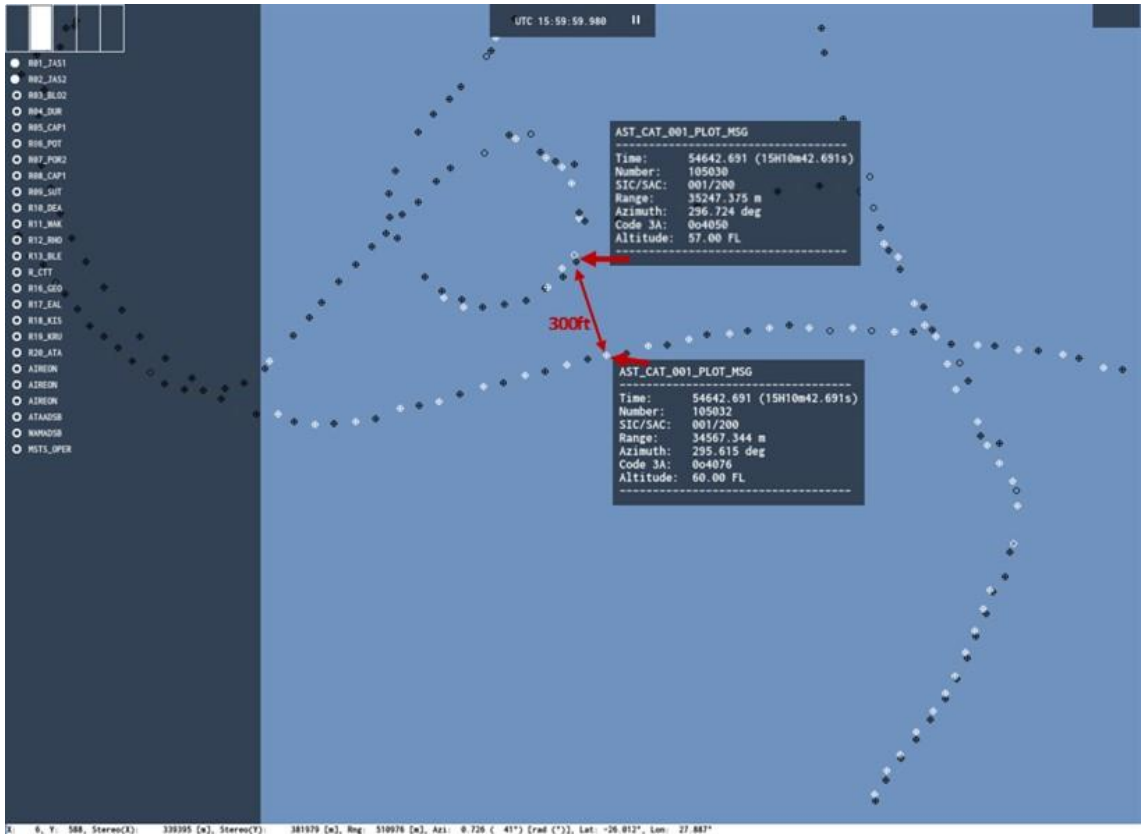
Figure 1: A radar plot of ZS-CPL and ZS-TWF indicating reduced vertical separation of 300ft. (Source: ATNS/TopSky)

1.1.7. The reduced vertical separation serious incident between 5 700ft and 6 000ft occurred on right downwind RWY 07 at FALA.

- 3.2.8. The two aircraft had a vertical separation of 300ft. The required separation is 500ft as stated in SACAA Standards and Procedures Air Traffic Control Instructions Manual Section 2. The loss of separation was caused by the error in the pitot-static system of ZS-CPL which resulted in the transponder reading 300ft less than the actual altitude.
